Restoration Report

**Restoration of
The Vestibule in Villa Medici of Merignano
Induno Olona (VA)**

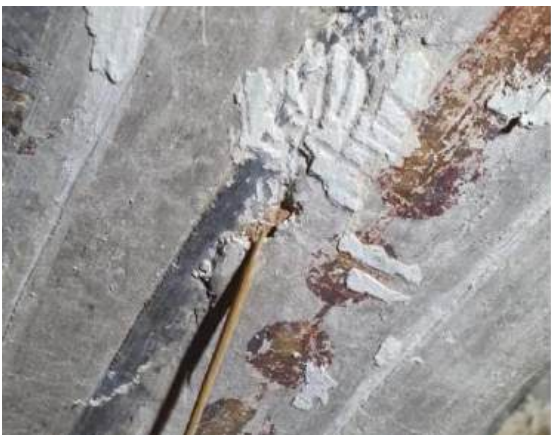
Fig 11 - Loss in plaster layer with view of brick of the support

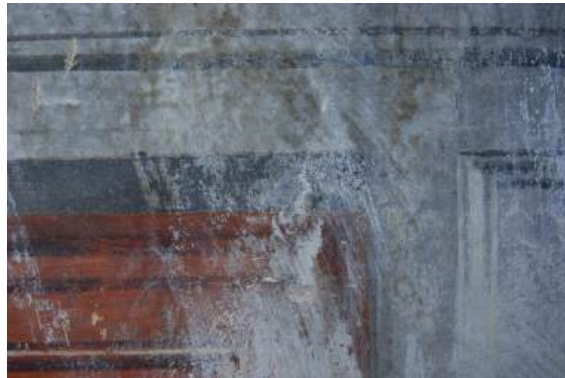
Fig 22 - Oldest Semi-transparent whitewash layer

It is clear that the whitewash layer also appears within abrasions and shrinkage cracks. This layer may have been applied during the construction of the church (1725-1727), when the arched passage in the southeast wall was created, and possibly when the capitals were removed. It is also likely that the door connecting the vestibule to the rear staircase was sealed at the same time.

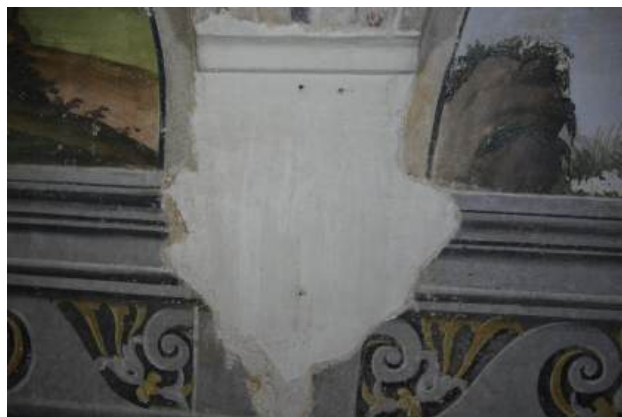
Fig 23 - Removed capitals for unknown reasons

For the capitals, one potential solution could involve maintaining the visibility of their original shapes, using materials and tones that blend harmoniously with the surrounding plaster while remaining distinguishable. This approach would preserve the historical memory of these architectural elements without excessive mimicry that might compromise the intervention's transparency. However, this method also poses challenges, such as the complexity of selecting appropriate materials and tones that might not fully align with aesthetic expectations.

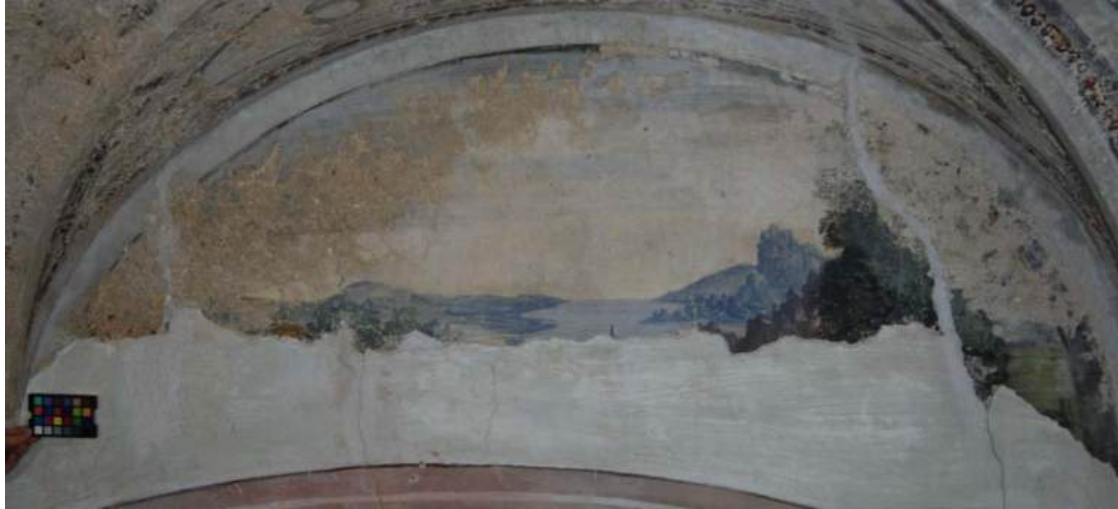
Fig 24 - Thick multiple layers of whitewash on the South-East wall above the entrance to the Chapel

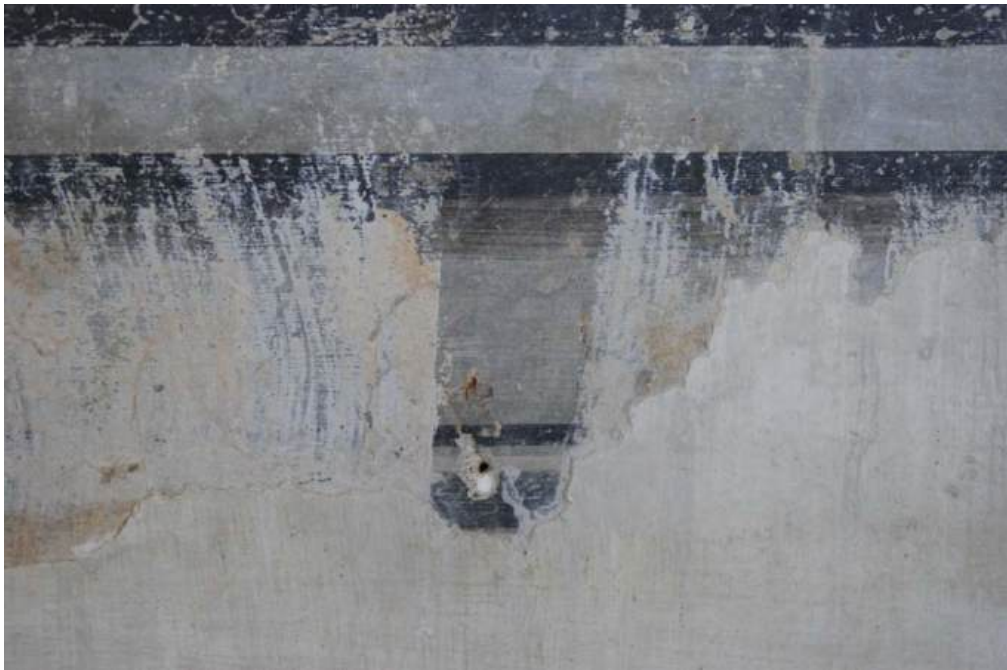
Fig 25 - Different layers of whitewash

The thick layer of dirt on top of this whitewash suggests a long period of time passed before the next layer was applied. This next layer consists of a thick whitewash, probably from the Austrian occupation, with an additional white coat applied on top. At an unknown point in time, an initial de-whitewashing intervention was carried out, which left several scratches and marks on the surface due to an inappropriate restoration technique.

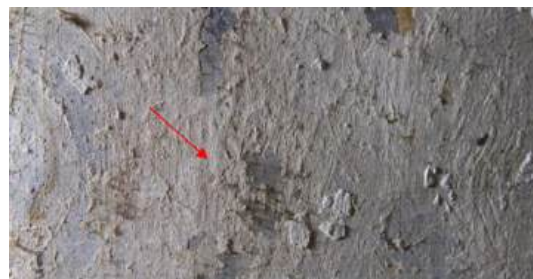
A first assumption was that there might have been wallpaper on the lunettes at some point in the past which was then removed and left glue and fibre residues, but the removal of wallpaper presumably would have caused damage to the wall paintings underneath, which there were no traces of. As these first two layers are only present on the lunettes, a change of the owner who covered the landscape depictions presumably in the 16th century is a possible hypothesis.

Fig 28 - Detail of second whitewash with fibers on lunettes, LNWI3

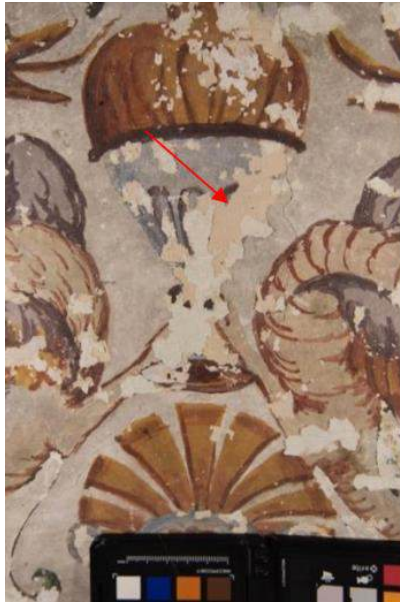
Fig 29 - Yellow whitewash layer on vault and lunettes, VNE1

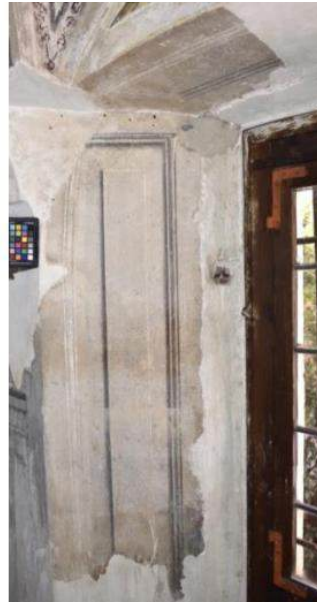
The walls surrounding the window on the southwest side exhibit a noticeable difference in paint color, appearing beige, in contrast to the grey tones of the lunettes' frames (Fig. 41 and 43). Since the infillings of the removed capitals show no signs of retouching and the walls were covered with at least the most recent whitewash, it is likely that this alteration occurred before the capitals were removed. The yellow whitewash and beige-painted window frame could represent a new color scheme applied by a potential new owner of the Villa, likely in the 17th century.

Fig 30 - Colour difference of frame of the window and lunette

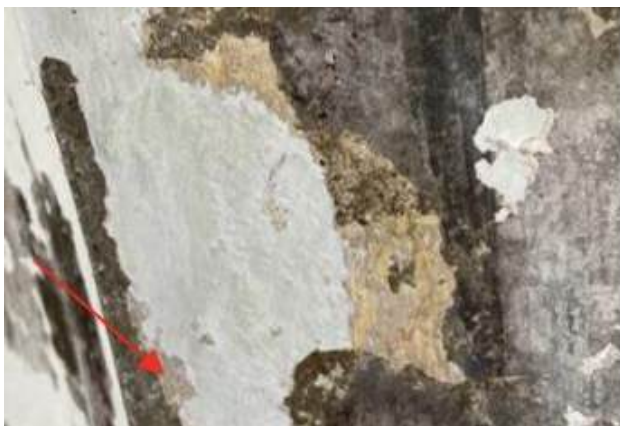
Fig 31 - gray whitewash, VSE2

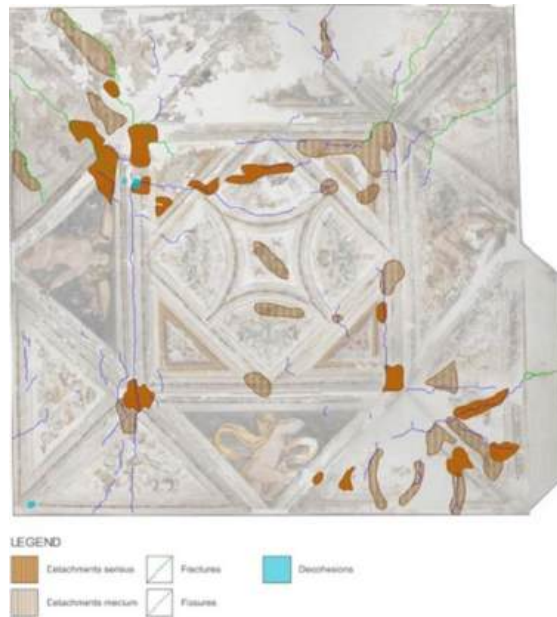
The plaster layers show widespread detachment and fractures. These discontinuities are likely caused by structural stresses related to the construction of the church adjacent to the vestibule. The detachment is particularly evident in areas where it overlaps with fractures, especially in the lunettes, suggesting a correlation between the two phenomena. In some instances, the fractures had been previously filled with stucco, but the detachment persists, indicating the need for consolidation interventions. Moreover, the presence of significant dust and dirt within these fractures suggests that they are not recent.

Fig 33 - Mapping of detachment, fractures, and de-cohesions

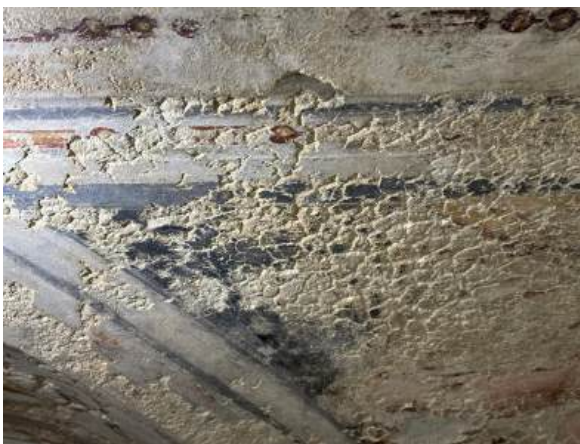
The artwork initially exhibited a combination of degradation phenomena affecting both the plaster layers and the paint layer. Among these were widespread fractures, some of which can be traced back to past structural interventions, while others resulted from the worsening of shrinkage cracks. These fractures are often accompanied by abrasions that have caused localized losses of plaster and paint, further exacerbated by past water infiltration. The water facilitated the solubilization of binders and the introduction of soluble salts, contributing to material disintegration and loss. The paint layer appears patchy and is still partially covered by layers of whitewash. Additionally, through UV light and Dino-lite examination, an organic carbonaceous deposit, likely soot, was detected on the paint layer. This is probably a result of the use of a stove when the vestibule was used as a living space

Fig 34 - Shrinkage cracks and material loss.

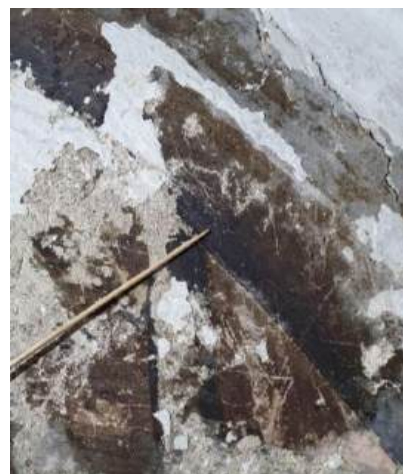
Fig 36 - Organic soot-like material on the surface LNE3

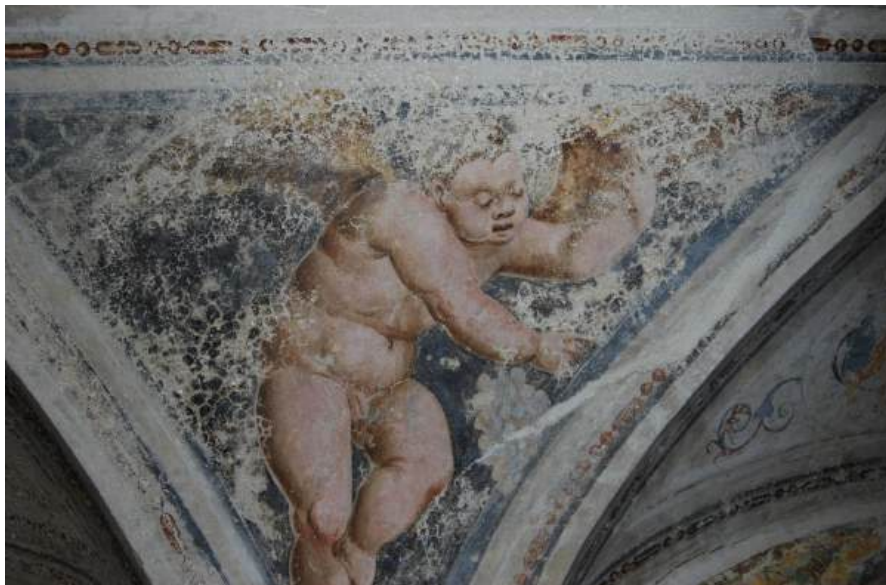
Thanks to previous restoration efforts, the artwork is in good condition, with the painted surface being well-fixed and stable, showing no signs of further structural degradation. However, the painted surface is visibly worn, and there are significant lacunae in some areas, which affect the overall readability of the piece. A key point of focus was the partial removal of the whitewash on the lunettes identified as VNW1, which had been addressed in prior interventions. Due to the strong adhesion of the whitewash to the painted surface, a complete removal was not possible. As a result, traces of whitewash remain in certain areas, particularly in more fragile spots or where removal is more difficult.

Fig 39 - Surface Highly Abraded, Loss of Artwork Legibility

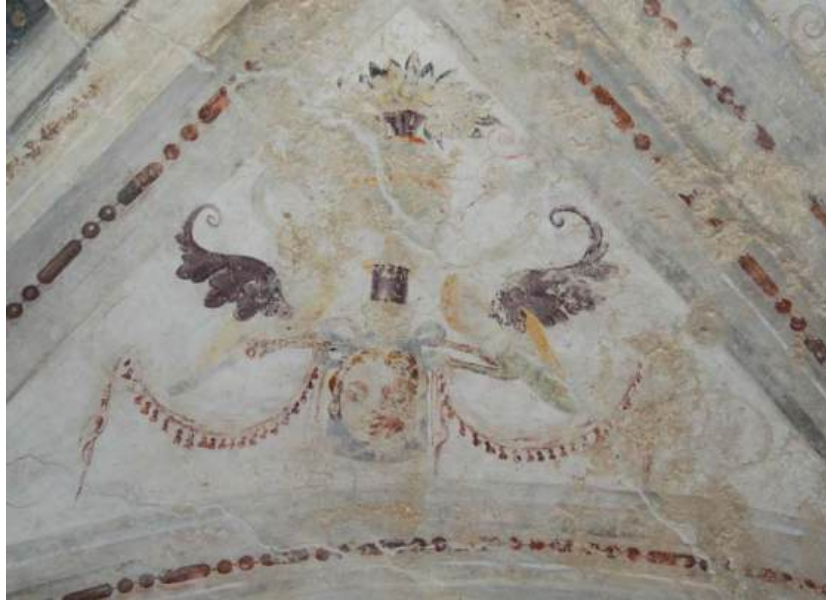
Fig 40 - Pigment loss
