Object: Fresco

Original Location: Breakfast Room at Hotel Mia Cara, Florence, Italy.

Subject: A nun, Saint Giovanni and a noble

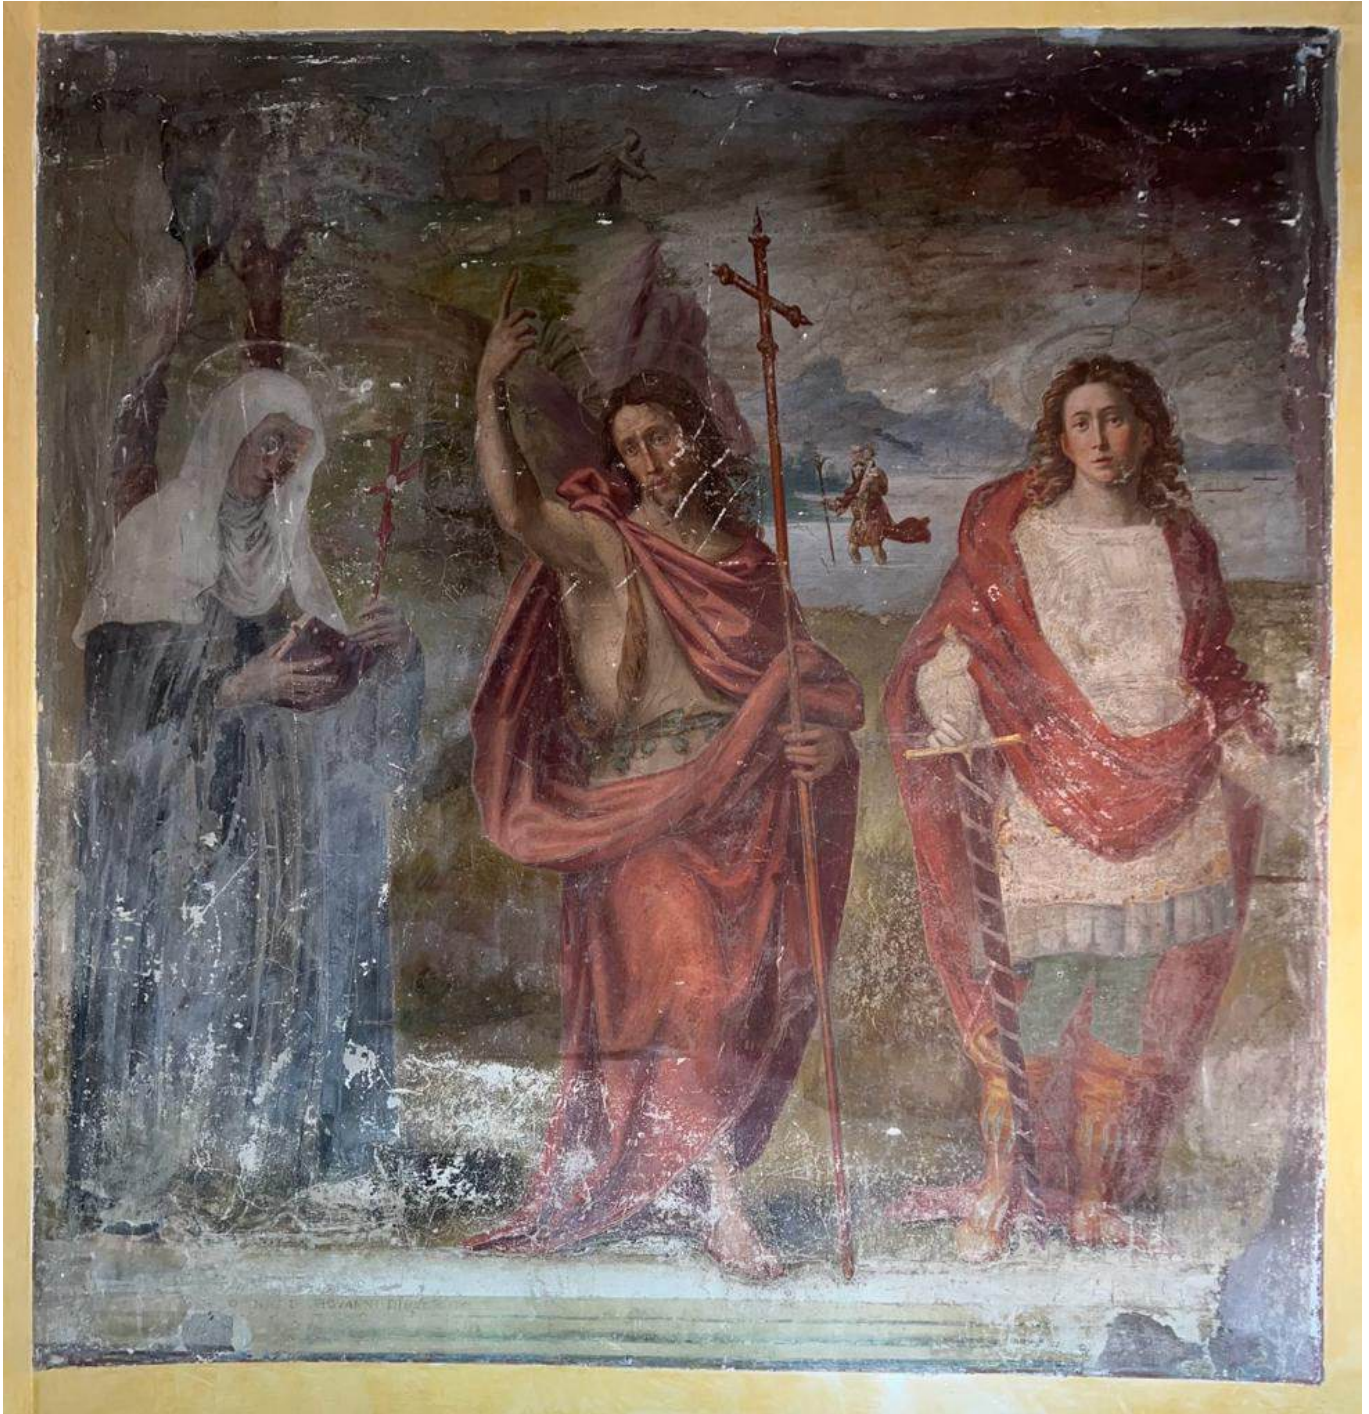
Fig. 1

This fresco is located on the wall of a breakfast room of Hotel Mia Cara, located in the city center of Florence, Italy. The fresco is painted next to another fresco that seems to be have painted around the same time but possibly by a different artist. The artist has painted 3 figures, a nun on the left, what possibly looks like Saint Giovanni and a noble man wearing a gold armor and other gold accessories. The entire fresco is painted using only three huge giornate or day pieces (Fig. 2). The fresco is exposed to tourists and is located in a closed and usually busy room. The bottom half of this fresco is in reach of people with average height. The nun seems to be looking down at a book while Saint Giovanni (possibly) is seen point one finger up and holding a cross in the other hand. The noble man is wearing a gold-gilded, intricately designed armor, holding a gold-gilded bird and a sword. In the background, the artist has painted, what seems to be a Joseph and baby Jesus on his shoulders (Fig. 3).

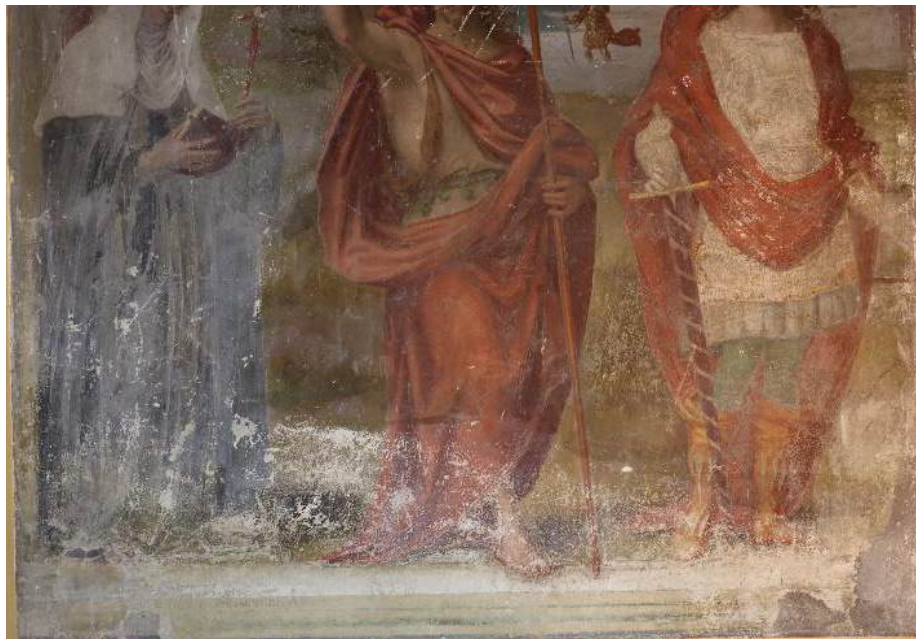
Fig. 4

The fresco is seen to be in a mediocre state of conservation. There is a deposit of incoherent materials like dust and grime, on the entire surface of the painting which is caused due to negligence of conservation of the fresco. As the fresco is located in a breakfast room filled with people, the lower half of the fresco seem to have a lot human interventions that have damaged the fresco (Fig. 4). The pictorial layer seems to have darkened and a lot of aspects of the fresco have faded away causing a loss in the brilliance of the pigments that were originally used. There are signs of previous restoration like some retouching and in-fillings. The material used for previous in-fillings seems to be loose and applied unevenly. There are big cracks that go around the top frame of the entire fresco, where the previous in-fillings were poorly executed (Fig.5). There are holes and losses in various places in the intonaco, some filled and some left un-filled. There is visible abrasion all over the fresco, predominantly on the left corner and around the nun (Fig. 6). There seem to be a patch of plastic-like filling stuck on the nun's eye (Fig.7). The saint and the noble man seem to be in a better condition, compared to the nun. The gold-gilding on the armor and sword seem to be lost in a lot of places, and only little details remain. The entire frame has been remade using a cement like material, causing cracks and an uneven frame. The documentation was done under UV light as well in order to reveal any foreign material on top of the surface layer (Fig. 8).
