## CHURCH OF SAN VITTORE, MURALTO (LOCARNO)

### THE CRUCIFIXION

#### Report on the Conservation Status of the Fresco Cantiere Studio – BWP 2.1

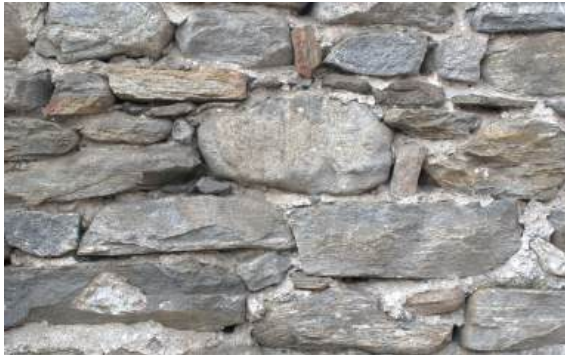
Fig.3. Exterior Mural Structure

These stone blocks are meticulously fitted together with minimal mortar (fig.3). The Romanesque style is prominent, particularly evident in the Lombard arches which is a characteristic decorative feature used to adorn the apses and the central part of the church's facade (fig.4).

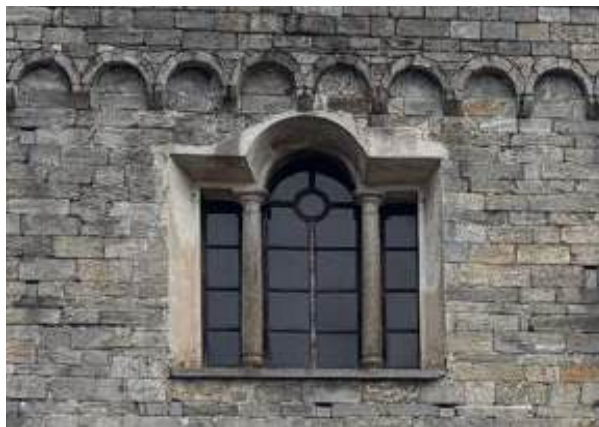
Fig.5. Serlian arched window replaced the original oculus

The main facade reflects the church's three-part internal structure. Pilasters frame the middle section, and a decorative frieze of hanging arches runs beneath the gabled roof. After 1597, during the Counter-Reformation period, the original medieval oculus (round window) was replaced by a new Serlian arch for facade changes with a Serlian window (fig.5). The granite entrance portal, dating to the 16th century, is flanked by ornate wooden doors carved with intricate floral patterns and symbolic designs, notably a depiction of the Tree of Life surrounded by lions (fig.6). The facade also incorporates 'bucce pontaiie,' small, partially filled rectangular apertures in the stonework, which are utilized by a protected species of swifts to build their nests.<sup>9</sup>

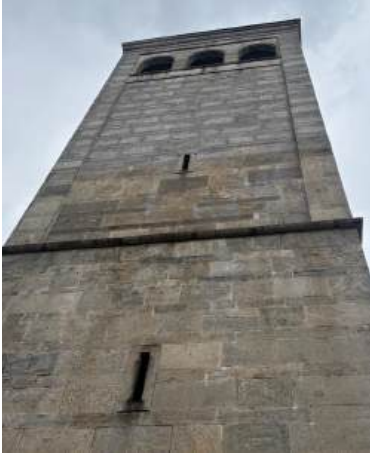
Fig.9. Evidence of different constructions on the bell tower

The bell tower, appended to the southern nave, clearly displays two phases of construction (Fig.9). The lower section, erected in 1524, is composed of yellowish stone blocks, some of which were repurposed from the Visconti Castle in Locarno.<sup>12</sup> A marble plaque dated 1527 on this lower part records grain prices during a period of famine. The upper portion, realized in granite and added in 1932, adheres to a neo-Romanesque style conceived to harmonize with the original stonework. A plaque featuring a bas-relief of San Vittore (Saint Victor) on horseback, holding a banner with a depiction of the Trinity (Fig.10), adorns the western side of the bell tower. Evidence suggests a doorway, possibly an earlier entrance, was filled in during the bell tower's second construction phase (Fig.11), and the entrance was relocated to the side, where a large arch was later created, subsequently filled, and fitted with a wooden

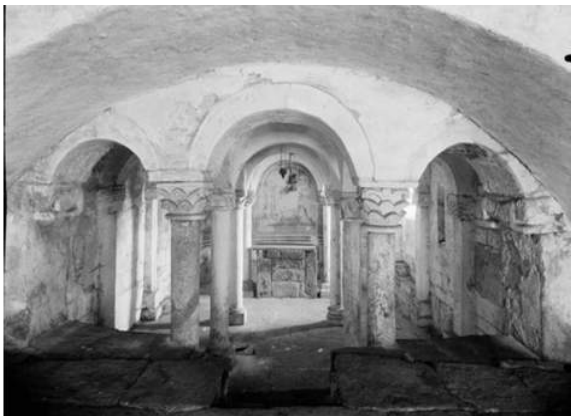
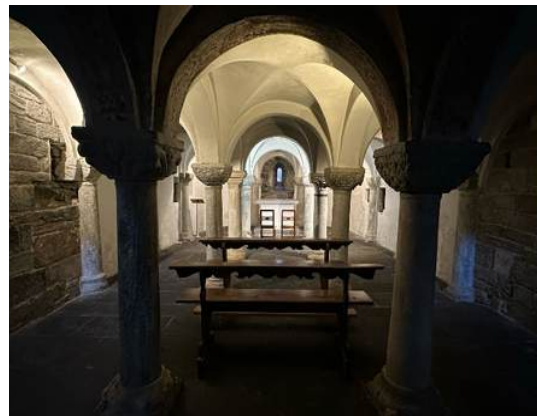
*Fig. 16 & 17. The crypt before and after conservation*

The 20th century was characterized by extensive restoration efforts aimed at recovering the church's medieval essence and artistic heritage. Crypt conservation was undertaken between 1960 and 1963, followed by a major restoration campaign from 1965 to 1984 (fig.16 & 17).<sup>27</sup> These initiatives led to the discovery of Gothic fresco fragments, the restoration of Baroque stucco, and the reopening of original Romanesque windows, as well as the removal of the neo-Gothic vaults which led to the rediscovery of the fresco of the Cycle of Genesis.<sup>28</sup> Additionally, archaeological openings were made in the walls to expose earlier structural elements, providing valuable insights into the church's history.

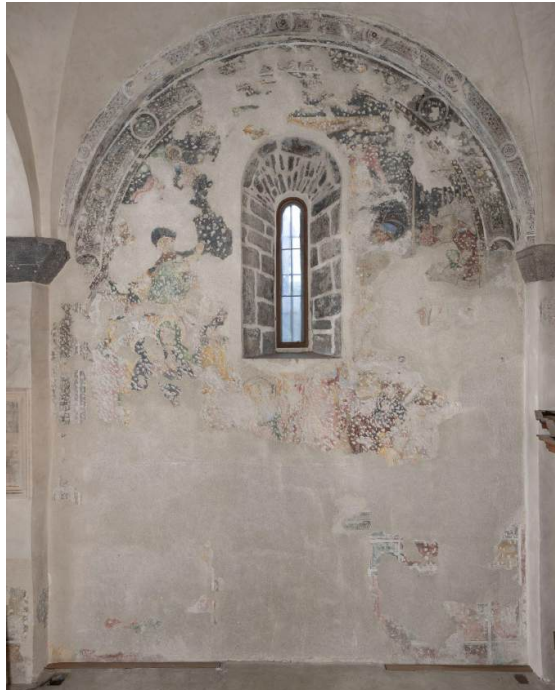
*Fig.18. The Crucifixion Fresco*

The Crucifixion fresco (fig.18) in San Vittore, dating to the early 15th century, stands as one of the church's most significant artistic expressions, though it has suffered considerable deterioration over time. Located in the right aisle, it portrays the classic composition of Christ's crucifixion in a Gothic style, with the cross in the centre, surrounded by angels, reminiscent of other regional frescoes, such as the one in Santa Maria in Selva, Locarno.<sup>30</sup>

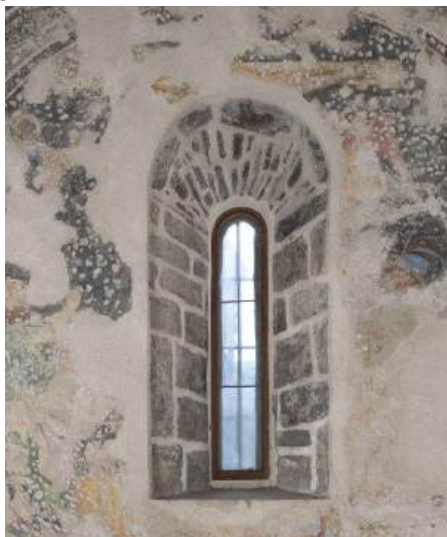
Fig.19. Figure of Christ on the cross with the window obstructing

The artist uses the most famous and common composition for any crucifixion depiction. Christ is positioned at the center on a cross, which is now obstructed because of the single lancet window(fig.19). A small part of Christ's face and arm can be seen but the rest is completely destroyed. The other prominent subjects in this fresco are the three Madonna figures whose halos, originally gilded, are rendered in relief, adding a sense of depth and radiance (fig.20). The third Madonna is hardly visible and can only be noticed due to a small fragment of her eye left behind. From all the different subjects painted in this fresco, there are Roman soldiers with horses positioned on either side of the cross(fig21 & fig.22). Incised

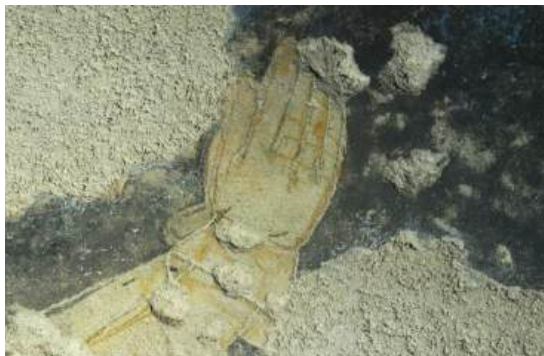
Fig.23. Incisions on Soldier's gloves and cuffs

details are used as preparatory drawings in different parts of the fresco, some are visible near the cuffs of their garments, on the spears they hold, as well as in the floral frame motifs(fig.23). One of the soldiers (San Longino) is notable for his distinctive headpiece(fig.24) and blue eyes, which sets him apart from the other figures while the other is seen in a metallic armour.<sup>31</sup>

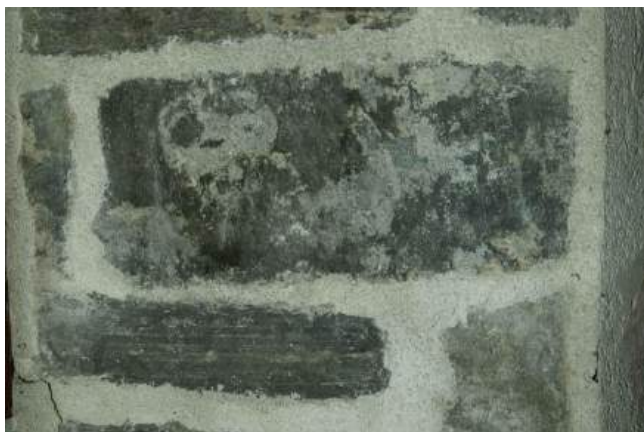
The Crucifixion fresco in San Vittore was created using both buon fresco, painting on wet plaster, and secco, painting on dry plaster, a combination that provided both lasting color and fine detail. The wall supporting the mural was constructed from roughly squared local stones of varying sizes, laid in regular courses and held together by mortar, which is visible around the single-light window (fig.25). The numerous pits caused by the hammering on the painted surface not only gives us evidence of past interventions but have also made it possible to observe the presence of a rough preparatory layer (rinzaffo) as well as the mortar used for the arriccio. Examination of the plaster stratigraphy (fig.26), reveals an overall absence of unreacted lime particles (calcinaroli), with only a few minor exceptions. This indicates that the lime employed as a binder had been thoroughly slaked and effectively combined with the aggregates during the preparation of the mortar.

*Fig.25. Mural support*

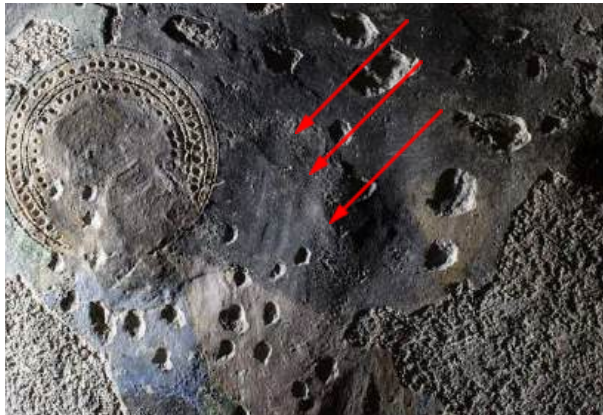
*Fig.30. Giornata evidence*

The Crucifixion is a mural painting primarily executed using the fresco technique. Despite the difficulty in immediately identifying the boundaries of the giornate (fig.30), due to numerous losses, some were recognized using raking light and further joined to reveal 7-8 possible giornate. Traces of a preliminary brush drawing, made with a black pigment which is visible in the outermost geometric frame and a yellow pigment which was used to outline the armor and spears of the soldiers on the right and Longinus on the left, are clearly distinguishable on the uppermost plaster layer. Direct incisions also appear to highlight the use of the fresco technique, particularly the deeper ones.

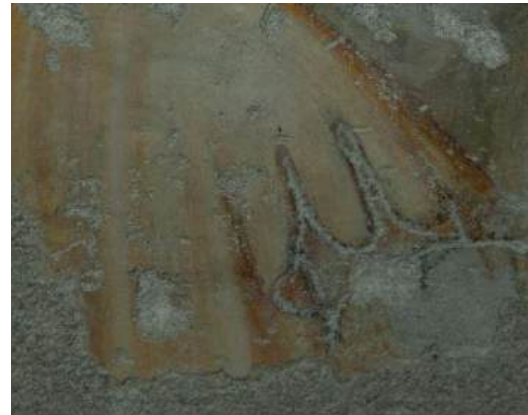
*Fig.31. Light incision with a tool*

Two types of direct incision were identified: shallow incisions made with a fine tool on the semi dry plaster, and deeper incisions defining the compass-drawn motifs of the innermost frame, the armor and spears of the soldiers on the right and Longinus on the left, and the halos of the depicted saints (fig.31,32 & 33). There were incisions in one of Madonna's dresses, a common technique for transferring drawings and guiding the fresco execution.

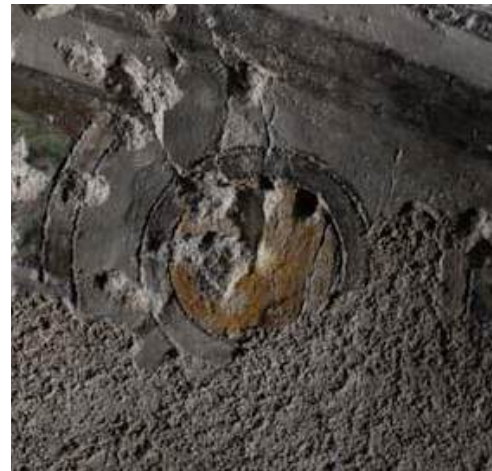
*Fig.33. Deep incisions with a compass*

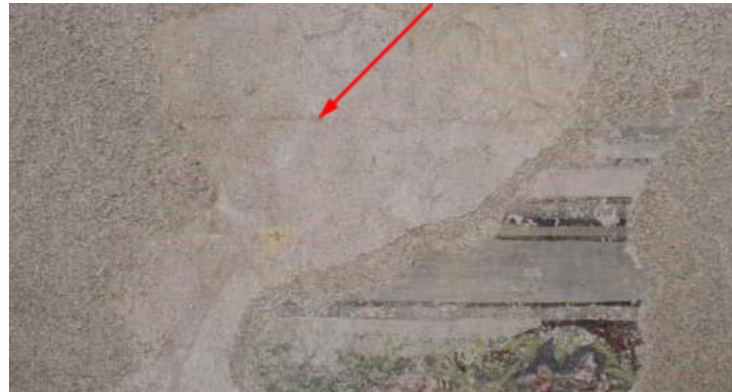
Small traces of sinopia (fig.34), a preparatory drawing made with a red pigment likely red ochre, were found on the marble altar fragment. The intonachino is the fine preparatory plaster layer applied over the arriccio (the layer which bears the sinopia drawing) to create the final painting surface; it appears this intonachino was made with a mortar of a similar composition to the arriccio. Furthermore, small wood fragments likely incorporated during preparation of the mortar, were found within the intonachino mortar in some areas of the painting (fig.35 & 36).

*Fig.34. Evidence of Sinopia*

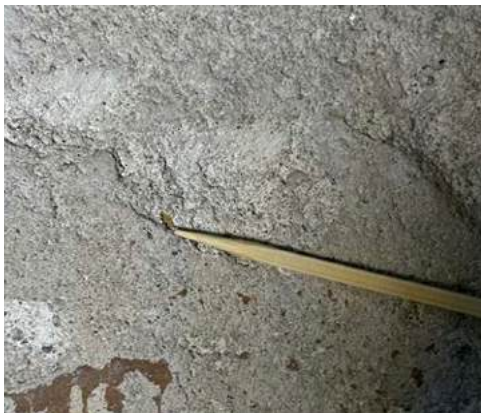
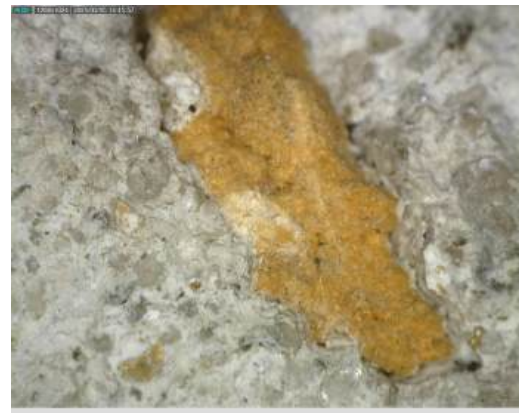
*Fig.35. Reference picture of the additive (wood)*

*Fig.36. Dino Lite (x50mag) picture of the additive (wood)*

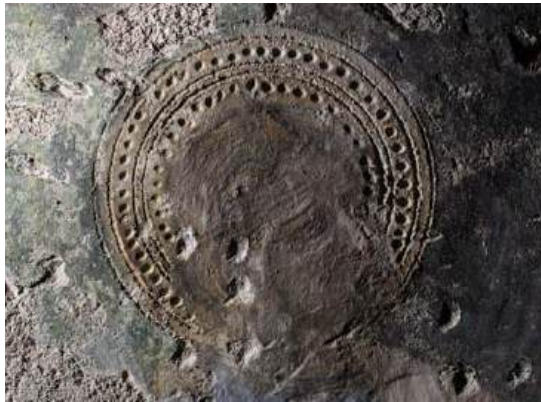
*Fig.39. Punzanatura using direct method on wet plaster*

Microscopic analysis using a portable Dino-Lite microscope, revealed traces of gilding on the spear near the helmet of the soldier Longinus within these deeper incisions, also visible under UV light, suggesting they were intended to hold gold or silver leaf (fig.37 & 38). The artist also made use of battitura di corda, a technique typically used for architectural elements or straight lines. Evidence of rope impression is visible in the lower part of the painting, in the imitation polychrome marble frame, and in the upper part, particularly on the spears of the soldiers on the right, where the rope was even pressed into the surface, leaving clear imprints of its weave. Punzonatura, or punching, was mainly used for the halos of the saints, exhibiting different execution styles. The halos of the angels at the top of the Crucifixion were created with simple direct incisions, likely with the back of a brush (fig.39). In contrast, the halos of Mary Magdalene and the three Madonna's are more refined and in relief, achieved through an additional application of plaster to the relevant painted areas (fig.40). In the upper part of the Crucifixion, near the arch, a very fine spolvero was used to outline small details of the floral motifs of the frame, likely applied a secco on top of the yellow and green base of the flowers (fig.41).

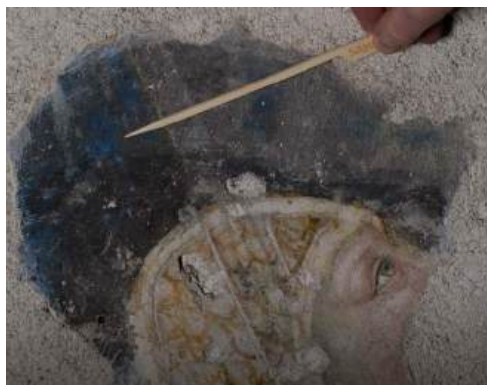
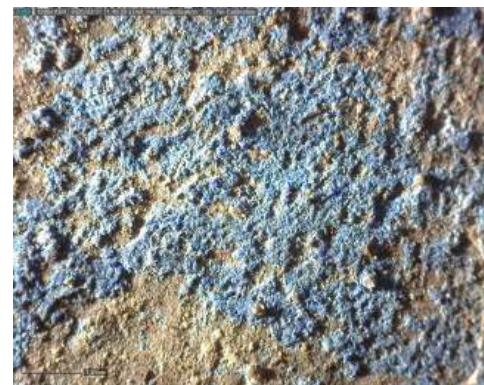
Pictorial finishes executed as secco were identified, for example, in the entire background of the artwork, a black preparatory layer was applied to affresco and finished with a blue pigment(copper-based), which is incompatible with the fresco technique (fig.42,43,44).

Fig.43. Dino-Lite image, x50 (raking light)

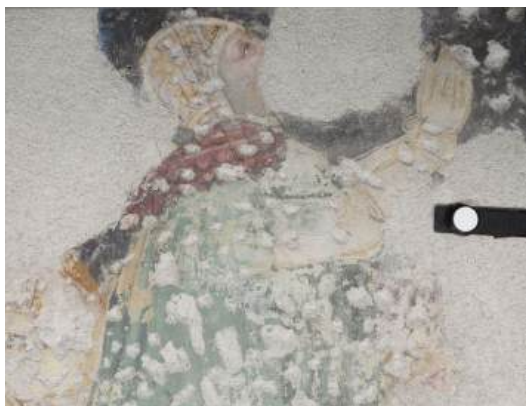
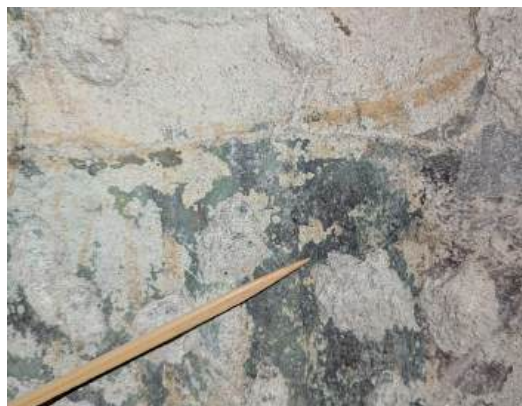
Regarding the portion of the fresco depicting San Longinus, technical photographs compared with visible light images revealed an anomaly in the pigment of the soldier's robe, which appears black in visible light but an intense pink in false-color infrared (fig.44,45,46). Many historical red lake pigments (organic dyes precipitated onto an inert base, like madder lake or cochineal) often appear bright pink or magenta in false-color infrared, even if they look dark red, brown, or even blackish in visible light due to degradation or the original depth of color. It's possible the robe was originally a deep red or purple (made with such a lake pigment) that has darkened considerably over time to appear black to the naked eye.

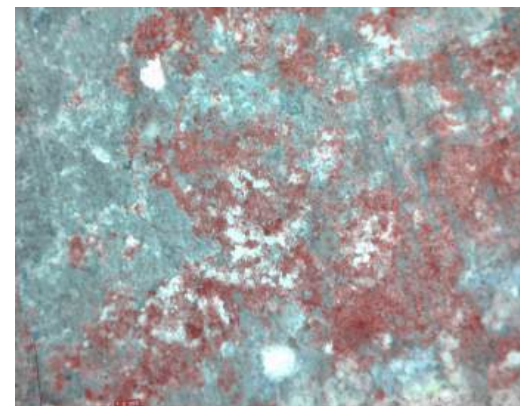
Fig.46. False Colour examination result

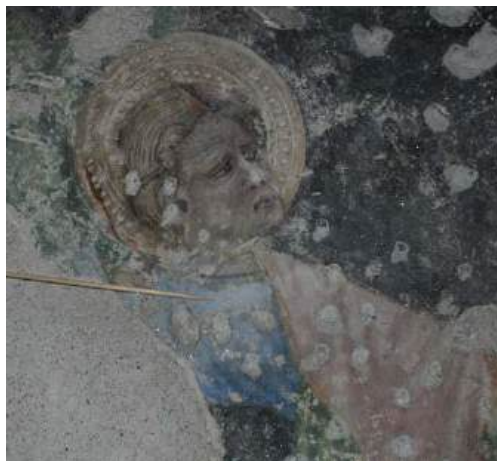
Subsequent analytical tests on the painting's pigments revealed the deliberate use of at least two distinct types of blue. Analysis with XRF analysis on the angels' garments indicated a blue pigment with no detectable copper, strongly suggesting the use of precious Lapis Lazuli (ultramarine) for these figures(fig.47). The evidence of presence of calcium, strontium and iron may be related to the support. In contrast, the blue embellishing the soldier's feathered hat was found to not contain copper (fig.48). The second part of the floral frame has a dark red pigment which under XRF turned out to be Terra Rossa

*Fig.47. Blue pigment with copper (Lapiz Lazuli)*

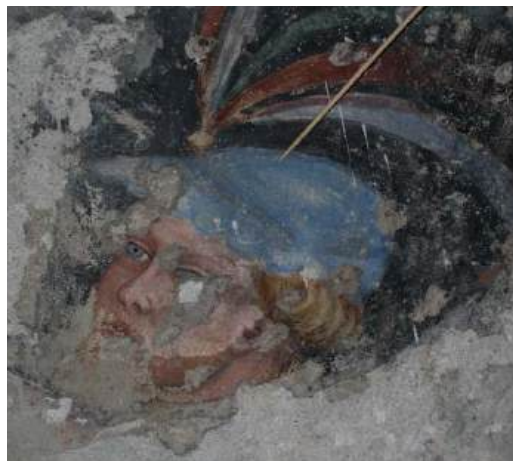
*Fig.48 Blue pigment without copper*

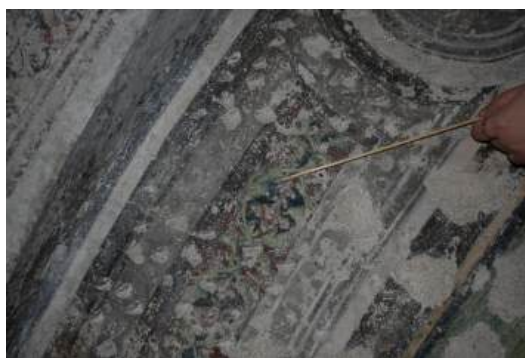
*Fig.49. Terra Rossa*

which showed traces of mercury, probably due to contamination from surrounding materials(fig.49). Historically, mercury was used in a gilding technique called fire-gilding (or mercury amalgamation). In this process, gold was dissolved in mercury to create an amalgam. This amalgam was applied to the surface to be gilded (often metal, but sometimes other materials on frames or decorative objects). The object was then heated, causing the mercury to vaporize, leaving a thin layer of gold adhered to the surface. This may possibly be one of the reasons behind the evidence of mercury.

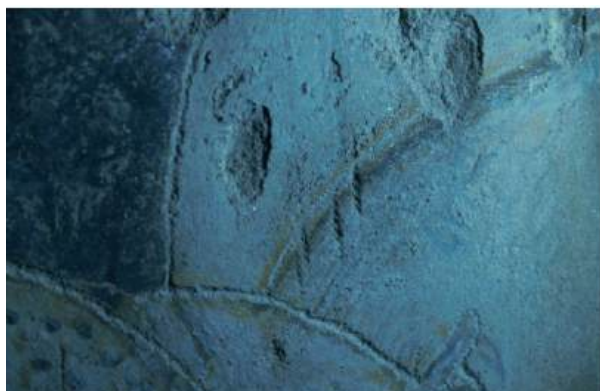
*Fig.50. Impression of Battuta di cordo in wet plaster*

The artist also used techniques like battita di cordo which can be seen due to the evidence of rope incision in some areas where it was used on a wet plaster (fig.50). In some areas, there are overlapping giornate where the artist layered fresh plastered on already existing, painted and dried plaster from the previous giornata resulting in layers of painted plaster (fig.51). Although it is very difficult to figure out all of them, hypothetically, there can be 7-8 giornate, after joining the fragmented pieces.

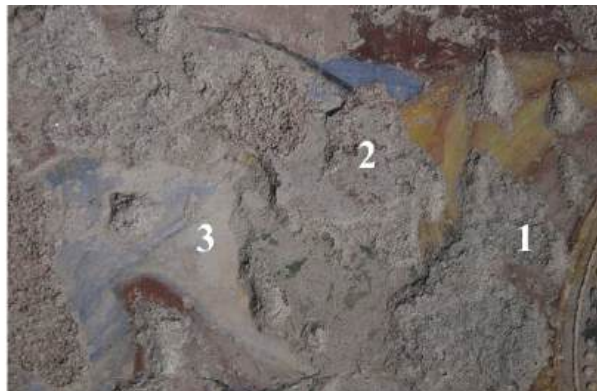
*Fig.51. Overlapping giornate*

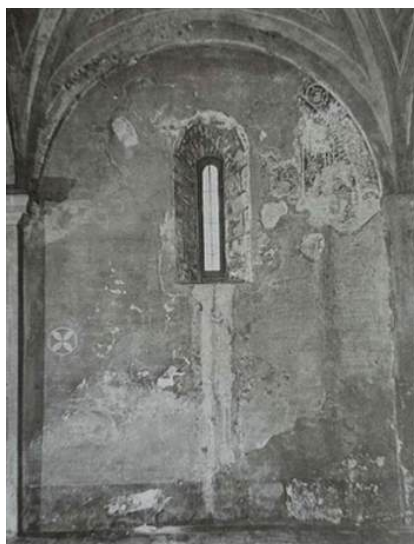
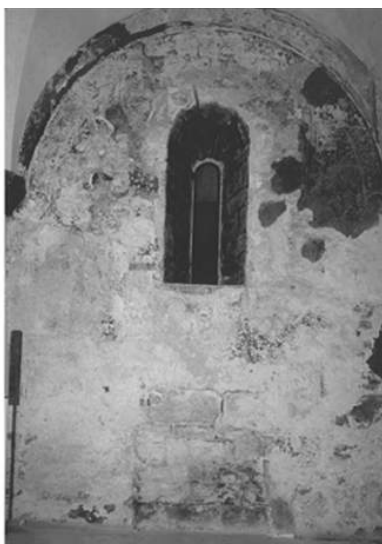
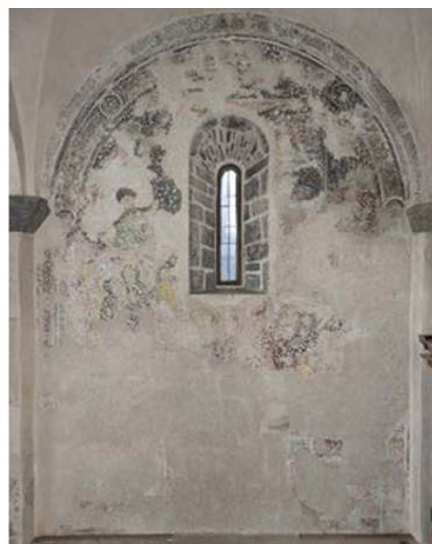
Plaster detachment in the upper right portion of the fresco, not only exposed the older artwork beneath but also subjected it to greater amounts of candle smoke than the rest of the wall (fig.51,52,53). This increased smoke exposure led to the development of concretions, which are responsible for the distinct color difference observed in that area today.

*Fig.51. Before conservation*

*Fig.52. During on-going conservation*

*Fig.53. After conservation*

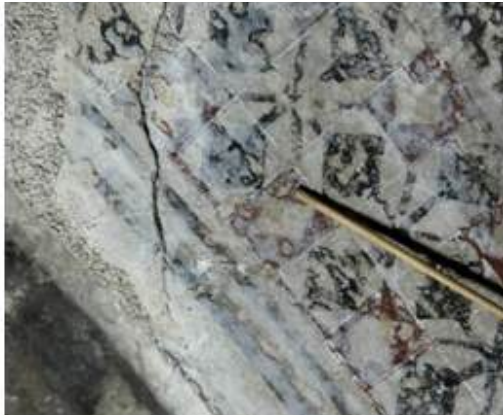
*Fig. 54. Reference image*

The traces of whitewash are also evident, which, according to archival documents, were probably applied in the 1500s, but there are also signs of de-whitewashing carried out during previous restorations that are particularly visible where the outermost geometric frame is located (fig.54,55).

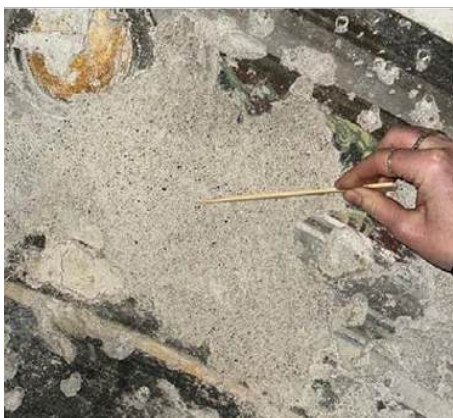
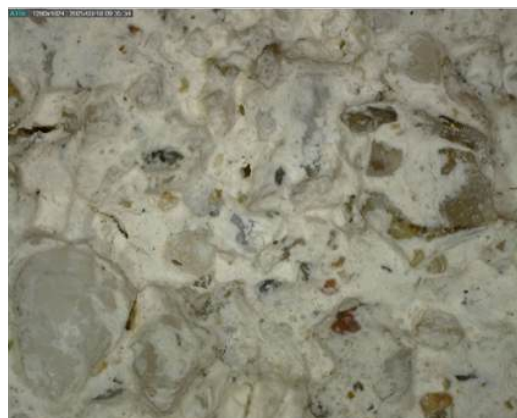
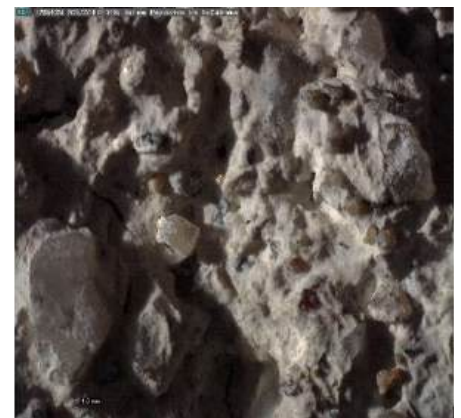
*Fig. 56. Reference photo*

On the wall, there are numerous and extensive lacunae (gaps/losses), which were probably reintegrated in the 1980s by Gianola. For this reintegration process, a distinct mortar was utilized, characterized by the inclusion of aggregate particles of varying dimensions. Detailed examination using a Dino-Lite portable digital microscope, and the subsequent analysis of the captured images, has revealed that these aggregate sizes range from extremely fine, near 0mm, to larger grains exceeding 1mm in diameter (fig.56,57,58).

*Fig. 57. Details of the filling (Dino-Lite image, 50x zoom inc)*

*Fig. 58. Dino-Lite image, 50x zoom rad*

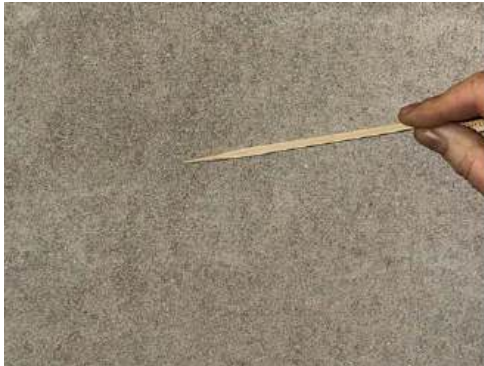
*Fig.59. Reference Image*

The same Type 1 stucco filling seems to have been used for the south apse (absidiola), the restoration of which is contemporary with that of the Crucifixion wall (fig.59,60). The choice to use the same type of mortar, only with the addition of more binder, to plaster both works may have been dictated by the surplus of material and/or the desire to finish the restoration site as soon as possible.

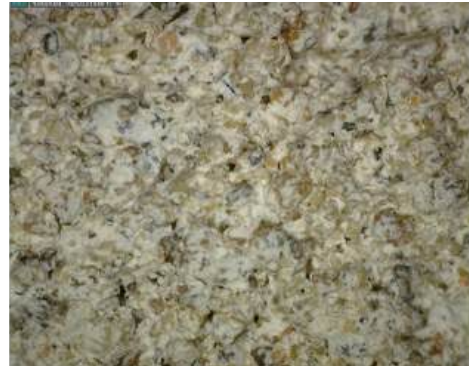
*Fig.60. Detail of the mortar used for the grouting of the apse (Dino-Lite image, 50xinc).*

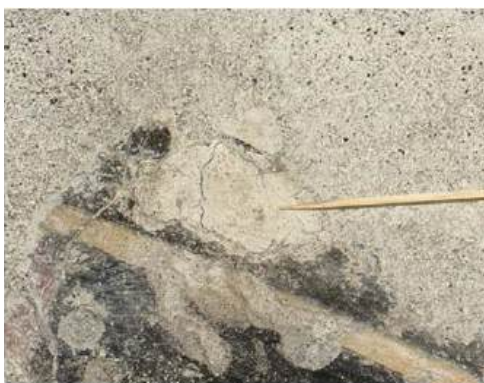
*Fig.61. Reference image*

Other such numerous lacunae were probably reintegrated in the 16th century (Cinquecento), likely with the intention of supporting the layer of whitewash (scialbo) subsequently applied during the same period. Although this is probably not an isolated case, it is difficult today to find similar traces in other areas of the wall. In contrast to other repairs, a Type 2 stucco can be identified in the vicinity of the arch. This particular filling is believed to be of an earlier origin, with current hypotheses suggesting it could date as far back as the 16th century. Interestingly, this older stucco was apparently not removed during later restoration campaigns undertaken by Gianola; the decision to preserve it was likely made because it was assessed as still being structurally sound and effective for its purpose. This 'type two' stucco is distinguishable not only by its different coloration when compared to the 'type one' fillings but also by the presence of specific surface marks. These marks are interpreted as having been inflicted during the process of 'descialbo,' which is the careful removal of overlying whitewash or limewash layers from the artwork (fig.61,62).

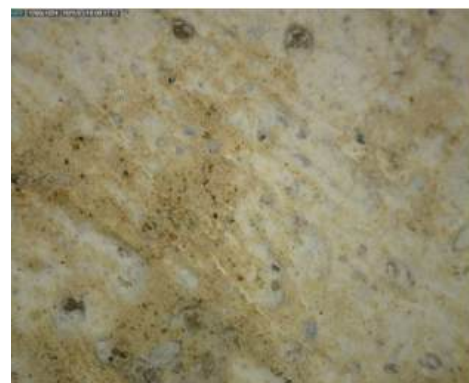
*Fig.62. Detail of type two stucco (Dino-Lite image, 50x inc)*

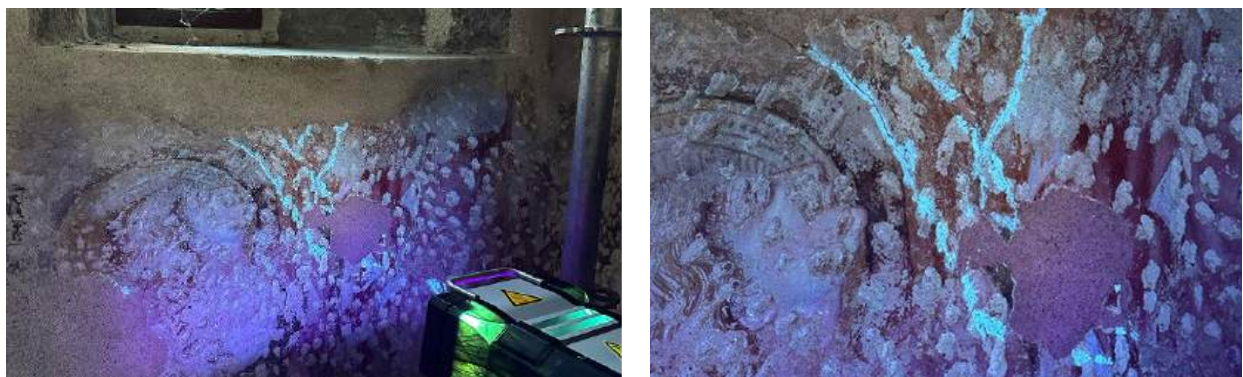
Further investigation using ultraviolet (UV) light revealed additional insights into the history of interventions near the window. Specifically, an earlier type of filling material located beneath the window was observed to exhibit luminescence when exposed to UV radiation (fig.60,61). The phenomenon of luminescence under UV light is significant because different materials fluoresce in distinct ways; this particular response helps to distinguish this earlier repair from other materials and suggests it possesses a different chemical composition, possibly due to older types of binders, varnishes, or pigments used in that specific filling.

*Fig.60,61. Luminescence detected in the fillings under the window*

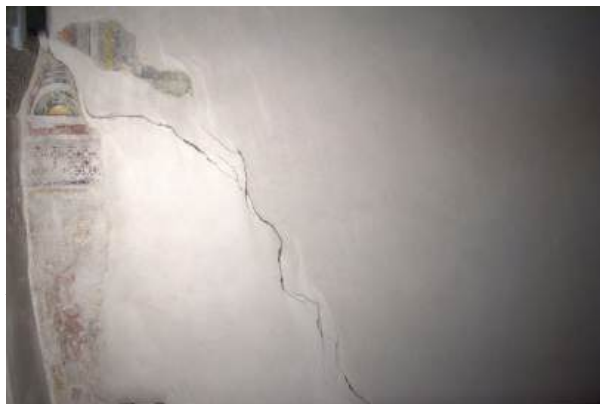
There is a fissure (fig.64) in the adjacent west wall that runs from the top of the vault down which may be connected to the ossario, and its activity should be assessed by examining Gianola's photographs, which show a displaced crack meter; observations suggest this same wall might have been plastered in the 16th century or possibly by Gianola, as traces of limewash have been left behind in the upper right area as a testimony to the past(fig.63).

*Fig.62. Fissure in the adjacent west wall*

This fissure can also be due to the pressure created while the construction of the ossario on the other side. There are cracks prevalent on the vault ceiling that start in the middle point and run down towards the wall of the painting displaying structural imbalance (fig.64). These cracks can also be caused by other factors like the vibration caused due to the constant vehicle traffic on the road as well as the train track located right next to the church. These cracks are dominantly visible around fillings that may be the cause behind the cracks (fig.65,66).

This monitoring must also extend to structural concerns, specifically including a thorough assessment and appropriate remediation strategy for the noted crack on the west wall at the back of the ossuary, alongside checks for the cracks in the vault.

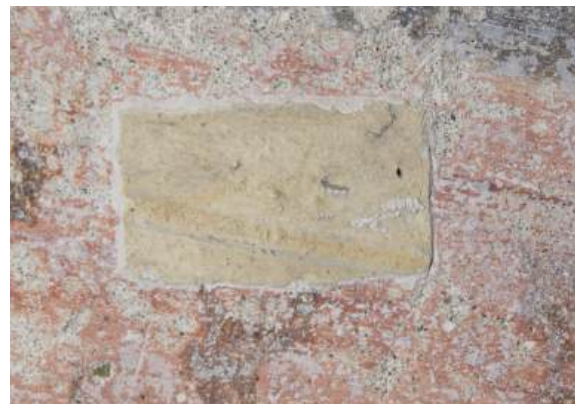
*Fig.63. Evidence of Lime wash left behind by Gianola*

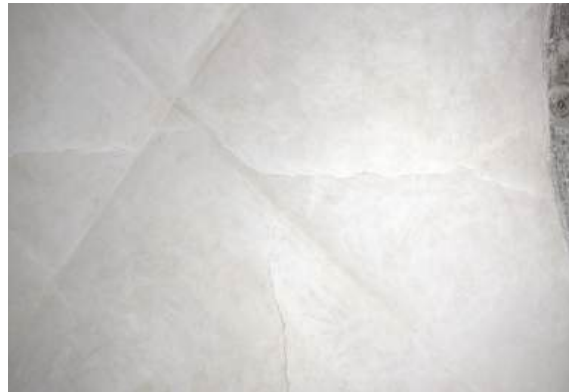
*Fig.64. Cracks in the ceiling*

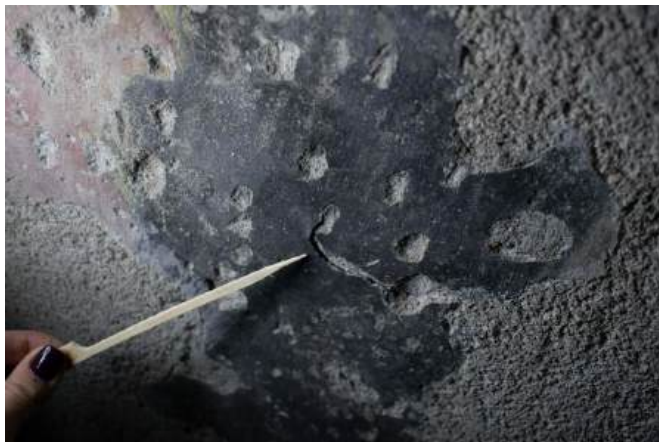
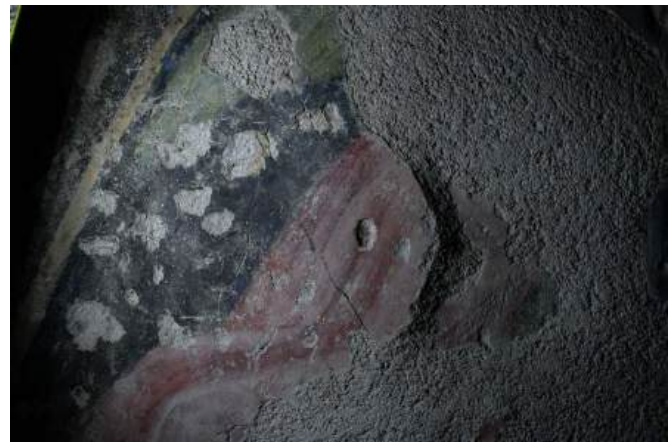
*Fig.65,66. Cracks and fissures formed near existing fillings*

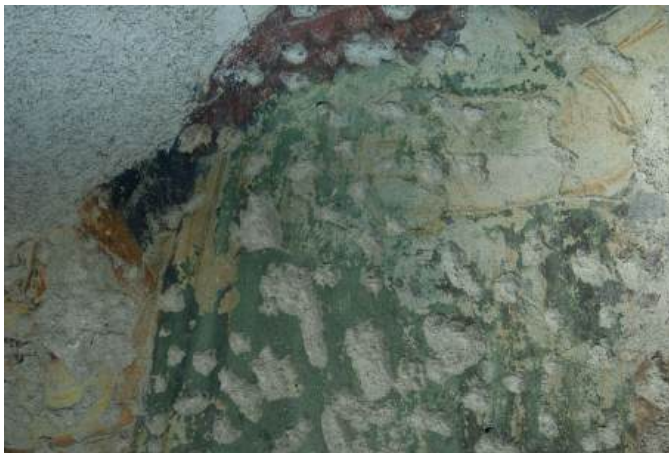
A significant degradation phenomenon observed is abrasion, which presents in several forms across the mural paintings. One potential cause of this abrasion is the descialbo process, the historical removal of limewash layers, which would have involved aggressive scraping or cleaning that could damage the delicate paint surface. This process is known to involve risks, particularly to the original surface of the artwork. A damaged or structurally unsound intonaco cannot provide a stable foundation for the paint layer, thus accelerating the decohesion and loss of pigments.

Most of the fragments of the intonachino are lost and the ones that are left behind show signs of abrasions all over the painting (fig. 67). Furthermore, the application and subsequent removal of lime washes, a recurring practice in the history of the church, has resulted in the stripping away of much of the metal leaf gilding, another form of abrasion specific to the gilded areas. A layer of deposits like dust and grime are present on both the pictorial surface and within the fillings and hammered grooves of the artwork. These deposits primarily consist of accumulated dust, a common occurrence over time in untreated surfaces (fig.68).

*Fig.67. Abrasione of the pictorial layer*

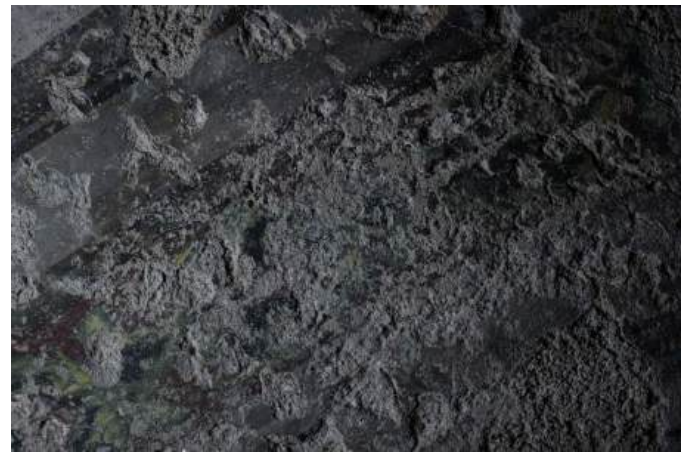
*Fig.68. Deposition of dust, discoloration due to deposit*

However, this phenomenon is also identified as a form of deposit, and it requires further analysis to determine its nature, specifically whether it is coherent (firmly attached) or incoherent (loosely attached); initial observations suggest it is incoherent. Understanding the composition and adherence of these deposits is crucial for selecting appropriate cleaning methods. In addition to general dust accumulation, there are also instances of paint drips visible in certain areas of the mural paintings (fig.69). These drips are likely a consequence of Gianola's restoration project, indicating that some paint may have run or splattered during the application process. Such drips, while potentially minor, can affect the aesthetic appearance of the artwork and need to be considered in conservation planning. Previous documentation of the fresco clearly shows signs of degradation caused by water infiltration and humidity which was solved by Gianola. The fractures however were either left unsolved or appeared later.

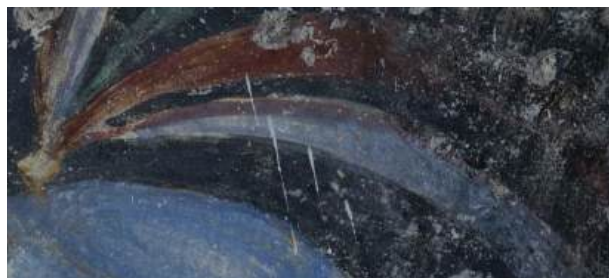
*Fig.69. Paint splatter*

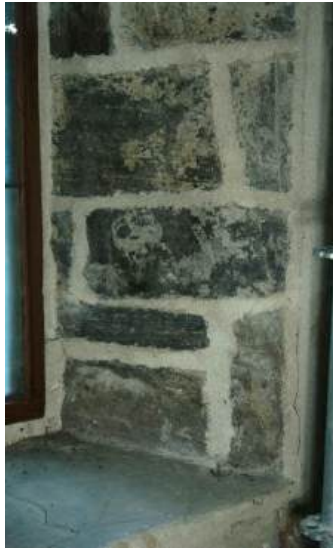
Load-bearing structure that provides the physical stability of the building, onto which the plaster layers are applied. It consists of a homogeneous composition of locally sourced stones, cut and roughly shaped. The various components of the wall are held together by a bedding mortar.

*Masonry visible in the splay of a window*

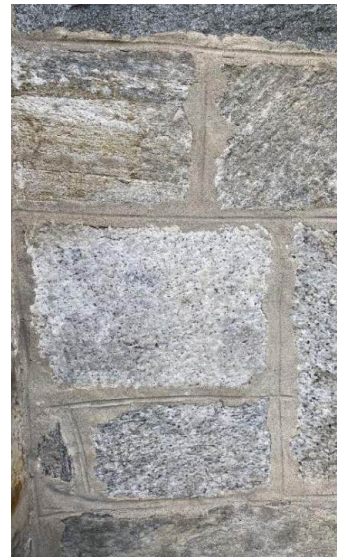
*External masonry with visible tooled (or pointed) joints*

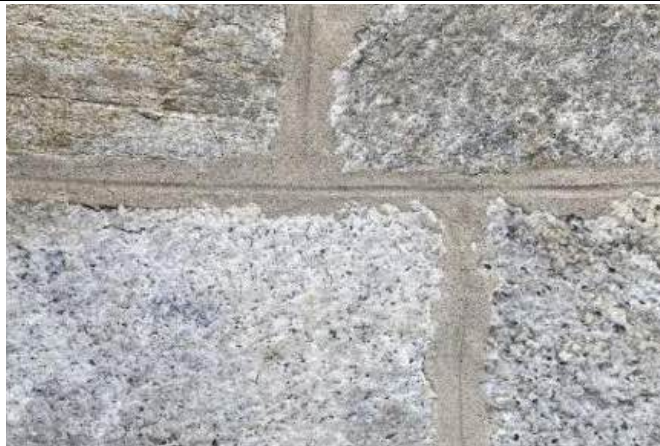
Layer of mortar applied between one stone of the masonry and another, serving as a binder. In this case, the joints are tooled as a decorative element.

*External masonry with visible tooled joints*

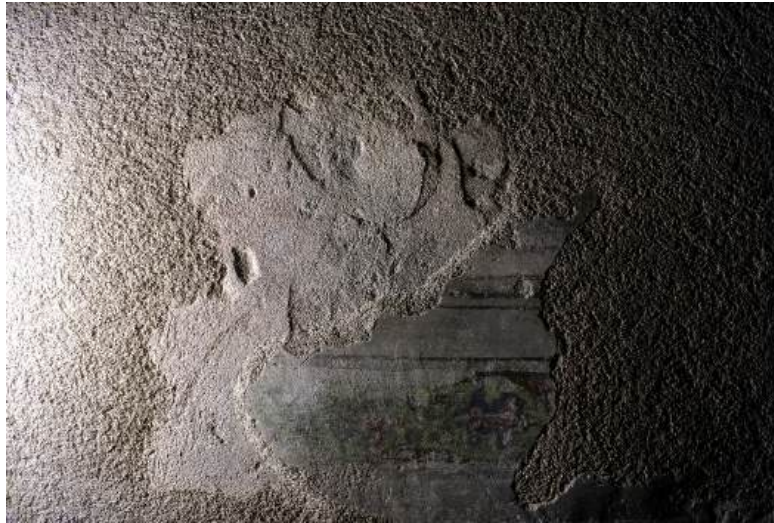
Application of an intermediate mortar layer between the masonry support and the finishing plaster (intonachino); the surface is relatively well-smoothed and contains aggregates ranging in size from 0 to 10 mm. Its function is to even out the surface and provide a suitable anchoring base for the intonachino.

*Base plaster (arriccio) with finishing plaster (intonachino), observed under raking light*

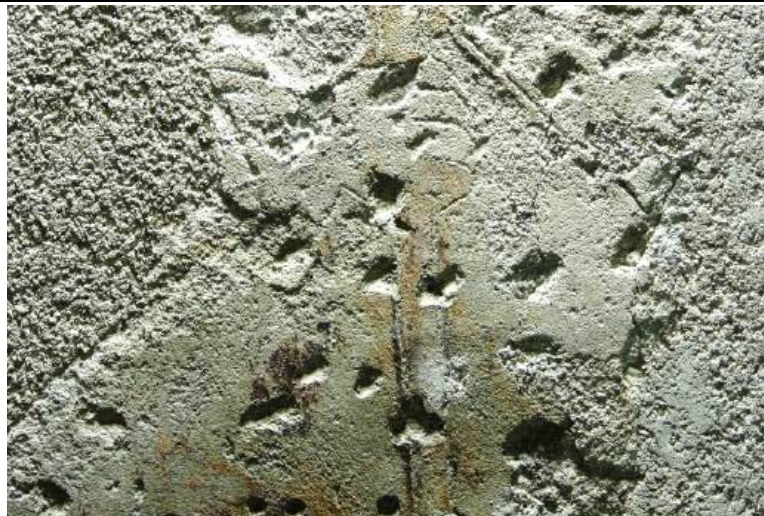
Application of a surface mortar layer approximately 5 mm thick; the finish is well-worked and smoothed, with aggregates ranging from 0 to 5 mm in size. Its function is to decorate the walls, with or without painted decoration.

*Intonachino privo di pellicola pittorica, luce radente.*

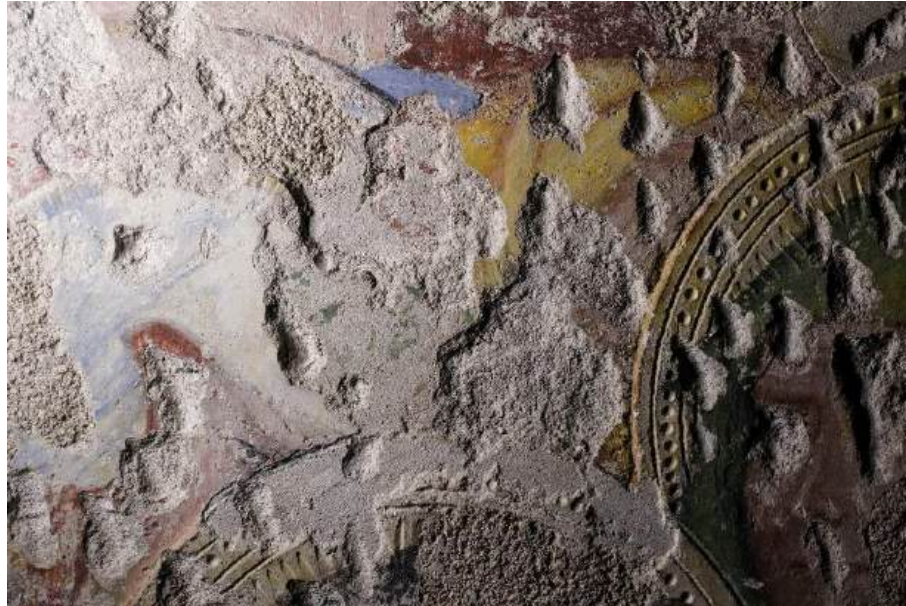
*Losses that reveal the superimposition of different plaster layers*

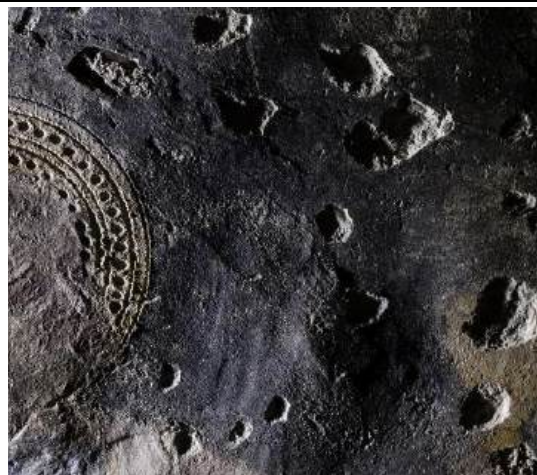
Division of the areas where the finishing plaster (intonachino) is applied in preparation for fresco painting. Since fresco painting must be executed within a limited time frame, the plaster is applied in sections known as *giornate*. These are identifiable by the overlapping of the edges, which is sometimes concealed by careful surface finishing.

Joint between giornate with visible tool marks

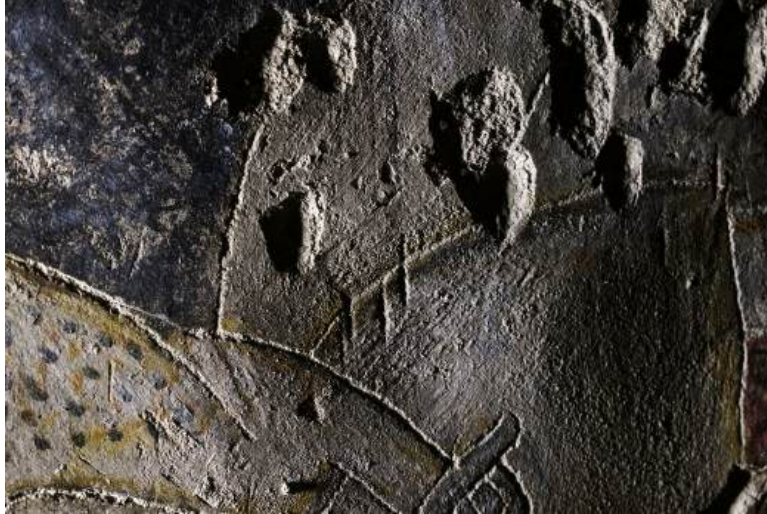
Marks left by tools used for surface smoothing, such as a trowel, or by a brush applied to the plaster while still fresh.

*Traces of brushstrokes applied to fresh plaster, visible under raking light.*

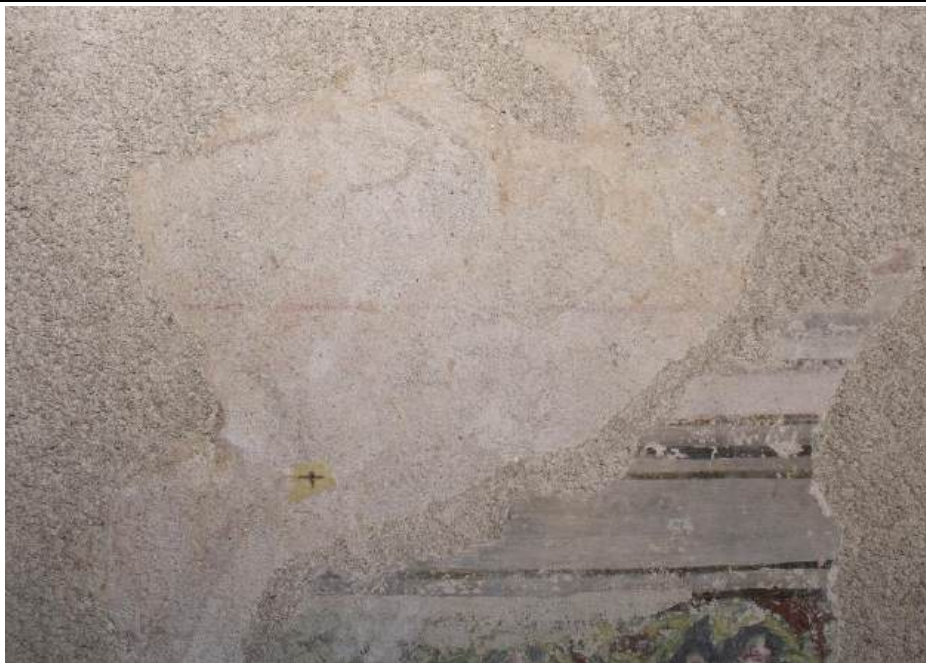
Preparatory drawing made on the arriccio layer, primarily used to organize the composition and serve as a draft for the final work, including the placement of figures and decorative frames.

*Arriccio layer with sinopia*

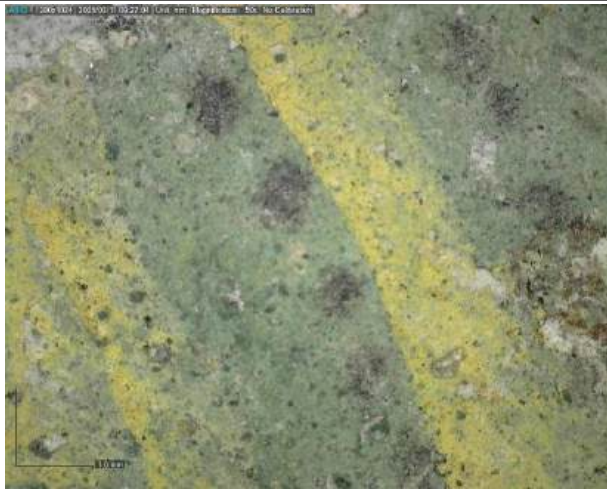
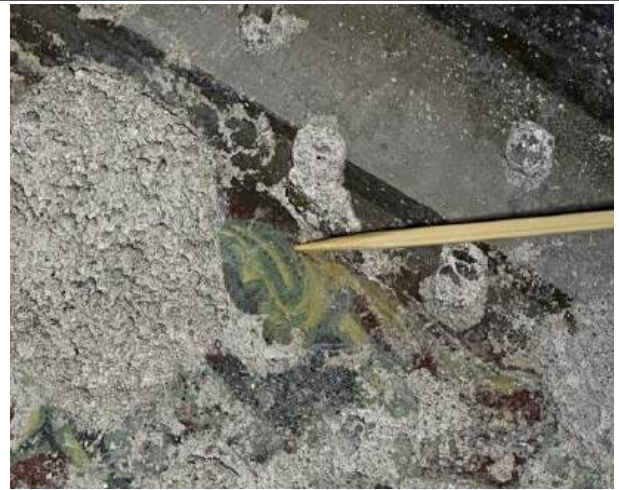
Technique used to transfer a drawing, generally employed to reproduce the same design or decoration multiple times by dabbing a cloth pouch filled with pigment over a cartoon perforated along the outlines of the figures. It appears as rows of dots following the contours of the figures.

*Pouncing used for the highlighting of a leaf, observed under a digital microscope*

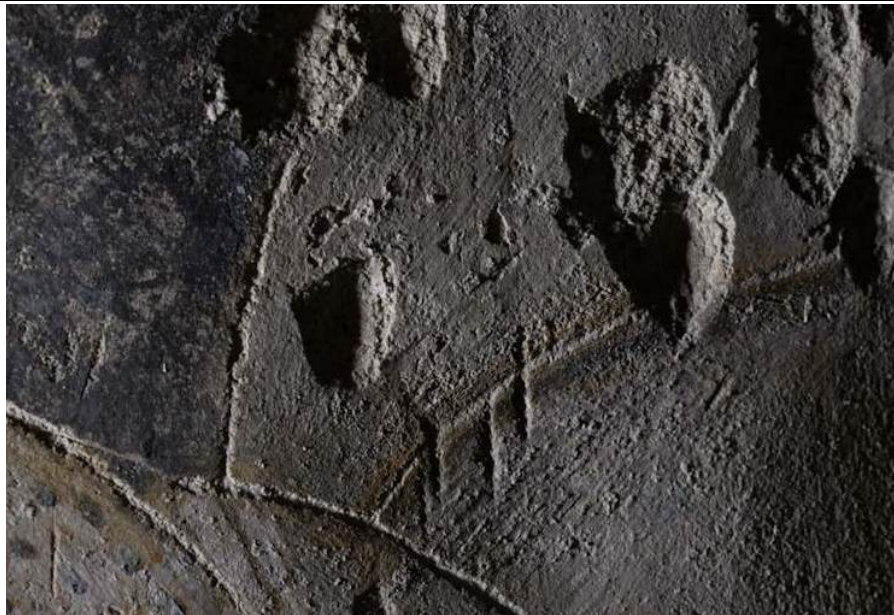
Definition of linear elements, such as frames and weapon shafts, created by striking a cord against the fresh plaster. This technique is identifiable by the imprint left in the plaster, which was sometimes reinforced with a brush-drawn line.

*Vertical imprints from cord beating used to draw a spear, visible under raking light.*

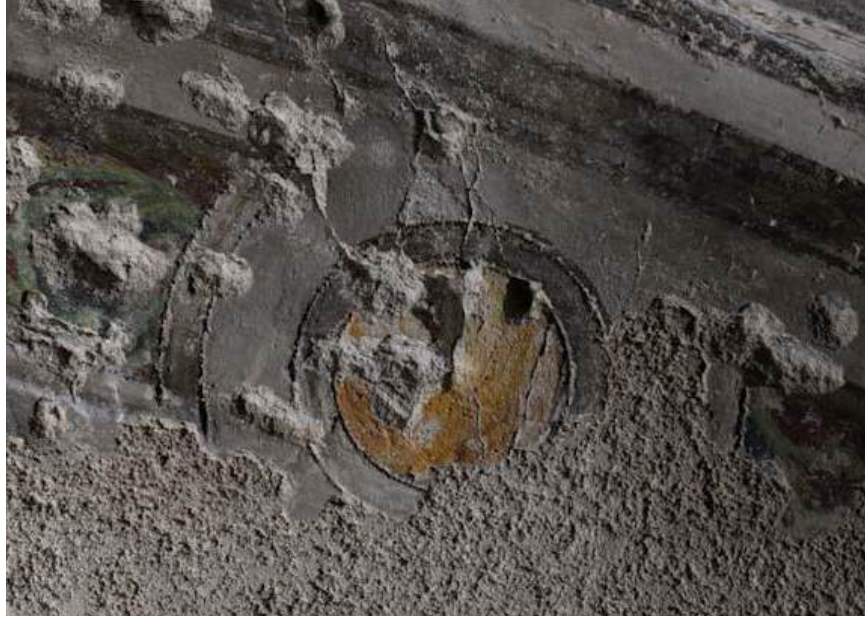
Marks made with various pointed tools, such as styluses, sticks, or compasses. These can be direct, when the marks are incised directly into the intonachino, or indirect, when a cartoon bearing the design is placed over the intonachino to transfer the drawing.

*Direct incisions made with a compass, visible under raking light.*

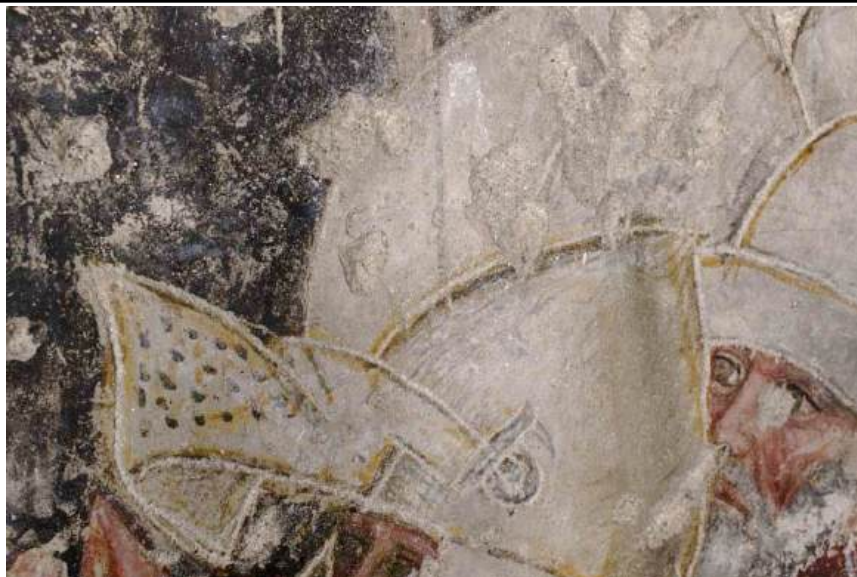
Drawings made with yellow, black, or red pigment as preparatory sketches on the intonachino, visible where the dry applications have been lost.

*Brush-drawn sketch in yellow pigment for the preparation of the helmets.*
