## CHURCH OF SAN VITTORE, MURALTO (LOCARNO)

### THE CRUCIFIXION

#### Report on the Conservation Status of the Fresco Cantiere Studio – BWP 2.1

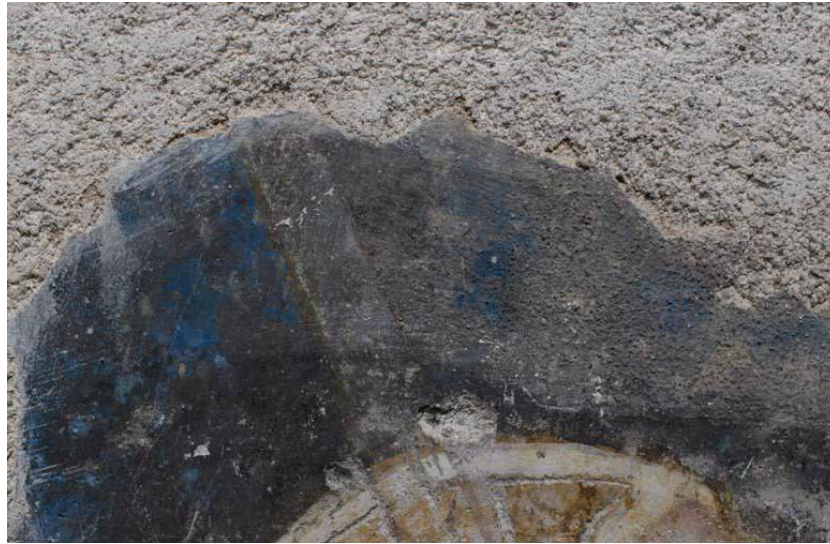
A layer of color usually applied to fresh plaster, intended to receive a subsequent dry application characterized by a brilliant, coarsely ground pigment, in order to achieve a particular chromatic effect.

*Black preparatory layer for the application of blue pigment.*

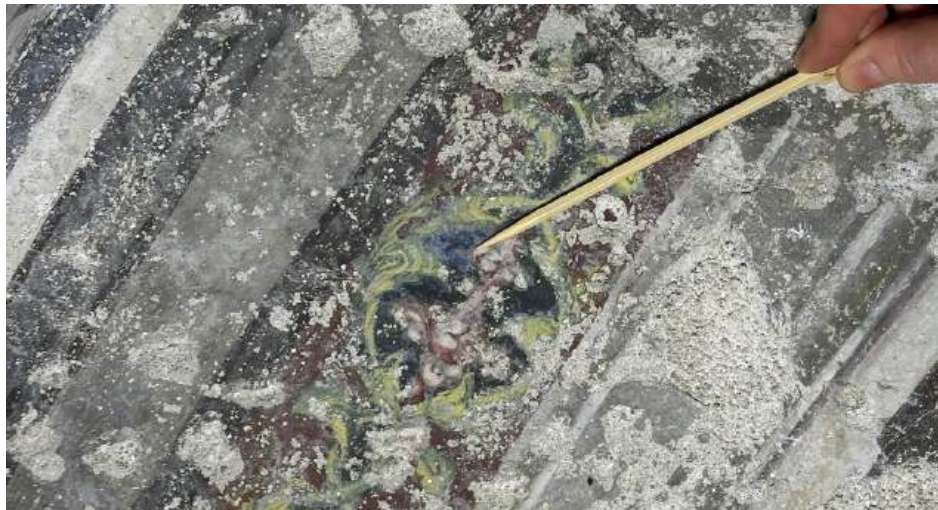
Applications applied to dry plaster using a binder—such as egg yolk or lime putty—of pigments that may or may not be compatible with the fresco technique, or metal leaf.

*Dry finish for the vegetal motif.*

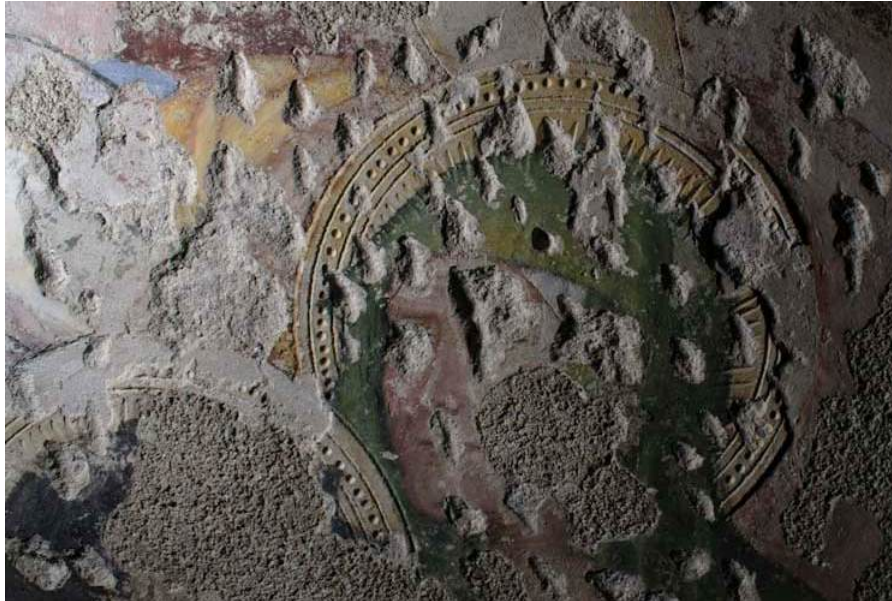
A technique that allows a decorative mark to be impressed into the plaster through applied pressure. This technique has been found exclusively in certain haloes.

*Raised crown of a Madonna decorated with punchwork.*

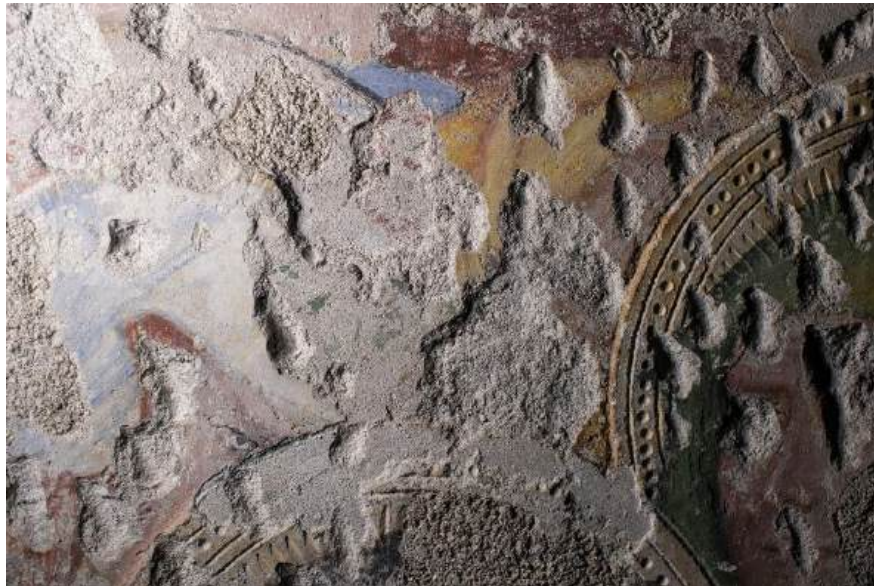
Remnants of a line or figure that were covered over because they were executed incorrectly or altered during the course of the work.

*Area where a layer of pigment is visible beneath fallen plaster, possibly indicating a pentimento.*

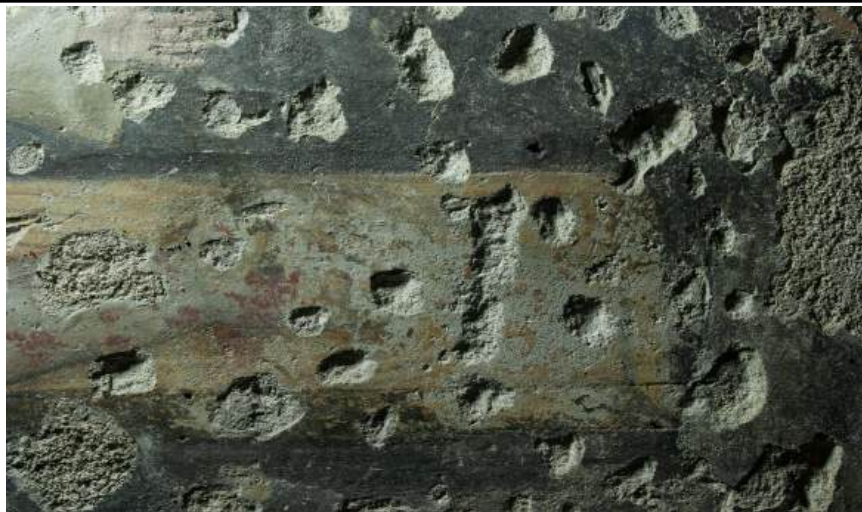
Roughening of plaster carried out with a hammer to promote the adhesion of a subsequent layer.

*Signs of Hammering*

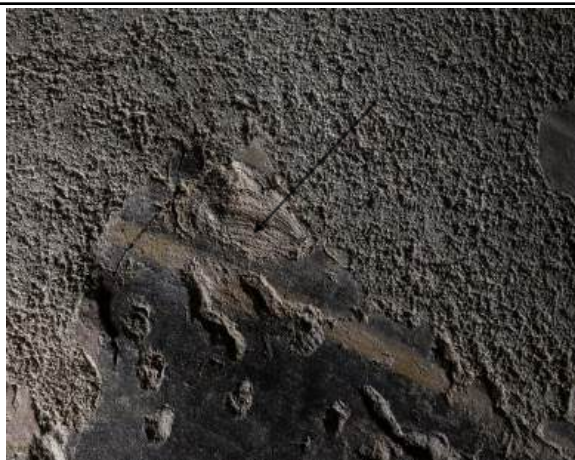
Filling of a lacuna or the loss of one or more support layers using a mortar composed of lime and medium-fine sand. The aim is to restore the continuity of the layers that make up the artwork, both structurally and aesthetically. These fillings are very extensive across the entire decorated wall area.

*Old stucco filling, date unknown*

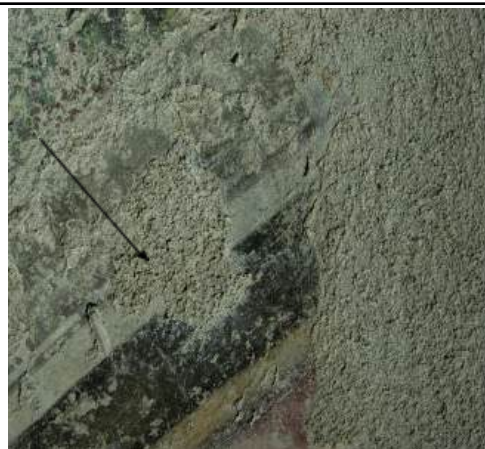
*Stucco filling dating to the restoration work by Luigi Gianola*

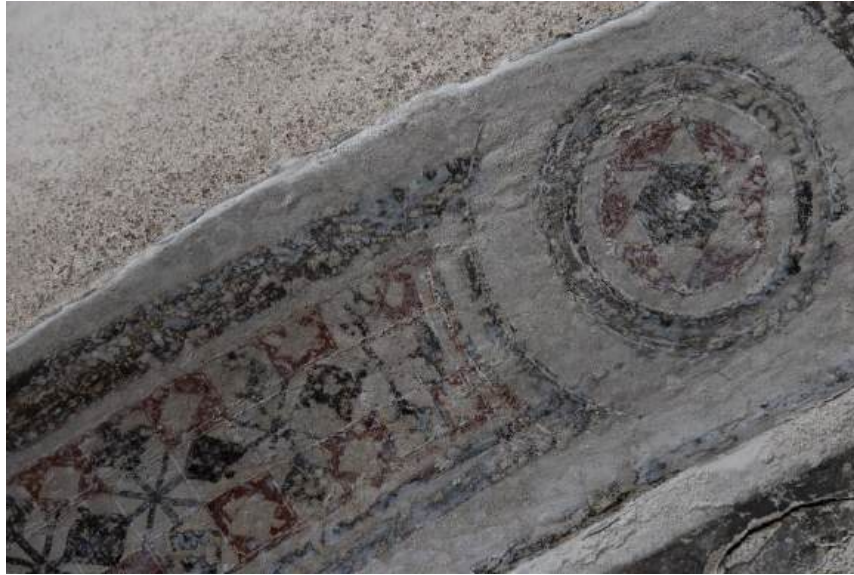
Thin white layer of lime or limewash, used to cover the painting (sometimes applied to conceal decorations for religious, political, or aesthetic reasons, hiding imagery deemed no longer appropriate).

*White patches of limewash remaining from the removal intervention.*

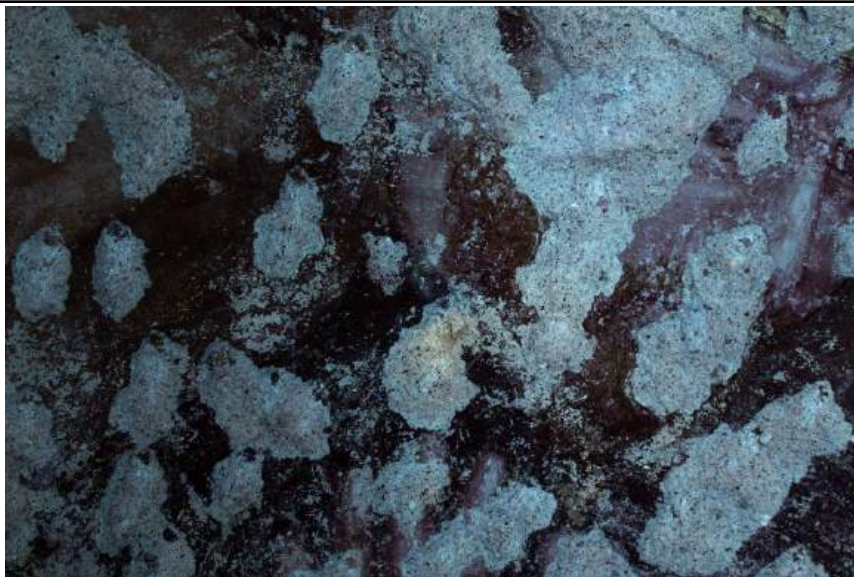
Holes that indicate the use of syringes (for example, with mortar) to bond two layers of plaster by filling voids in cases of detachment or delamination. Sometimes, instead of creating holes, injections are performed through already accessible areas of detachment.

Possible injection mortar (yellow), either injected or leaked. (UV light)

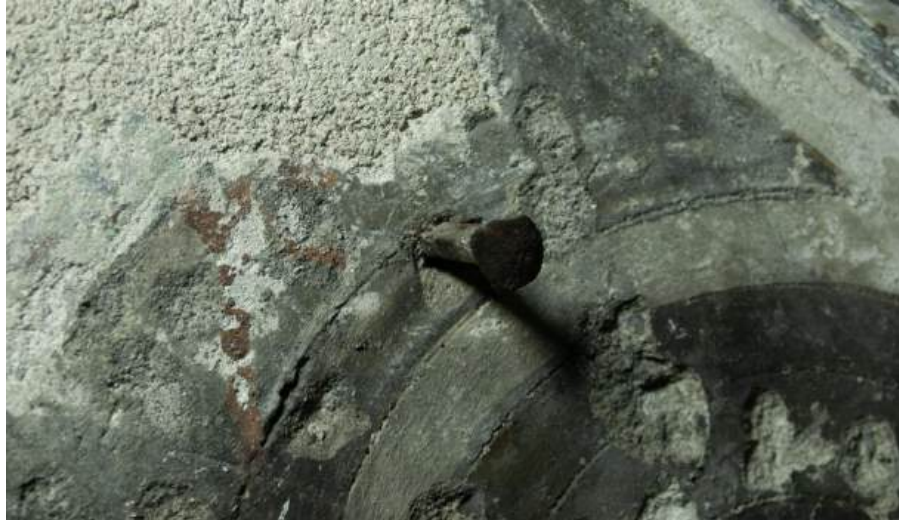
They can serve various functions, such as securing decorative elements; they may also be part of the execution technique (e.g., string beating).

*Large nail embedded in the plaster; its purpose is unknown.*

It remained to be verified whether the work's surface showed signs of small holes, attributable to consolidation efforts via mortar injections, and to determine the originality (or lack thereof) of the nail positioned below the arch, which, however, seemed to be present in archival documentation photos from around the 1800s.<sup>40</sup>

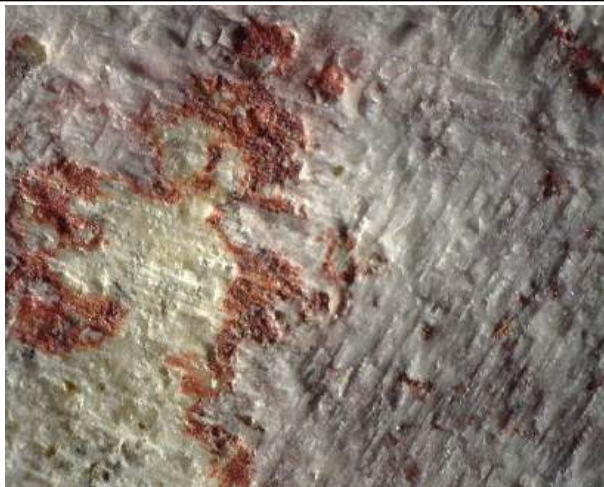
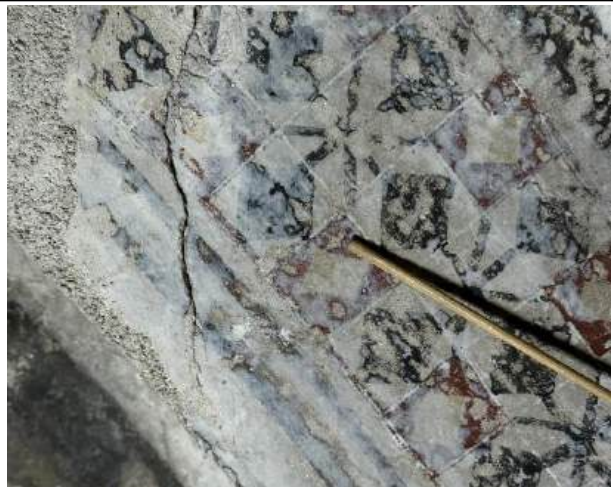
Marks on the surface left by the tools used for the removal of the limewash. They vary depending on the type of tool used.

*Limewash removal with signs of micro-erosion, digital microscope.*

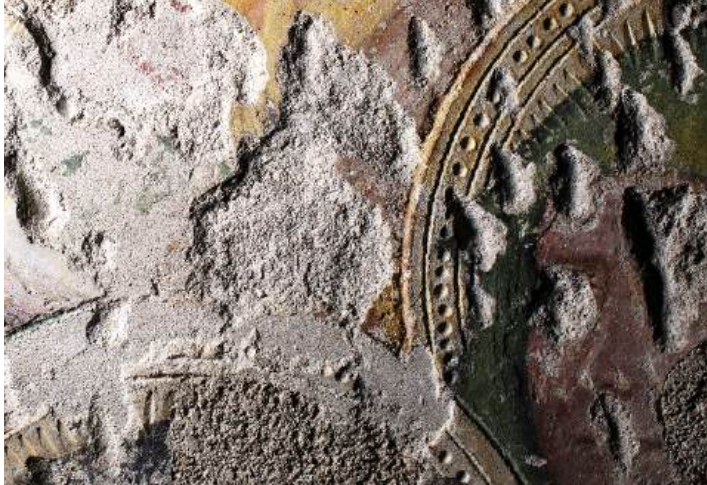
Partial loss in the thickness of a layer of the work, which may involve the plaster or the paint layer.

*Abrasion of Intonaco*

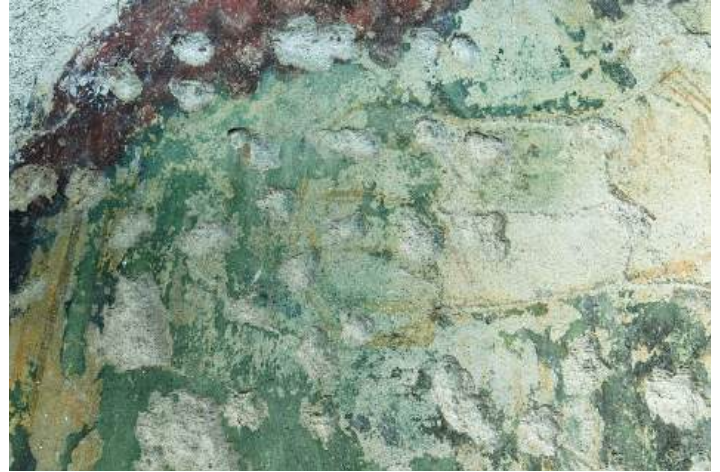
*Abrasion of paint layer*

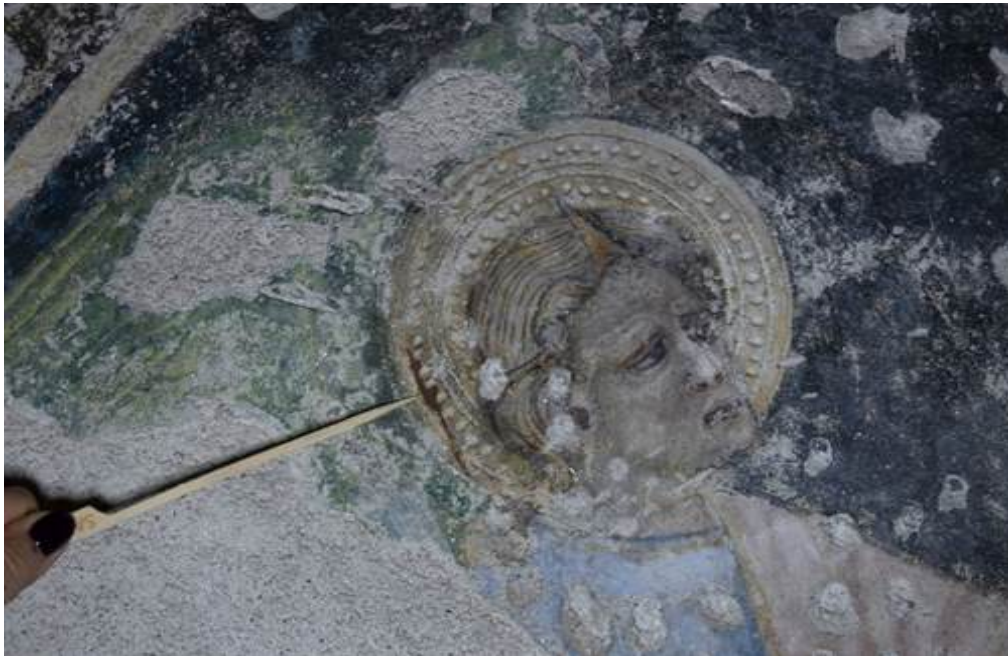
Drops of color that fell onto the surface during the execution technique.

*Dripping of pigment or binder*

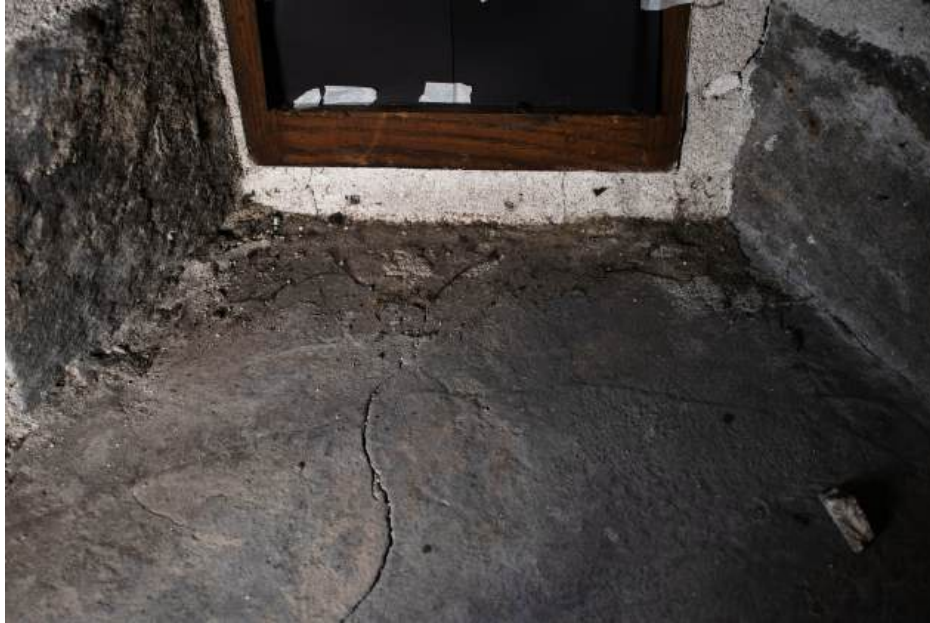
Material deposited on the surface of the artwork with low or no adhesion. It can be identified as dust, cobwebs, debris, etc.

*Cobwebs, dust, and debris at the base of the single-light window (monofora)*

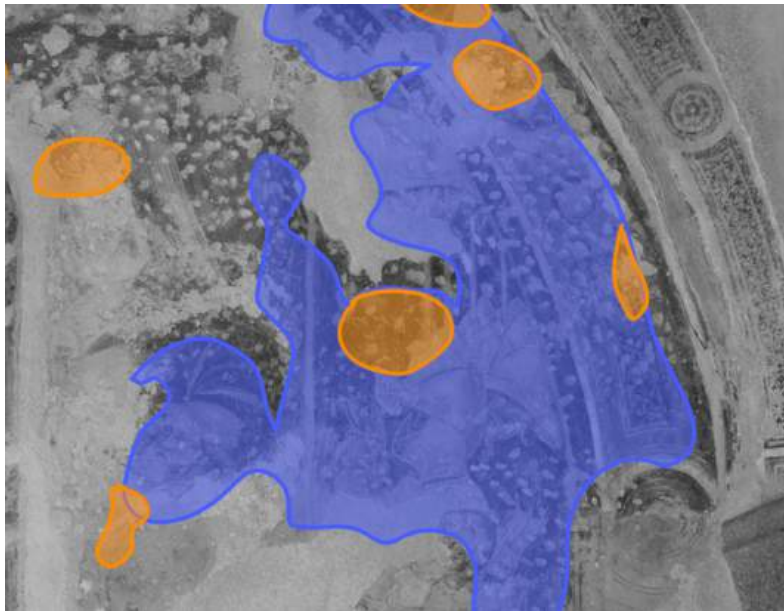
Separation of two layers of plaster, classified into two categories based on severity using empirical methods.

*Mapping of a detachment that includes both categories.*

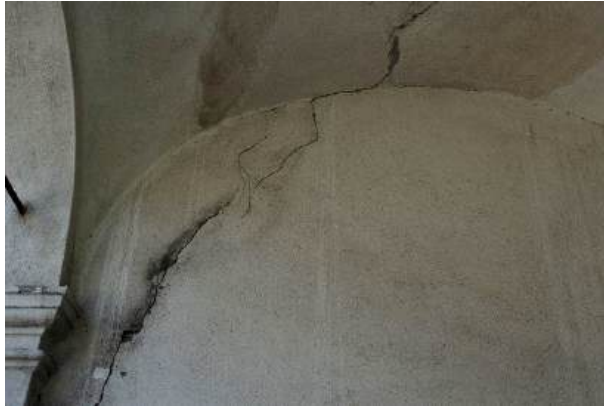
A crack that runs through the wall and affects the masonry support; it may be a sign of structural instability of the entire wall and requires particular attention.

*Through crack, exterior*

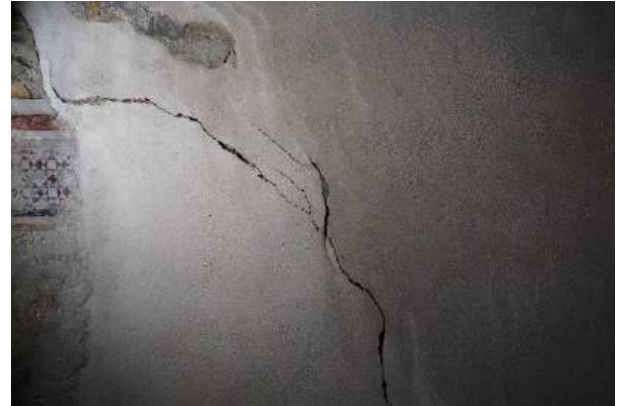
*Through crack, interior*

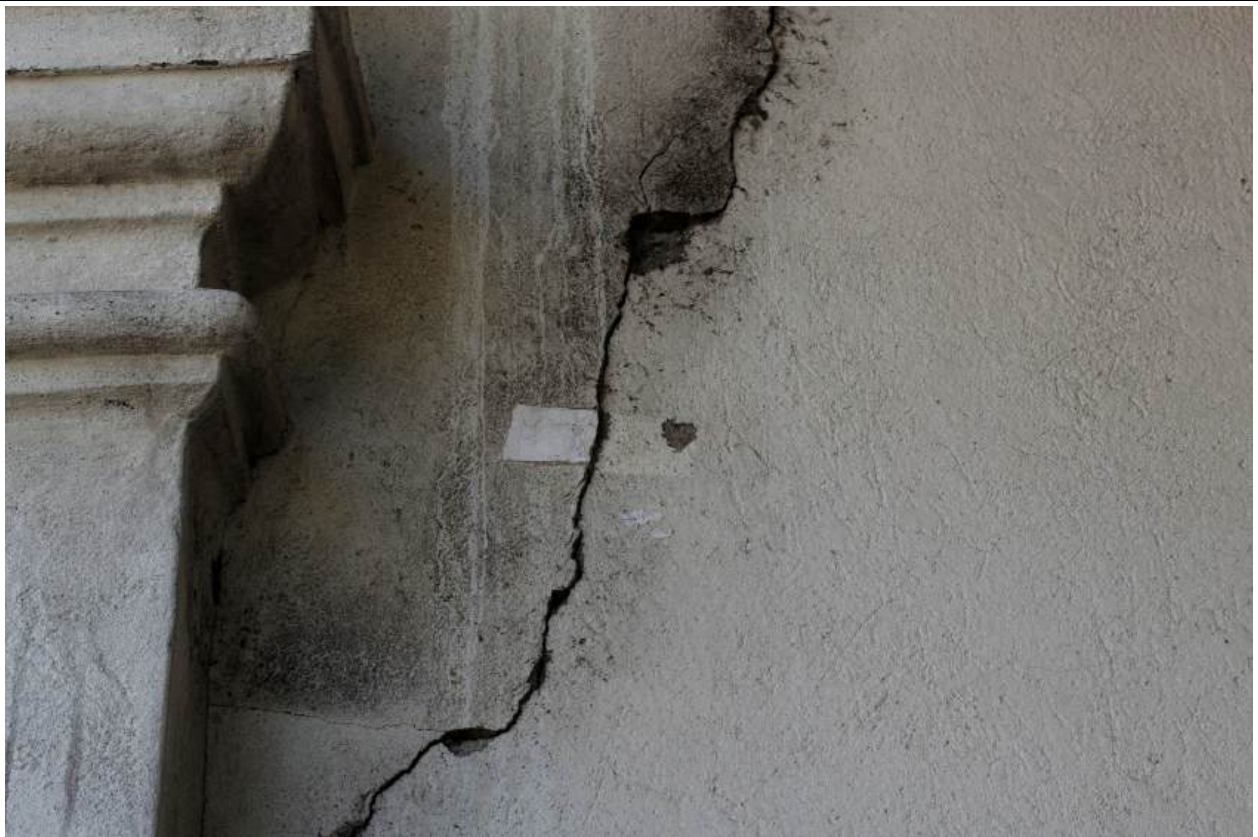
Plate applied over a crack to determine whether the cause remains active over time.

*Activated Crack meter*

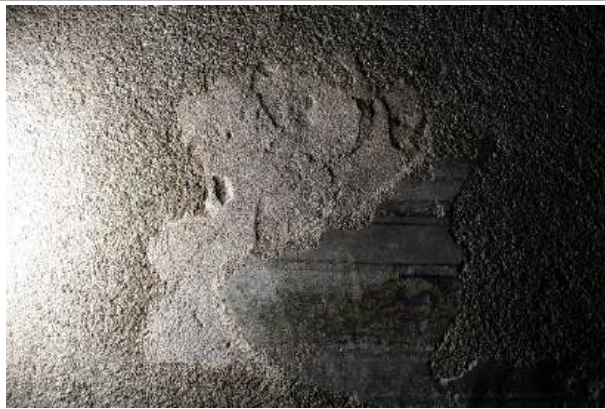
Partial loss of a layer of the artwork, which may involve either the plaster or the paint layer. Unlike abrasion, a lacuna includes a clearly defined area where the entire thickness of the layer is missing. It occurs when a detached surface completely separates from the artwork.

*Lacuna of the Intonaco*

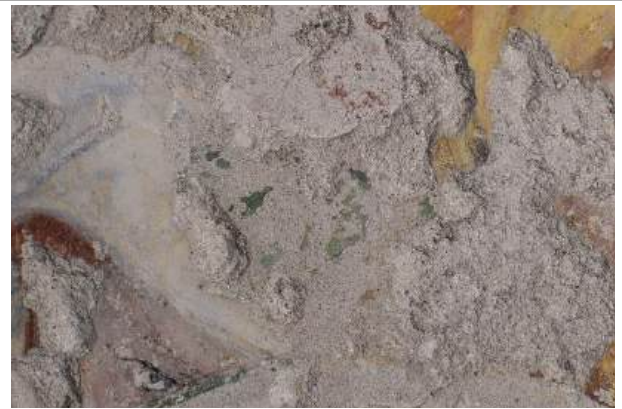
*Lacuna of the paint layer*

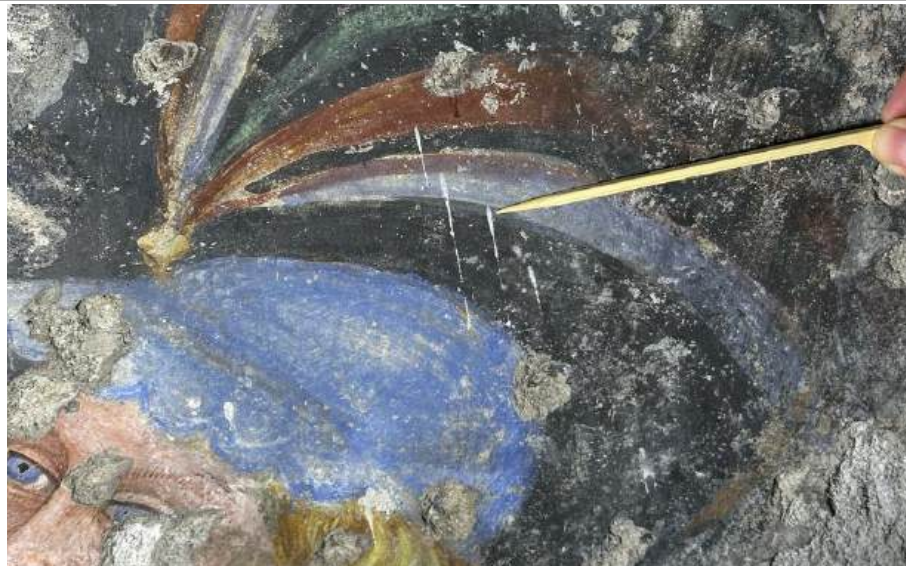
Droplets of mortar that fell onto the surface during the application of a fill (stuccatura).

*Splashes of mortar*

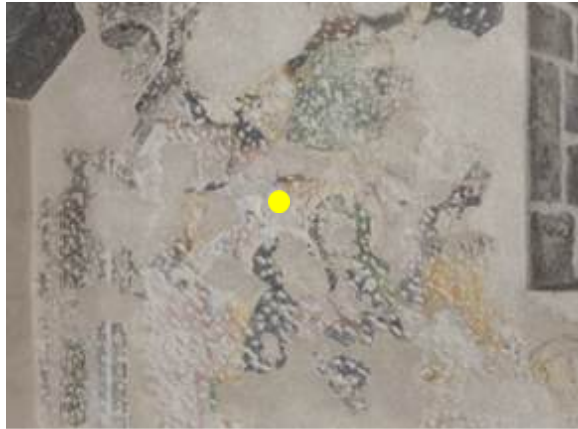
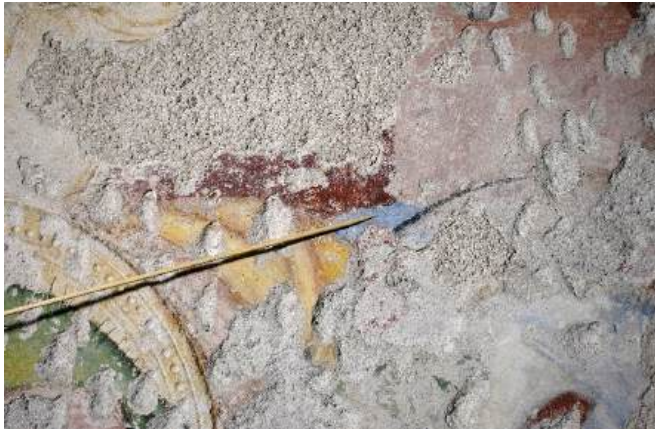
Blue		X01_A8

<b>Location:</b> Area above the halos of the three Marys.							
<b>Chemical Elements (count/s)</b>							
<b>K (K<math>\alpha_1</math>)</b>	<b>Ca (K<math>\alpha_1</math>)</b>	<b>Fe (K<math>\alpha_1</math>)</b>	<b>Cu (K<math>\alpha_1</math>)</b>	<b>Hg (L<math>\alpha_1</math>)</b>	<b>Pb (L<math>\alpha_1</math>)</b>	<b>Sr (K<math>\alpha_1</math>)</b>	<b>Sn (K<math>\alpha_1</math>)</b>
-	32.59	4.40	-	-	5.70	12.91	-
<b>Interpretation:</b> The presence of calcium, strontium and iron may be related to the support. There are no identifying elements for the blue pigment which could, in this case, be identifiable as Lapis Lazuli.

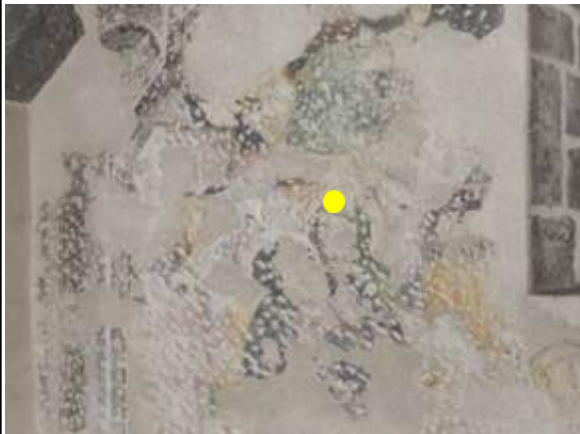
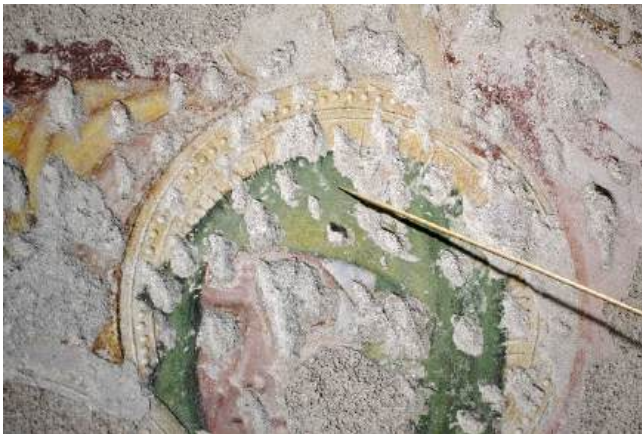
Green		X02_A8

<b>Location:</b> Robe covering the head of Mary of Clopas (?).							
<b>Chemical Elements (count/s)</b>							
<b>K (K<math>\alpha_1</math>)</b>	<b>Ca (K<math>\alpha_1</math>)</b>	<b>Fe (K<math>\alpha_1</math>)</b>	<b>Cu (K<math>\alpha_1</math>)</b>	<b>Hg (L<math>\alpha_1</math>)</b>	<b>Pb (L<math>\alpha_1</math>)</b>	<b>Sr (K<math>\alpha_1</math>)</b>	<b>Sn (K<math>\alpha_1</math>)</b>
-	6.47	25.16	1.86	-	170.63	2.75	12.14
<b>Interpretation:</b> The presence of calcium, strontium and iron can be related to the support. With the considerable presence of lead and tin it is assumed that Gallorino was used, probably applied in a mixture with green earth.

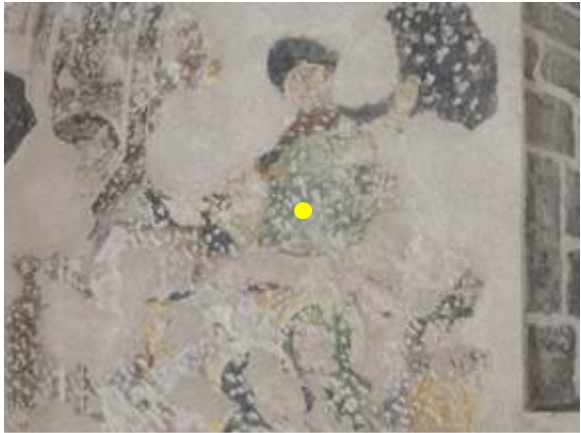
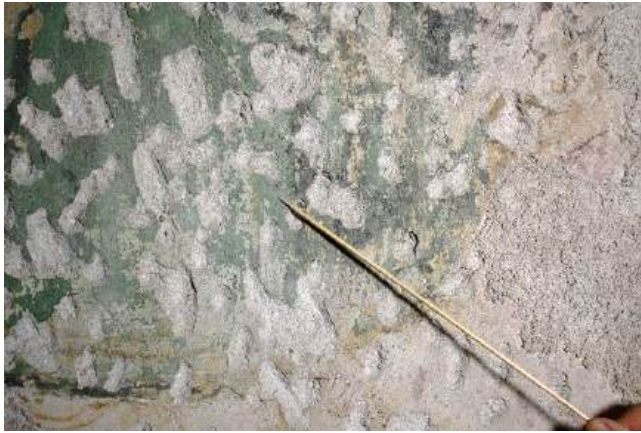
Green		X03_A6

<b>Location:</b> Robe of Saint Longinus							
<b>Chemical Elements (count/s)</b>							
<b>K (<math>K\alpha_1</math>)</b>	<b>Ca (<math>K\alpha_1</math>)</b>	<b>Fe (<math>K\alpha_1</math>)</b>	<b>Cu (<math>K\alpha_1</math>)</b>	<b>Hg (<math>L\alpha_1</math>)</b>	<b>Pb (<math>L\alpha_1</math>)</b>	<b>Sr (<math>K\alpha_1</math>)</b>	<b>Sn (<math>K\alpha_1</math>)</b>
-	30.35	36.24	20.11	-	34.63	6.73	-
<b>Interpretation:</b> The presence of calcium and iron could be related to the support. The presence of copper could indicate the use of Malachite even if the quantity of copper is very low; instead, lead could be traced back to the use of a pigment (such as Biacca) present in residues and/or in a mixture.

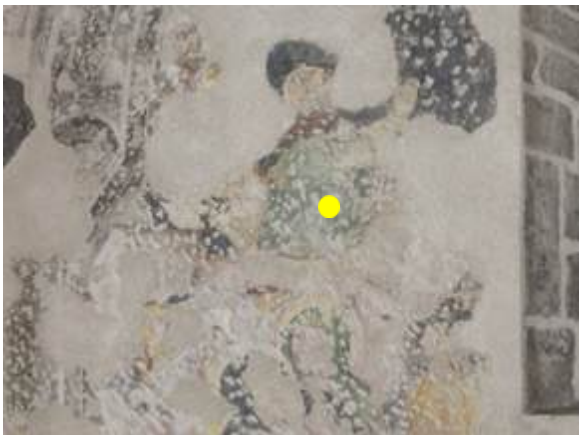
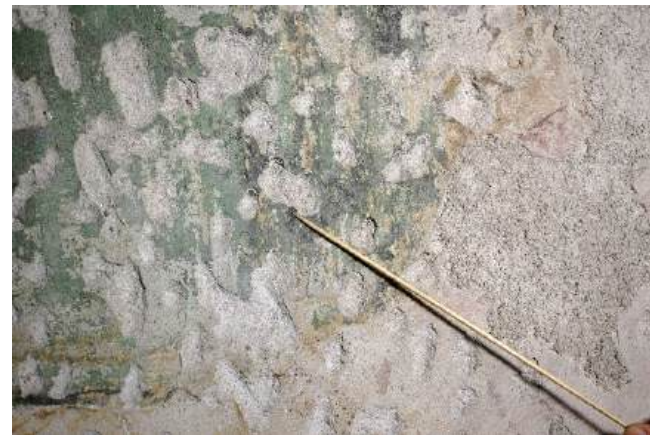
Black		X04_A6

<b>Location:</b> Robe of San Longinus.							
<b>Chemical Elements (count/s)</b>							
<b>K (<math>K\alpha_1</math>)</b>	<b>Ca (<math>K\alpha_1</math>)</b>	<b>Fe (<math>K\alpha_1</math>)</b>	<b>Cu (<math>K\alpha_1</math>)</b>	<b>Hg (<math>L\alpha_1</math>)</b>	<b>Pb (<math>L\alpha_1</math>)</b>	<b>Sr (<math>K\alpha_1</math>)</b>	<b>Sn (<math>K\alpha_1</math>)</b>
-	24.24	28.52	133.95	-	17.95	6.68	-
<b>Interpretation:</b> The presence of calcium, iron and strontium could be related to the support. Copper is much more consistent than the measurement point X03 and suggests the presence of a copper-based pigment. The presence of lead could indicate the use of a lead-based pigment (White lead?) used in a mixture or used for some finishes.

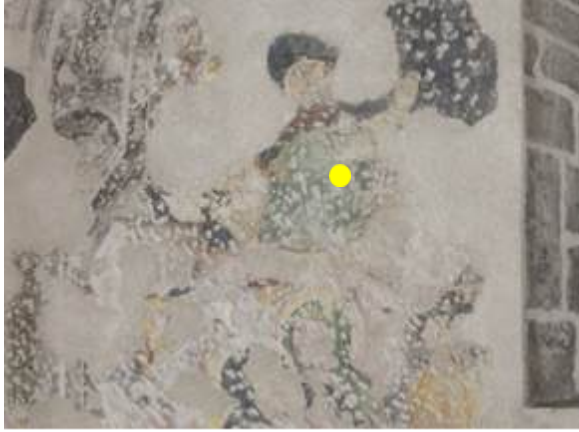
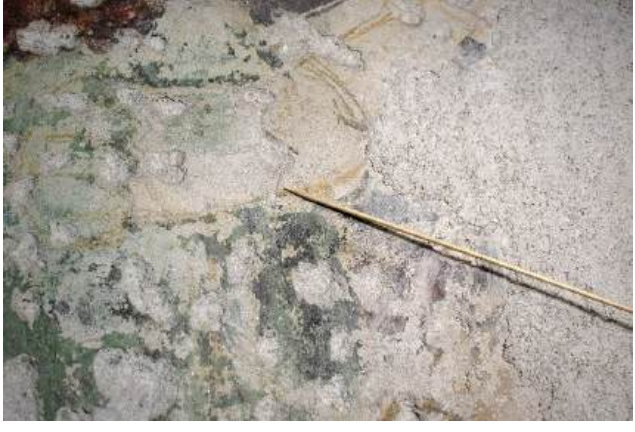
Yellow		X05_A6

<b>Location:</b> Saint Longinus's sleeve, part of the armour.							
<b>Chemical Elements (count/s)</b>							
<b>K (K<math>\alpha_1</math>)</b>	<b>Ca (K<math>\alpha_1</math>)</b>	<b>Fe (K<math>\alpha_1</math>)</b>	<b>Cu (K<math>\alpha_1</math>)</b>	<b>Hg (L<math>\alpha_1</math>)</b>	<b>Pb (L<math>\alpha_1</math>)</b>	<b>Sr (K<math>\alpha_1</math>)</b>	<b>Sn (K<math>\alpha_1</math>)</b>
-	35.36	11.09	1.59	-	14.13	6.88	-
<b>Interpretation:</b> The presence of calcium, iron and strontium could be related to the support or to the yellow ochre (ferrous pigment) used for the preparatory drawing; the Lead could be linked to the use of oily substances that were used to apply the metal sheets (see luminescence, in mur_crx_a6_soldato_uvl).

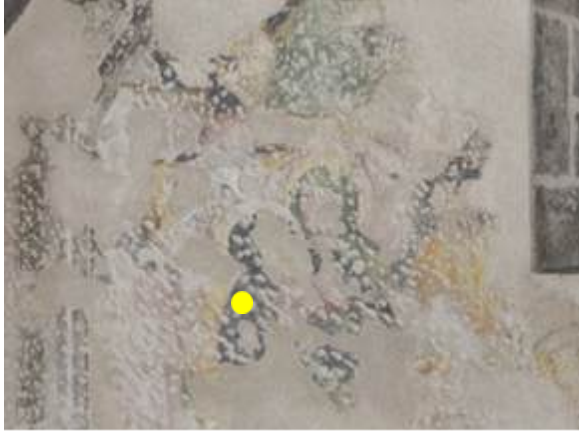
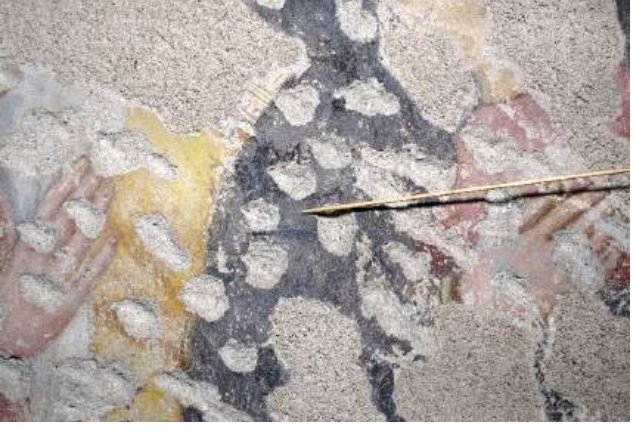
Blue		X06_A8

<b>Location:</b> Virgin Mary's robe. Preparatory layer.							
<b>Chemical Elements (count/s)</b>							
<b>K (K<math>\alpha_1</math>)</b>	<b>Ca (K<math>\alpha_1</math>)</b>	<b>Fe (K<math>\alpha_1</math>)</b>	<b>Cu (K<math>\alpha_1</math>)</b>	<b>Hg (L<math>\alpha_1</math>)</b>	<b>Pb (L<math>\alpha_1</math>)</b>	<b>Sr (K<math>\alpha_1</math>)</b>	<b>Sn (K<math>\alpha_1</math>)</b>
-	25.45	5.54	3.95	-	1.73	6.25	-
<b>Interpretation:</b> The presence of calcium, iron and strontium can be related to the support and/or black pigment. The presence of copper and lead is to be considered in traces.

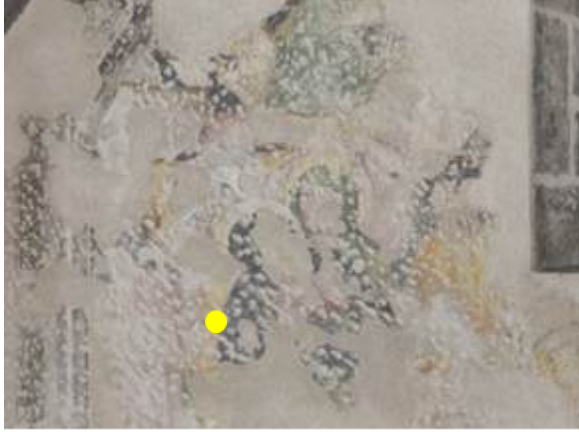
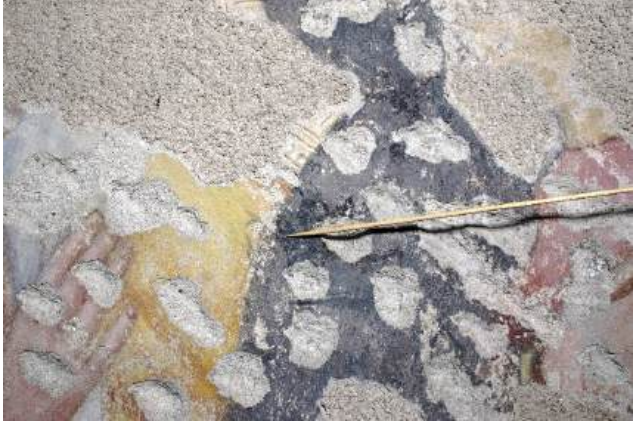
Dark Blue		X07_A8

<b>Location:</b> Virgin Mary's robe. Darker finishing coat							
<b>Chemical Elements (count/s)</b>							
<b>K (Kα1)</b>	<b>Ca (Kα1)</b>	<b>Fe (Kα1)</b>	<b>Cu (Kα1)</b>	<b>Hg (Lα1)</b>	<b>Pb (Lα1)</b>	<b>Sr (Kα1)</b>	<b>Sn (Kα1)</b>
-	5.44	9.61	411.85	-	4.64	2.88	-
<b>Interpretation:</b> The presence of calcium, iron and strontium can be related to the support. Lead is present in traces while copper indicates the presence of a copper-based pigment. The IR False Color technical photography excludes the use of Azurite.

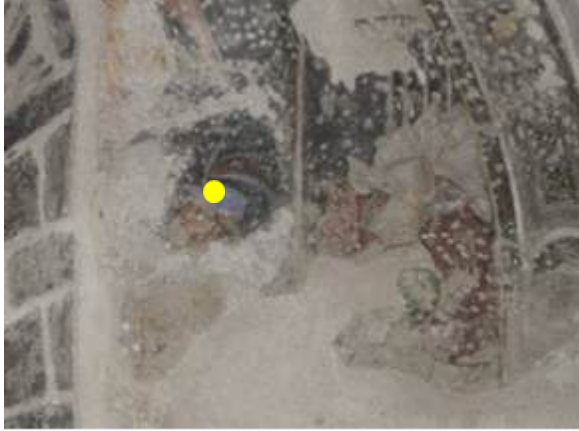
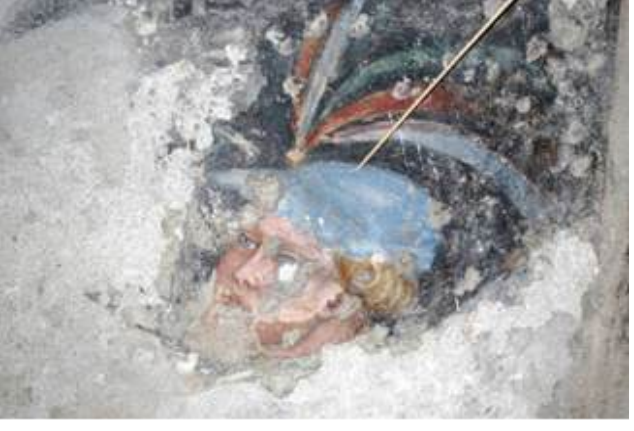
Blue		X08_A7

<b>Location:</b> The soldier's headpiece.							
<b>Chemical Elements (count/s)</b>							
<b>K (Kα1)</b>	<b>Ca (Kα1)</b>	<b>Fe (Kα1)</b>	<b>Cu (Kα1)</b>	<b>Hg (Lα1)</b>	<b>Pb (Lα1)</b>	<b>Sr (Kα1)</b>	<b>Sn (Kα1)</b>
-	22.64	5.59	1.38	-	1.45	6.46	-
<b>Interpretation:</b> The presence of calcium, iron and strontium can be related to the support. There are no identifying elements for the blue pigment which could, in this case, be recognizable as Lapis Lazuli.

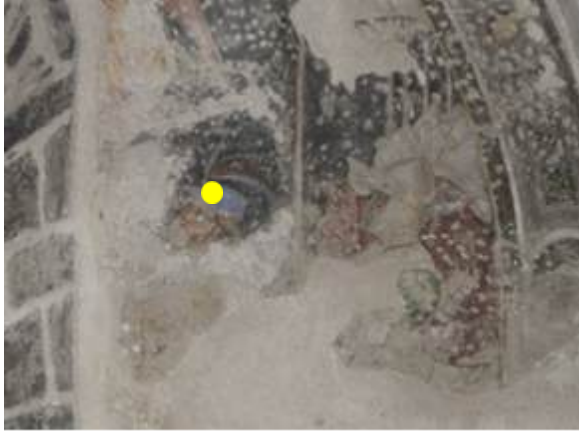
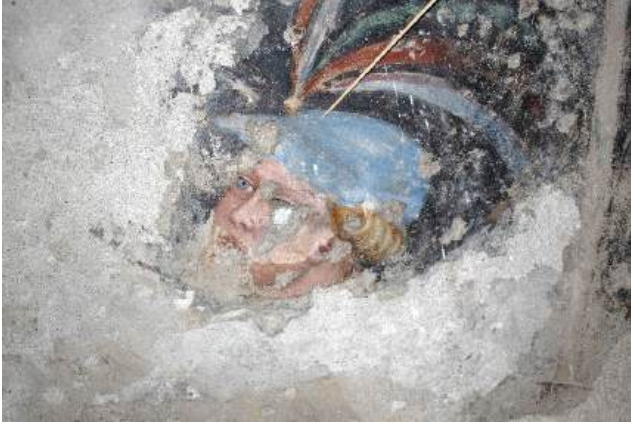
Blue		X09_A7

<b>Location:</b> Soldiers Cap							
<b>Chemical Elements (count/s)</b>							
<b>K (Ka1)</b>	<b>Ca (Ka1)</b>	<b>Fe (Ka1)</b>	<b>Cu (Ka1)</b>	<b>Hg (La1)</b>	<b>Pb (La1)</b>	<b>Sr (Ka1)</b>	<b>Sn (Ka1)</b>
-	22.46	5.07	1.45	-	2.54	6.74	-
<b>Interpretation:</b> The presence of calcium, iron and strontium can be related to the support. There are no identifying elements for the blue pigment which could, in this case, be recognizable as Lapis Lazuli.

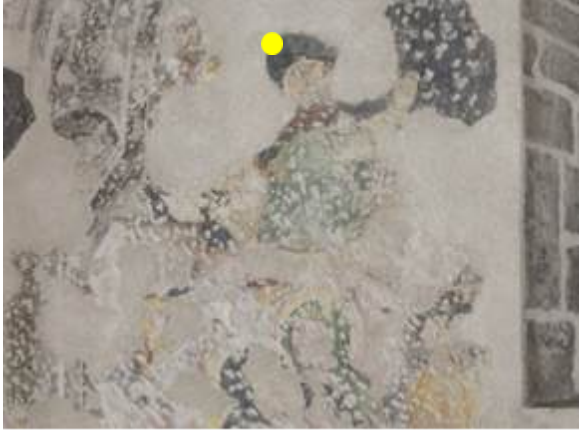
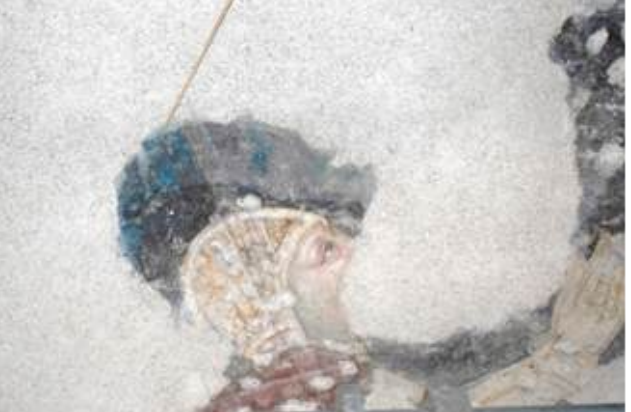
Blue		X10_A6

<b>Location:</b> Background near the figure of Saint Longinus.							
<b>Chemical Elements (count/s)</b>							
<b>K (Ka1)</b>	<b>Ca (Ka1)</b>	<b>Fe (Ka1)</b>	<b>Cu (Ka1)</b>	<b>Hg (La1)</b>	<b>Pb (La1)</b>	<b>Sr (Ka1)</b>	<b>Sn (Ka1)</b>
-	30.04	7.38	91.74	-	5.12	6.58	-
<b>Interpretation:</b> The presence of calcium, iron and strontium can be related to the support. The presence of copper probably suggests the use of a copper pigment. Lead is present in traces.

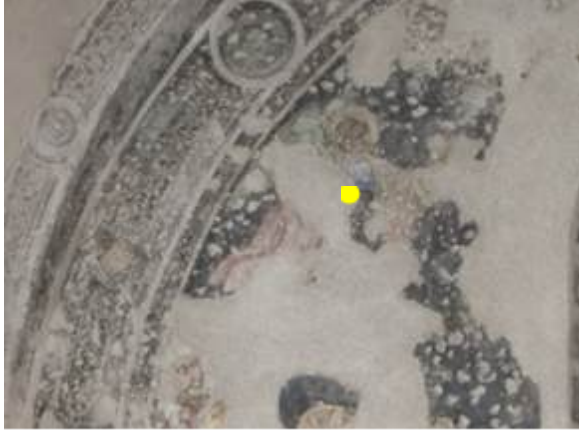
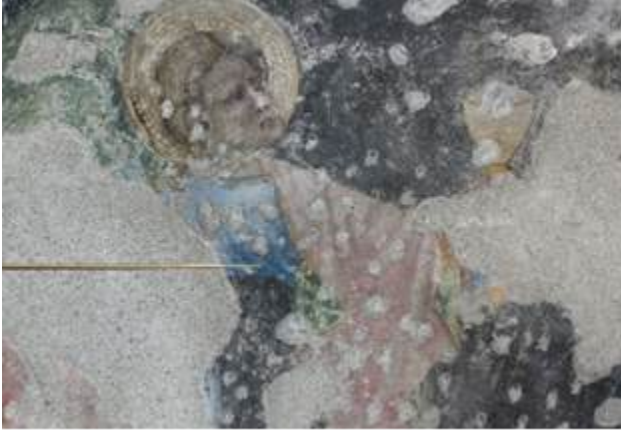
Blue		X11_A6

<b>Location:</b> Angel's robe (dark section)							
<b>Chemical Elements (count/s)</b>							
K (K $\alpha$ 1)	Ca (K $\alpha$ 1)	Fe (K $\alpha$ 1)	Cu (K $\alpha$ 1)	Hg (L $\alpha$ 1)	Pb (L $\alpha$ 1)	Sr (K $\alpha$ 1)	Sn (K $\alpha$ 1)
-	17.32	6.28	8.01	1.44	3.46	7.29	-
<b>Interpretation:</b> The presence of calcium, strontium and iron can be related to the support. Lead and copper are present in trace amounts.

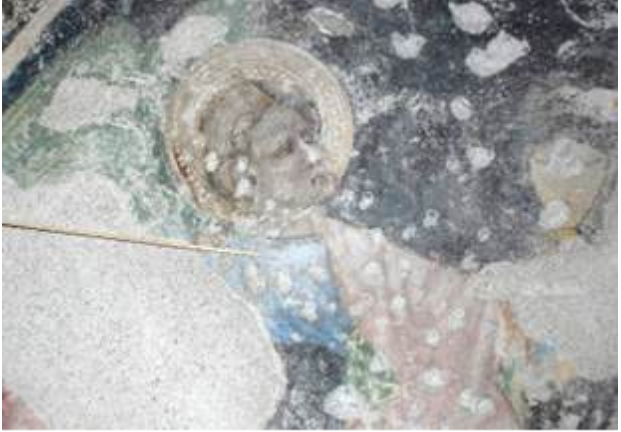
Blue		X12_A6

<b>Localizzazione:</b> Angel's robe (light section)							
<b>Chemical Elements (count/s)</b>							
K (K $\alpha$ 1)	Ca (K $\alpha$ 1)	Fe (K $\alpha$ 1)	Cu (K $\alpha$ 1)	Hg (L $\alpha$ 1)	Pb (L $\alpha$ 1)	Sr (K $\alpha$ 1)	Sn (K $\alpha$ 1)
-	27.14	2.29	-	-	2.43	5.57	-
<b>Interpretation:</b> The presence of calcium, strontium and iron can be related to the support. There are no identifying elements for the blue pigment (perhaps Lapis Lazuli), probably mixed with a lime white.

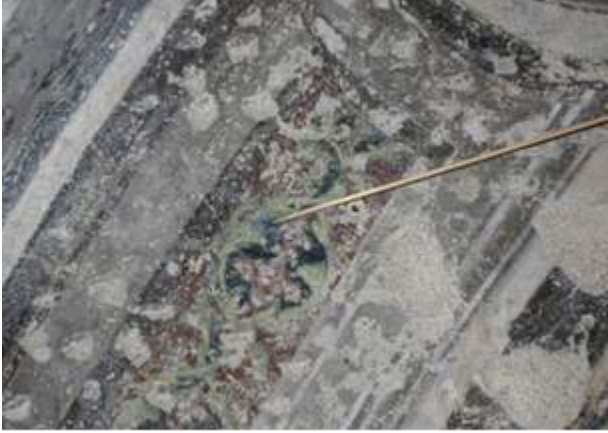
Blue		X13_A3

<b>Location:</b> Detail of internal figurative frame with vegetal scrolls.							
<b>Chemical Elements (count/s)</b>							
K (K $\alpha$ 1)	Ca (K $\alpha$ 1)	Fe (K $\alpha$ 1)	Cu (K $\alpha$ 1)	Hg (L $\alpha$ 1)	Pb (L $\alpha$ 1)	Sr (K $\alpha$ 1)	Sn (K $\alpha$ 1)
-	21.83	16.96	163.88	3.08	24.03	9.01	8.52
<b>Interpretation:</b> The presence of calcium, strontium and iron can be related to the support. The high presence of copper suggests the use of Azurite; the presence of lead and mercury could be traced back to the neighbouring yellow (see also X22) and red (see also X16) layers.

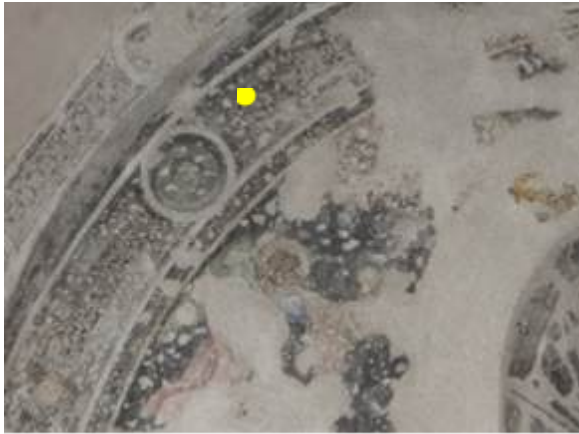
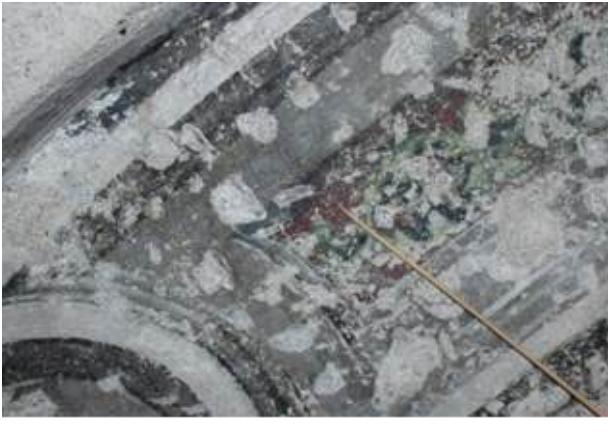
Red		X14_A3

<b>Location:</b> Detail of internal figurative frame with vegetal scrolls							
<b>Chemical Elements (count/s)</b>							
K (K $\alpha$ 1)	Ca (K $\alpha$ 1)	Fe (K $\alpha$ 1)	Cu (K $\alpha$ 1)	Hg (L $\alpha$ 1)	Pb (L $\alpha$ 1)	Sr (K $\alpha$ 1)	Sn (K $\alpha$ 1)
-	26.54	54.18	-	-	15.47	5.06	-
<b>Interpretation:</b> The presence of calcium, strontium and iron may be related to the substrate, but, in particular, the iron peak probably indicates the use of a red ochre.

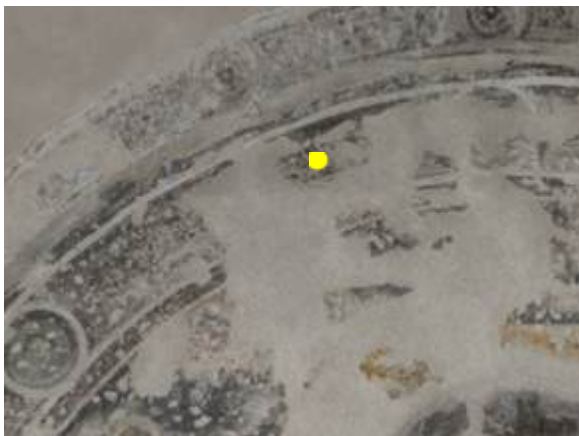
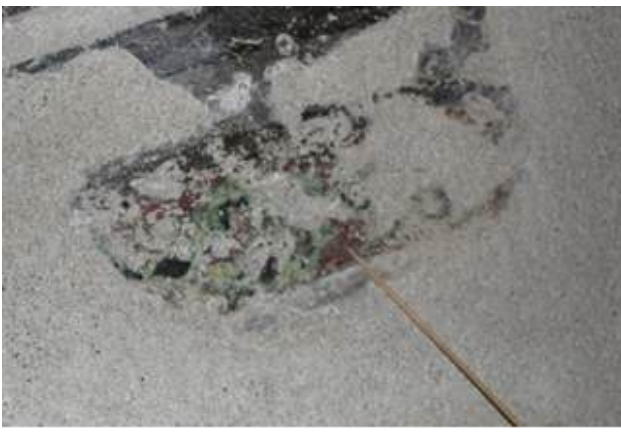
Red		X15_A3

<b>Location:</b> Detail of internal figurative frame with vegetal scrolls							
<b>Chemical Elements (count/s)</b>							
<b>K (K<math>\alpha_1</math>)</b>	<b>Ca (K<math>\alpha_1</math>)</b>	<b>Fe (K<math>\alpha_1</math>)</b>	<b>Cu (K<math>\alpha_1</math>)</b>	<b>Hg (L<math>\alpha_1</math>)</b>	<b>Pb (L<math>\alpha_1</math>)</b>	<b>Sr (K<math>\alpha_1</math>)</b>	<b>Sn (K<math>\alpha_1</math>)</b>
-	16.85	44.06	-	-	43.76	9.99	7.88
<b>Interpretation:</b> The presence of calcium, strontium and iron can be related to the support; since it is a red pigment, the iron peak could indicate a red ochre; on the contrary, the lead, present in equal quantities to the iron, could signal the presence of a lead based pigment (perhaps Giallorino?) or Minio used in a mixture.

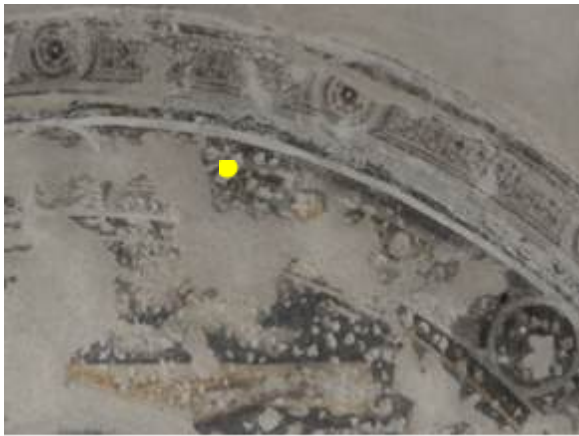
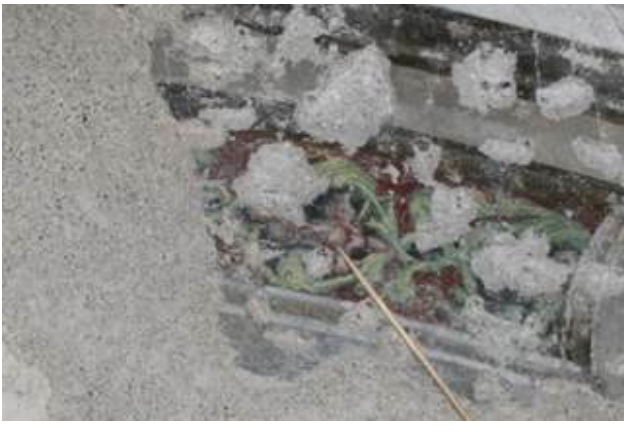
Red		X16_A4

<b>Location:</b> Floral detail of the internal figurative frame with vegetal swirls.							
<b>Chemical Elements (count/s)</b>							
<b>K (K<math>\alpha_1</math>)</b>	<b>Ca (K<math>\alpha_1</math>)</b>	<b>Fe (K<math>\alpha_1</math>)</b>	<b>Cu (K<math>\alpha_1</math>)</b>	<b>Hg (L<math>\alpha_1</math>)</b>	<b>Pb (L<math>\alpha_1</math>)</b>	<b>Sr (K<math>\alpha_1</math>)</b>	<b>Sn (K<math>\alpha_1</math>)</b>
-	18.44	22.05	-	62.23	26.94	8.42	8.98
<b>Interpretation:</b> The presence of calcium, strontium and iron can be related to the support. The mercury peak indicates the presence of Cinnabar pigment. The presence of lead could be related to the use of a lead-based layer (perhaps Giallorino?).

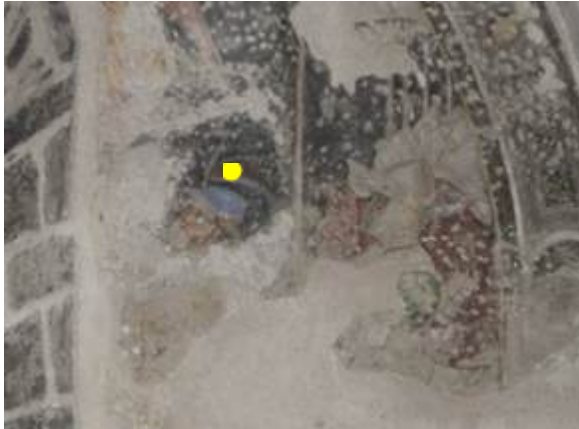
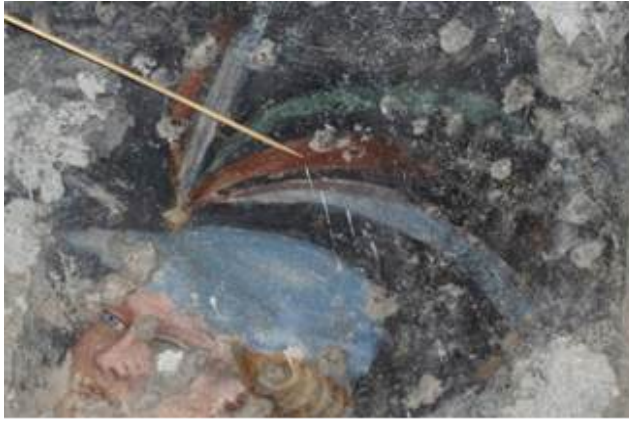
Red		X17_A7

<b>Location:</b> Red feather sticking out of the soldier's blue headpiece							
<b>Chemical Elements (count/s)</b>							
<b>K (K<math>\alpha_1</math>)</b>	<b>Ca (K<math>\alpha_1</math>)</b>	<b>Fe (K<math>\alpha_1</math>)</b>	<b>Cu (K<math>\alpha_1</math>)</b>	<b>Hg (L<math>\alpha_1</math>)</b>	<b>Pb (L<math>\alpha_1</math>)</b>	<b>Sr (K<math>\alpha_1</math>)</b>	<b>Sn (K<math>\alpha_1</math>)</b>
-	19.10	31.19	1.01	2.89	4.49	5.21	-
<b>Interpretation:</b> Calcium, strontium and iron may be related to the medium and/or the use of red ochre. Lead and mercury are present in trace amounts.
