## CHURCH OF SAN VITTORE, MURALTO (LOCARNO)

### THE CRUCIFIXION

#### Report on the Conservation Status of the Fresco Cantiere Studio – BWP 2.1

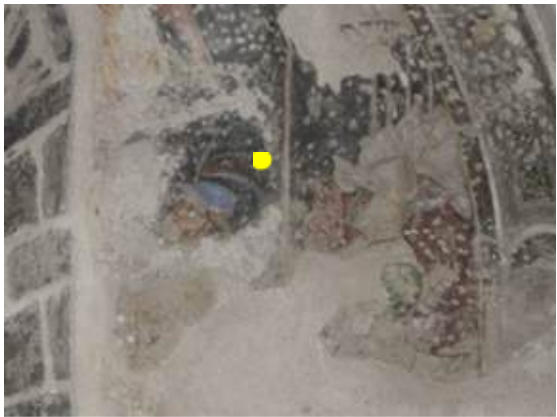
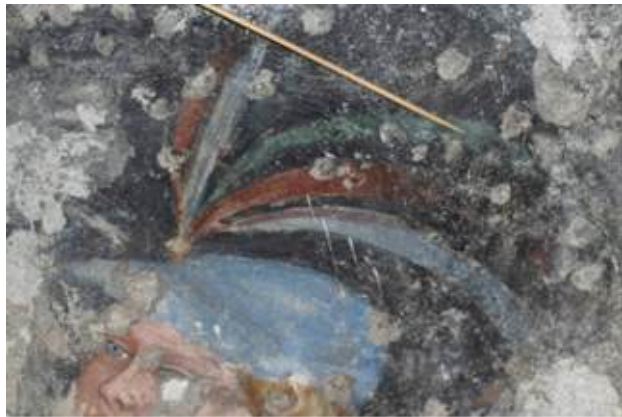
Green		X18_A7

<b>Location:</b> Green feather sticking out of the soldier's blue headpiece.							
<b>Chemical Elements (count/s)</b>							
<b>K (K<math>\alpha_1</math>)</b>	<b>Ca (K<math>\alpha_1</math>)</b>	<b>Fe (K<math>\alpha_1</math>)</b>	<b>Cu (K<math>\alpha_1</math>)</b>	<b>Hg (L<math>\alpha_1</math>)</b>	<b>Pb (L<math>\alpha_1</math>)</b>	<b>Sr (K<math>\alpha_1</math>)</b>	<b>Sn (K<math>\alpha_1</math>)</b>
1.37	17.93	14.25	1.73	3.02	12.10	5.47	-
<b>Interpretation:</b> The presence of calcium, strontium and iron can be related to the support and/or the use of green earth (also confirmed by the presence of potassium); the lead peak (slightly lower than the other two elements) does not allow to determine with certainty the presence of a lead-based pigment, therefore it could be present due to a possible contamination.

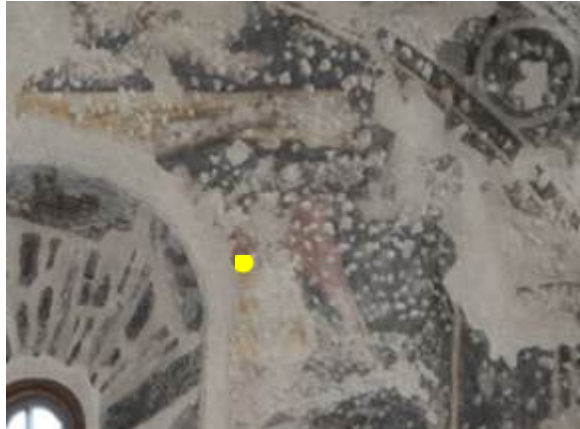
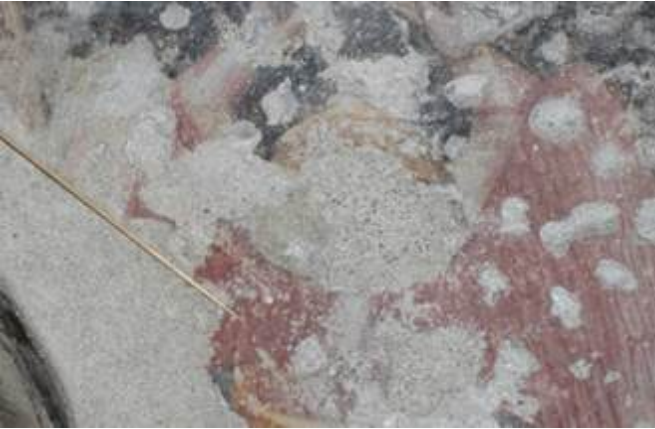
Red		X19_A7

<b>Location:</b> Angel wing from behind.							
<b>Chemical Elements (count/s)</b>							
<b>K (K<math>\alpha_1</math>)</b>	<b>Ca (K<math>\alpha_1</math>)</b>	<b>Fe (K<math>\alpha_1</math>)</b>	<b>Cu (K<math>\alpha_1</math>)</b>	<b>Hg (L<math>\alpha_1</math>)</b>	<b>Pb (L<math>\alpha_1</math>)</b>	<b>Sr (K<math>\alpha_1</math>)</b>	<b>Sn (K<math>\alpha_1</math>)</b>
-	25.78	19.16	-	-	2.62	6.12	-
<b>Interpretation:</b> The presence of calcium, strontium and iron can be related to the support and use of a red ochre.

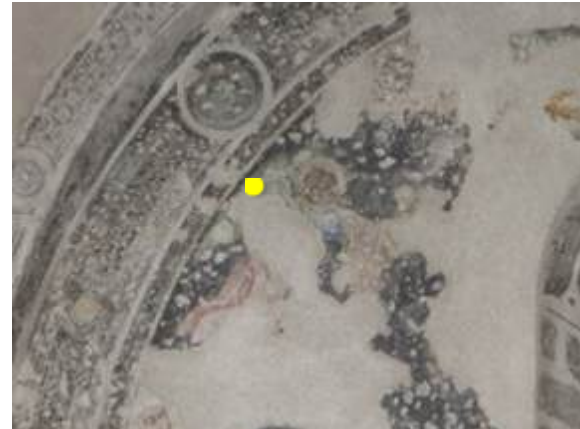
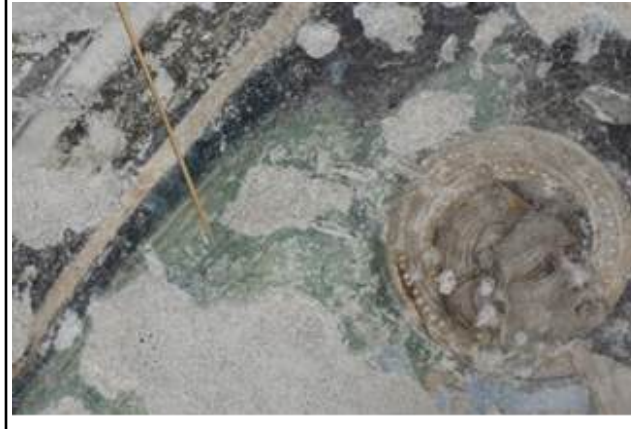
Green		X20_A3

<b>Location:</b> Angel with chalice.							
<b>Chemical Elements (count/s)</b>							
<b>K (K<math>\alpha_1</math>)</b>	<b>Ca (K<math>\alpha_1</math>)</b>	<b>Fe (K<math>\alpha_1</math>)</b>	<b>Cu (K<math>\alpha_1</math>)</b>	<b>Hg (L<math>\alpha_1</math>)</b>	<b>Pb (L<math>\alpha_1</math>)</b>	<b>Sr (K<math>\alpha_1</math>)</b>	<b>Sn (K<math>\alpha_1</math>)</b>
1.63	15.62	39.86	3.88	-	70.09	10.10	9.56
<b>Interpretation:</b> The presence of calcium, strontium and iron can be related to the support and/or the use of green earth (presence of potassium). The presence of lead and tin could be attributable to the use of Giallorino for yellow finishes.

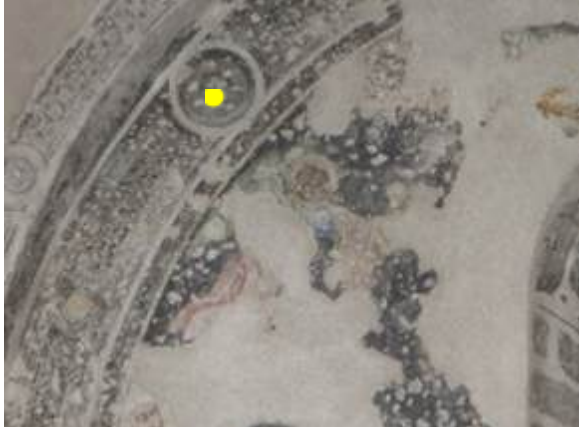
Green		X21_A3

<b>Location:</b> Circular decorative motif of the figurative frame with vegetal swirls.							
<b>Chemical Elements (count/s)</b>							
<b>K (Ka<sub>1</sub>)</b>	<b>Ca (Ka<sub>1</sub>)</b>	<b>Fe (Ka<sub>1</sub>)</b>	<b>Cu (Ka<sub>1</sub>)</b>	<b>Hg (La<sub>1</sub>)</b>	<b>Pb (La<sub>1</sub>)</b>	<b>Sr (Ka<sub>1</sub>)</b>	<b>Sn (Ka<sub>1</sub>)</b>
1.90	22.01	28.03	-	-	52.48	4.95	11.96
<b>Interpretazione:</b> The presence of calcium, strontium and iron can be related to the support and/or the use of green earth (presence of potassium). The presence of lead and tin could be attributable to the use of Giallorino for yellow finishes.

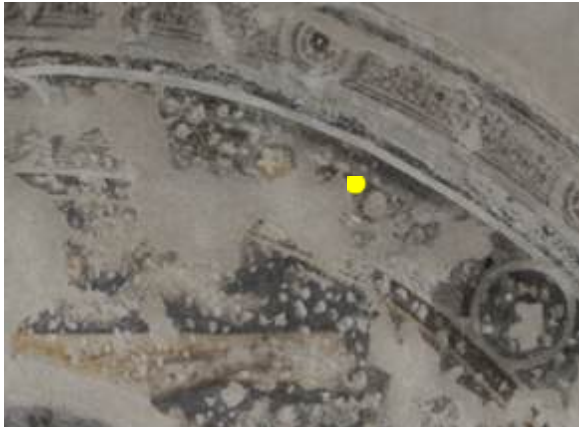
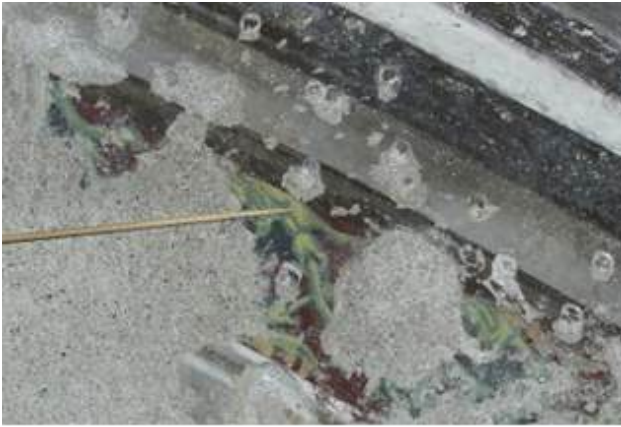
Yellow		X22_A4

<b>Location:</b> Floral detail of the figurative frame with vegetal swirls.							
<b>Chemical Elements (count/s)</b>							
<b>K (Ka<sub>1</sub>)</b>	<b>Ca (Ka<sub>1</sub>)</b>	<b>Fe (Ka<sub>1</sub>)</b>	<b>Cu (Ka<sub>1</sub>)</b>	<b>Hg (La<sub>1</sub>)</b>	<b>Pb (La<sub>1</sub>)</b>	<b>Sr (Ka<sub>1</sub>)</b>	<b>Sn (Ka<sub>1</sub>)</b>
-	7.04	8.92	-	-	210.31	3.27	13.91
<b>Interpretation:</b> The presence of calcium, strontium and iron may be related to the support. The presence of lead and tin could be related to the use of Giallorino.

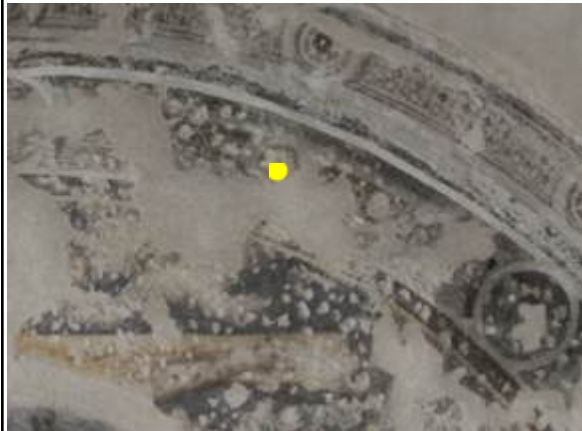
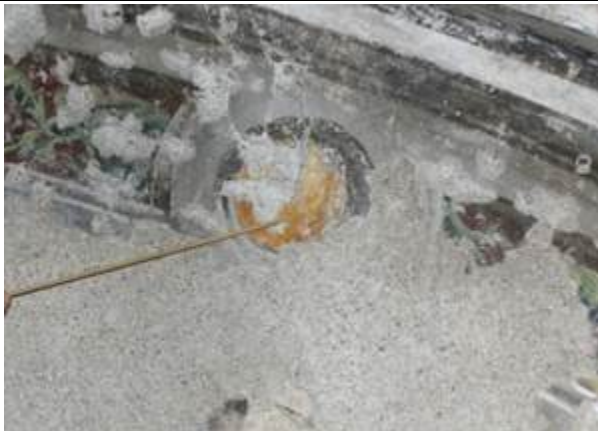
Yellow		X23_A4

<b>Location:</b> Circular decorative motif of the figurative frame with vegetal swirls							
<b>Chemical Elements (count/s)</b>							
<b>K (Ka<sub>1</sub>)</b>	<b>Ca (Ka<sub>1</sub>)</b>	<b>Fe (Ka<sub>1</sub>)</b>	<b>Cu (Ka<sub>1</sub>)</b>	<b>Hg (La<sub>1</sub>)</b>	<b>Pb (La<sub>1</sub>)</b>	<b>Sr (Ka<sub>1</sub>)</b>	<b>Sn (Ka<sub>1</sub>)</b>
-	30.27	19.23	-	-	-	6.46	-
<b>Interpretation:</b> The presence of calcium, strontium and iron may be related to the support and/or the use of yellow ochre.

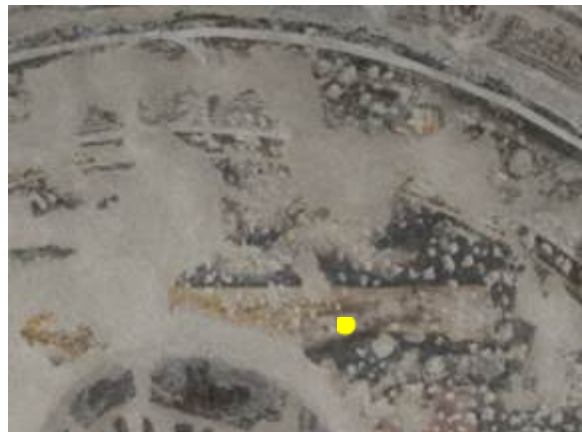
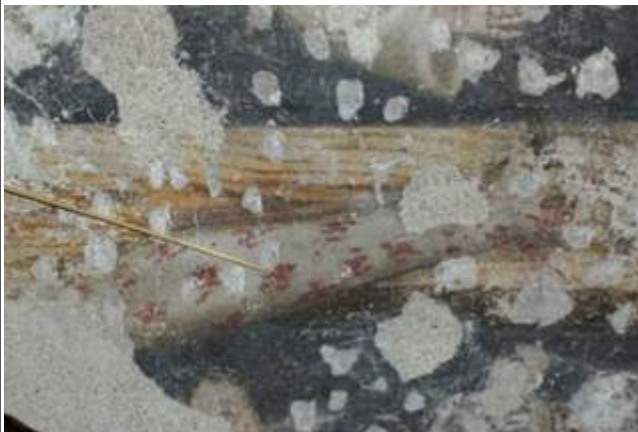
Red		X24_A5

<b>Location:</b> Crucifixion, blood stain on the arm.							
<b>Chemical Elements (count/s)</b>							
<b>K (Ka<sub>1</sub>)</b>	<b>Ca (Ka<sub>1</sub>)</b>	<b>Fe (Ka<sub>1</sub>)</b>	<b>Cu (Ka<sub>1</sub>)</b>	<b>Hg (La<sub>1</sub>)</b>	<b>Pb (La<sub>1</sub>)</b>	<b>Sr (Ka<sub>1</sub>)</b>	<b>Sn (Ka<sub>1</sub>)</b>
	33.72	12.63			1.58	5.45	
<b>Interpretation:</b> The presence of calcium, strontium and iron may be related to the support and/or the use of a red ochre

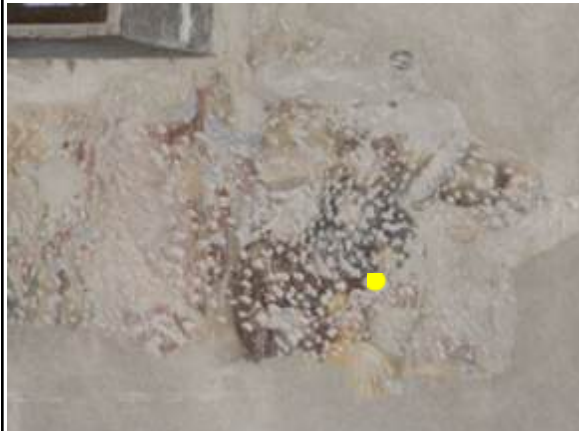
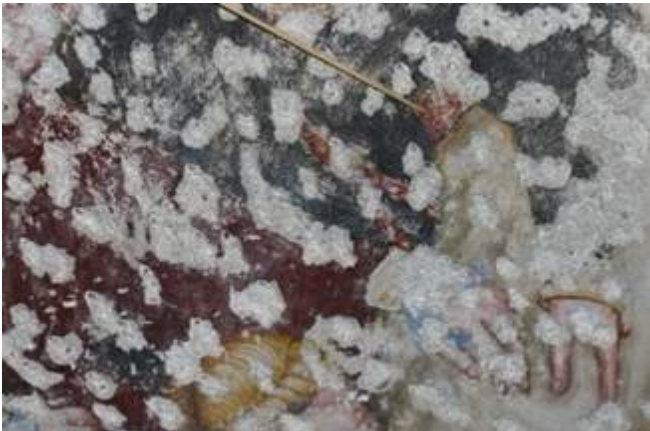
Red		X025_A9

<b>Location:</b> Red sleeve of one of the figures caring for a sick person at the foot of the cross.							
<b>Chemical Elements (count/s)</b>							
<b>K (K<math>\alpha_1</math>)</b>	<b>Ca (K<math>\alpha_1</math>)</b>	<b>Fe (K<math>\alpha_1</math>)</b>	<b>Cu (K<math>\alpha_1</math>)</b>	<b>Hg (L<math>\alpha_1</math>)</b>	<b>Pb (L<math>\alpha_1</math>)</b>	<b>Sr (K<math>\alpha_1</math>)</b>	<b>Sn (K<math>\alpha_1</math>)</b>
-	19.04	24.06	-	108.17	4.93	7.94	-
<b>Interpretation:</b> The presence of calcium, strontium and iron can be related to the support while mercury indicates the use of Cinnabar.

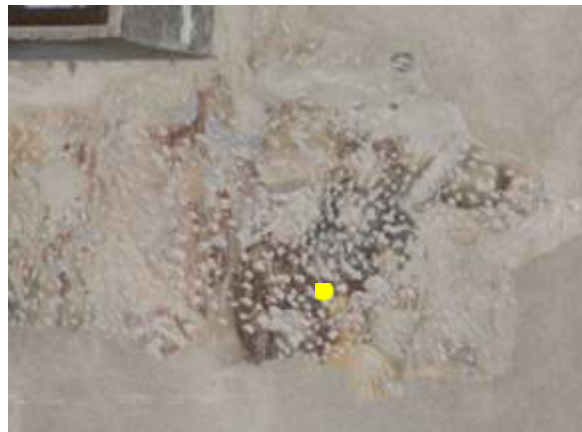
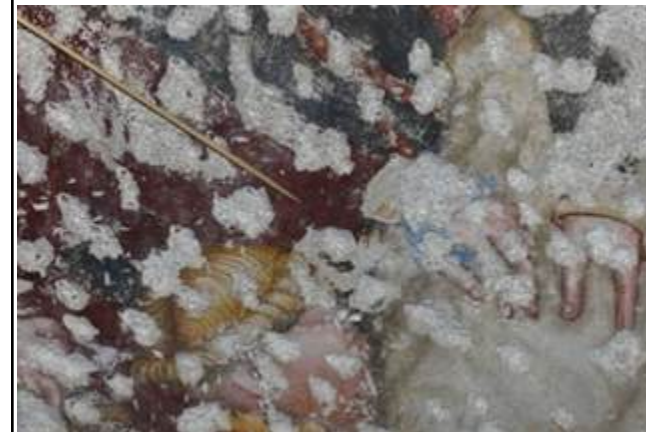
Red		X026_A9

<b>Location:</b> Red robe of one of the figures caring for a sick person at the foot of the cross.							
<b>Chemical Elements (count/s)</b>							
<b>K (K<math>\alpha_1</math>)</b>	<b>Ca (K<math>\alpha_1</math>)</b>	<b>Fe (K<math>\alpha_1</math>)</b>	<b>Cu (K<math>\alpha_1</math>)</b>	<b>Hg (L<math>\alpha_1</math>)</b>	<b>Pb (L<math>\alpha_1</math>)</b>	<b>Sr (K<math>\alpha_1</math>)</b>	<b>Sn (K<math>\alpha_1</math>)</b>
-	20.49	-	60.10	-	1.58	6.61	-
<b>Interpretation:</b> The presence of calcium, strontium and iron may be related to the support and/or the use of a red ochre.

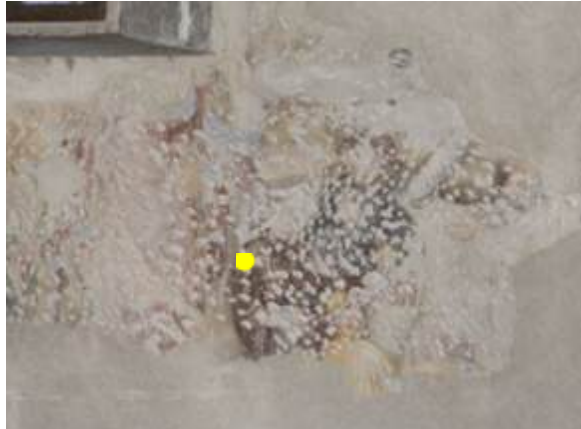
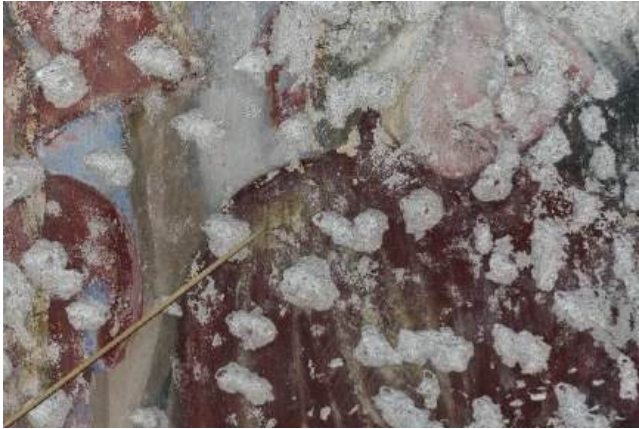
Yellow		X027_A9

<b>Location:</b> Highlighting the robe of a figure caring for a sick person at the foot of the cross.							
<b>Chemical Elements (count/s)</b>							
<b>K (K<math>\alpha_1</math>)</b>	<b>Ca (K<math>\alpha_1</math>)</b>	<b>Fe (K<math>\alpha_1</math>)</b>	<b>Cu (K<math>\alpha_1</math>)</b>	<b>Hg (L<math>\alpha_1</math>)</b>	<b>Pb (L<math>\alpha_1</math>)</b>	<b>Sr (K<math>\alpha_1</math>)</b>	<b>Sn (K<math>\alpha_1</math>)</b>
-	6.16	11.75	-	32.85	155.96	4.00	7.27
<b>Interpretation:</b> The presence of calcium, strontium and iron may be related to the support. The presence of lead and tin may indicate the use of a Giallorino. Mercury could indicate the use of Cinnabar for finishes now lost.

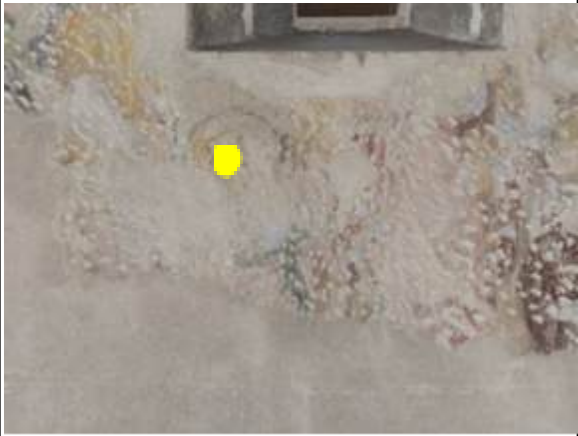
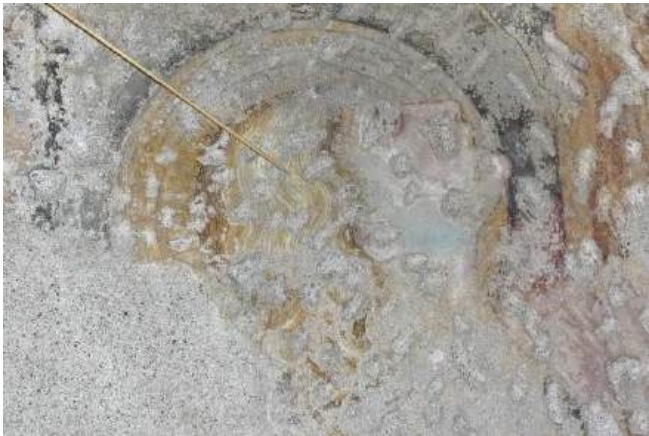
Yellow		X028_A8

<b>Location:</b> Highlights of Mary Magdalene's hair.							
<b>Chemical Elements (count/s)</b>							
<b>K (K<math>\alpha_1</math>)</b>	<b>Ca (K<math>\alpha_1</math>)</b>	<b>Fe (K<math>\alpha_1</math>)</b>	<b>Cu (K<math>\alpha_1</math>)</b>	<b>Hg (L<math>\alpha_1</math>)</b>	<b>Pb (L<math>\alpha_1</math>)</b>	<b>Sr (K<math>\alpha_1</math>)</b>	<b>Sn (K<math>\alpha_1</math>)</b>
-	15.88	3.75	-	-	160.89	3.59	10.53
<b>Interpretation:</b> The presence of calcium, strontium and iron can be related to the support. The presence of lead and tin can indicate the use of Giallorino. The presence of Biacca or Bianco San Giovanni for highlights is not excluded.

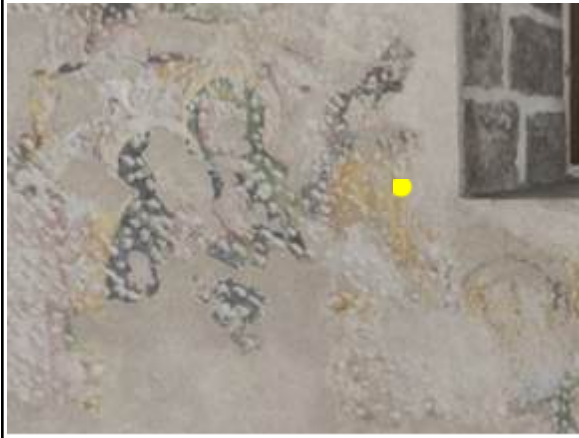
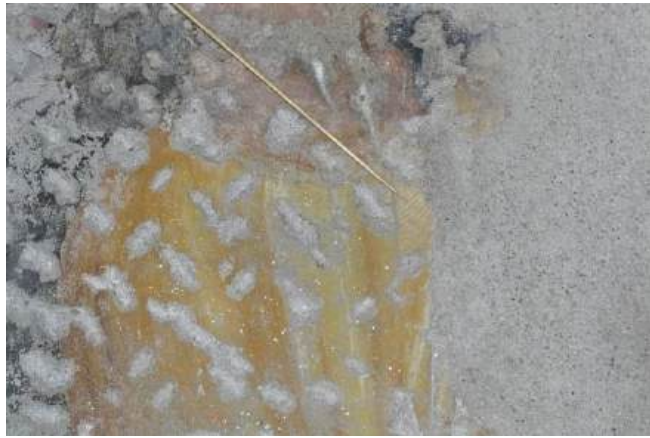
Yellow		X029_A8

<b>Location:</b> Highlight on the robe of the figure next to the three Madonna's.							
<b>Chemical Elements (count/s)</b>							
<b>K (K<math>\alpha_1</math>)</b>	<b>Ca (K<math>\alpha_1</math>)</b>	<b>Fe (K<math>\alpha_1</math>)</b>	<b>Cu (K<math>\alpha_1</math>)</b>	<b>Hg (L<math>\alpha_1</math>)</b>	<b>Pb (L<math>\alpha_1</math>)</b>	<b>Sr (K<math>\alpha_1</math>)</b>	<b>Sn (K<math>\alpha_1</math>)</b>
-	13.67	2.50	1.08	-	215.92	2.33	12.75
<b>Interpretation:</b> The presence of calcium, strontium and iron can be related to the support. The presence of lead and tin can indicate the use of Giallorino. The presence of Biacca or Bianco San Giovanni for highlights is not excluded

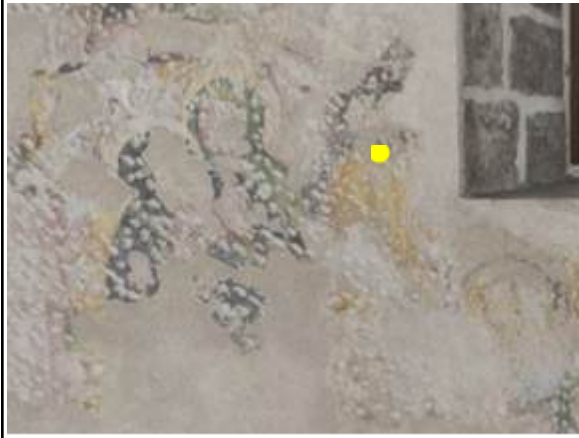
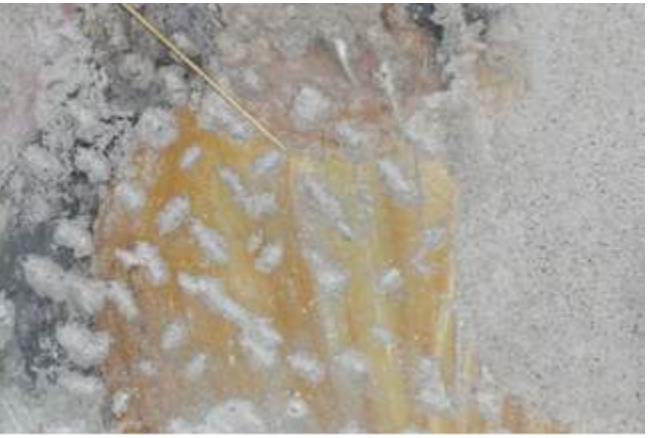
Yellow		X030_A8

<b>Location:</b> Highlight on the robe of the figure next to the three Madonna's.							
<b>Chemical Elements (count/s)</b>							
<b>K (K<math>\alpha_1</math>)</b>	<b>Ca (K<math>\alpha_1</math>)</b>	<b>Fe (K<math>\alpha_1</math>)</b>	<b>Cu (K<math>\alpha_1</math>)</b>	<b>Hg (L<math>\alpha_1</math>)</b>	<b>Pb (L<math>\alpha_1</math>)</b>	<b>Sr (K<math>\alpha_1</math>)</b>	<b>Sn (K<math>\alpha_1</math>)</b>
-	16.45	4.49	1.52	-	162.92	4.33	11.96
<b>Interpretation:</b> The presence of calcium, strontium and iron can be related to the support. The presence of lead and tin can indicate the use of Giallorino. The presence of Biacca or Bianco San Giovanni for highlights is not excluded.

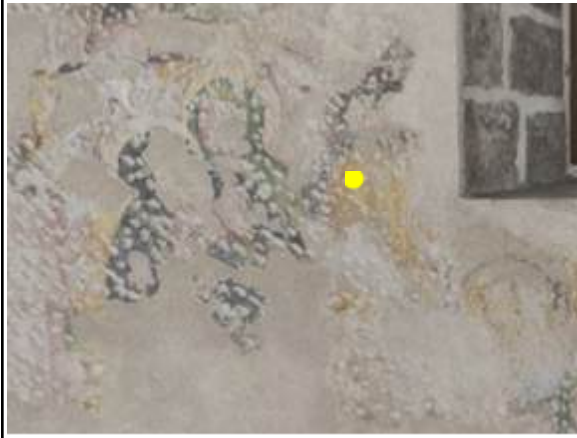
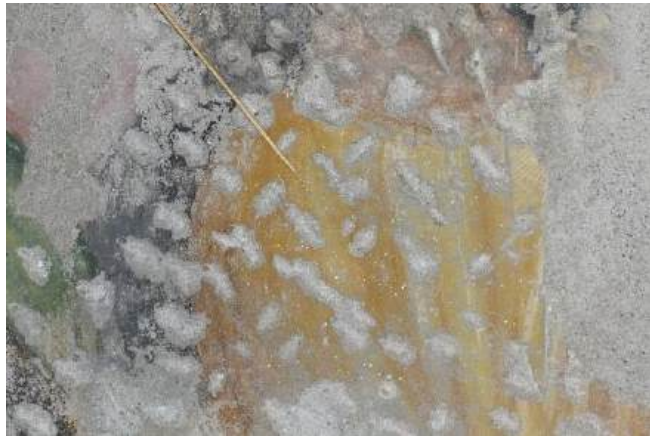
Yellow		X031_A8

<b>Location:</b> Highlight on the robe of the figure next to the three Madonna's.							
<b>Chemical Elements (count/s)</b>							
<b>K (K<math>\alpha_1</math>)</b>	<b>Ca (K<math>\alpha_1</math>)</b>	<b>Fe (K<math>\alpha_1</math>)</b>	<b>Cu (K<math>\alpha_1</math>)</b>	<b>Hg (L<math>\alpha_1</math>)</b>	<b>Pb (L<math>\alpha_1</math>)</b>	<b>Sr (K<math>\alpha_1</math>)</b>	<b>Sn (K<math>\alpha_1</math>)</b>
-	19.51	11.72	-	-	103.07	5.66	10.62
<b>Interpretation:</b> The presence of calcium, strontium and iron can be related to the support. The presence of lead and tin can indicate the use of Giallorino.

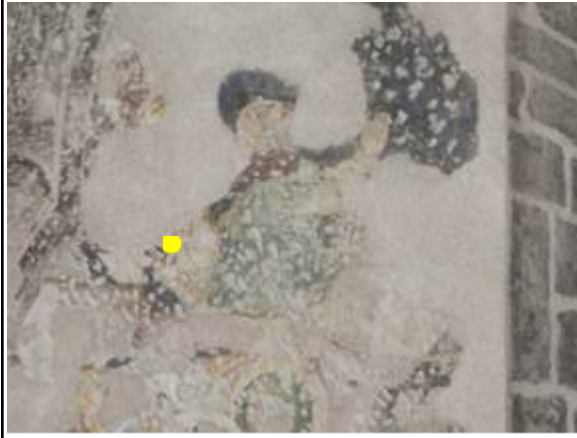
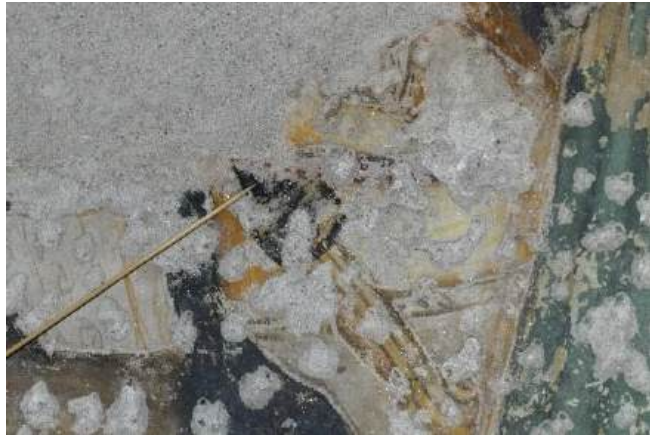
Black		X032_A6

<b>Location:</b> Horse harnesses near Saint Longinus.							
<b>Chemical Elements (count/s)</b>							
<b>K (K<math>\alpha_1</math>)</b>	<b>Ca (K<math>\alpha_1</math>)</b>	<b>Fe (K<math>\alpha_1</math>)</b>	<b>Cu (K<math>\alpha_1</math>)</b>	<b>Hg (L<math>\alpha_1</math>)</b>	<b>Pb (L<math>\alpha_1</math>)</b>	<b>Sr (K<math>\alpha_1</math>)</b>	<b>Sn (K<math>\alpha_1</math>)</b>
-	33.84	10.82	-	-	3.12	8.13	-
<b>Interpretation:</b> The presence of calcium, strontium and iron can be related to the support and/or the black pigment. Lead is present in traces.

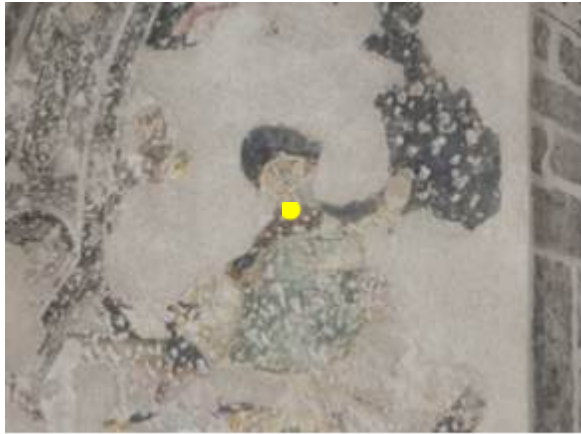
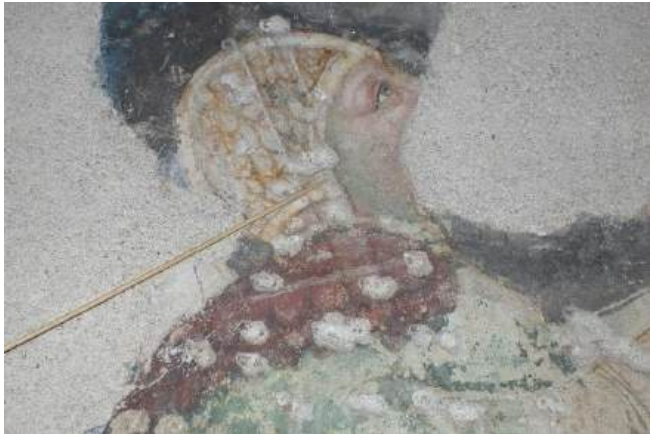
Intonaco		X033_A6

<b>Location:</b> Lance/helmet of Saint Longinus (UV glowing area).							
<b>Chemical Elements (count/s)</b>							
<b>K (K<math>\alpha_1</math>)</b>	<b>Ca (K<math>\alpha_1</math>)</b>	<b>Fe (K<math>\alpha_1</math>)</b>	<b>Cu (K<math>\alpha_1</math>)</b>	<b>Hg (L<math>\alpha_1</math>)</b>	<b>Pb (L<math>\alpha_1</math>)</b>	<b>Sr (K<math>\alpha_1</math>)</b>	<b>Sn (K<math>\alpha_1</math>)</b>
-	18.57	10.17	3.92	-	138.59	4.96	-
<b>Interpretation:</b> The presence of calcium, strontium and iron may be related to the support and/or the use of yellow ochre for the preparatory drawing. The presence of lead could indicate the use of an oily mission for the metal sheet.

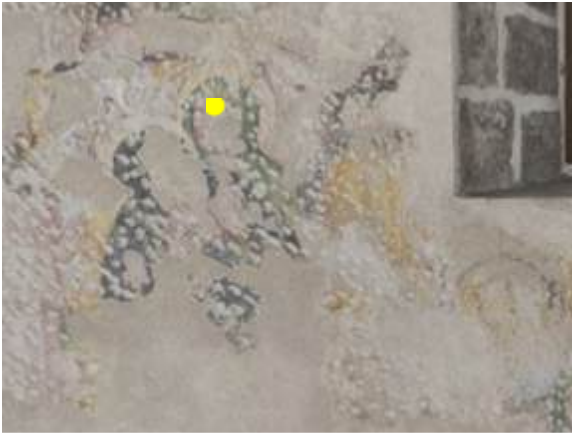
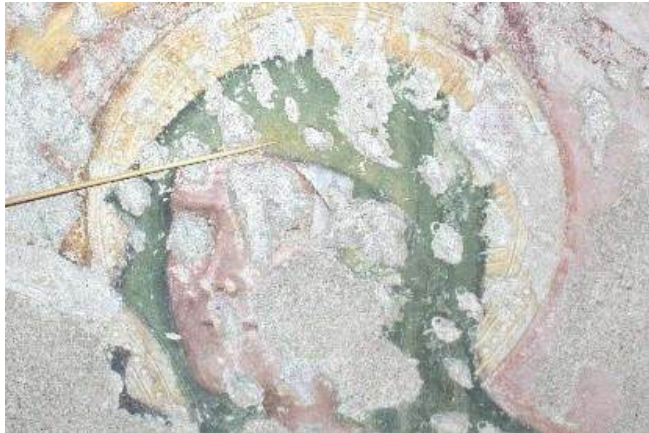
Green		X034_A8

<b>Location:</b> Traces of decoration on the dress of Mary of Cleophas (?).							
<b>Chemical Elements (count/s)</b>							
<b>K (K<math>\alpha_1</math>)</b>	<b>Ca (K<math>\alpha_1</math>)</b>	<b>Fe (K<math>\alpha_1</math>)</b>	<b>Cu (K<math>\alpha_1</math>)</b>	<b>Hg (L<math>\alpha_1</math>)</b>	<b>Pb (L<math>\alpha_1</math>)</b>	<b>Sr (K<math>\alpha_1</math>)</b>	<b>Sn (K<math>\alpha_1</math>)</b>
-	8.91	8.58	1.90	-	221.20	2.39	13.70
<b>Interpretation:</b> The presence of calcium, strontium and iron can be related to the support. The presence of lead and tin suggests the use of Giallorino used in a mixture probably with a green earth.

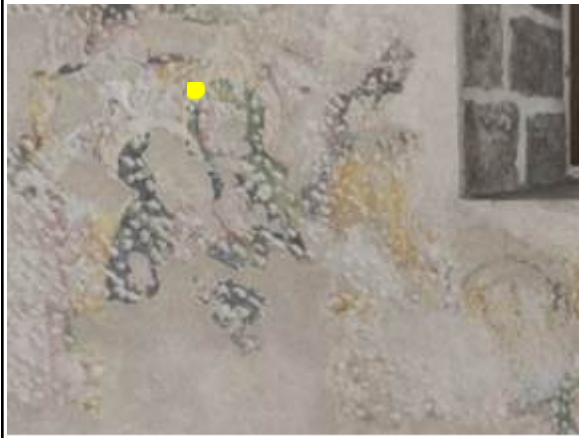
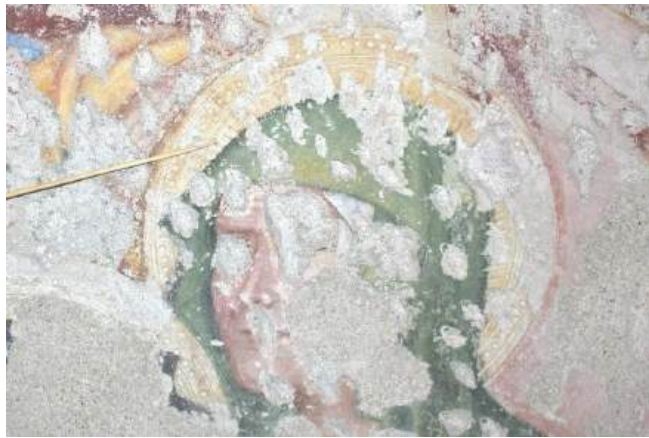
Yellow		X035_A6

<b>Location:</b> Halo of Mary of Cleophas (?)							
<b>Chemical Elements (count/s)</b>							
<b>K (K<math>\alpha_1</math>)</b>	<b>Ca (K<math>\alpha_1</math>)</b>	<b>Fe (K<math>\alpha_1</math>)</b>	<b>Cu (K<math>\alpha_1</math>)</b>	<b>Hg (L<math>\alpha_1</math>)</b>	<b>Pb (L<math>\alpha_1</math>)</b>	<b>Sr (K<math>\alpha_1</math>)</b>	<b>Sn (K<math>\alpha_1</math>)</b>
-	35.91	7.81	-	-	4.52	6.23	-
<b>Interpretation:</b> The presence of calcium, strontium and iron may be related to the support and/or the use of yellow ochre.

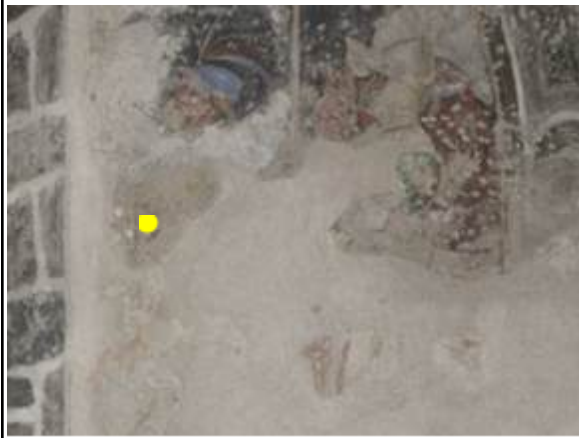
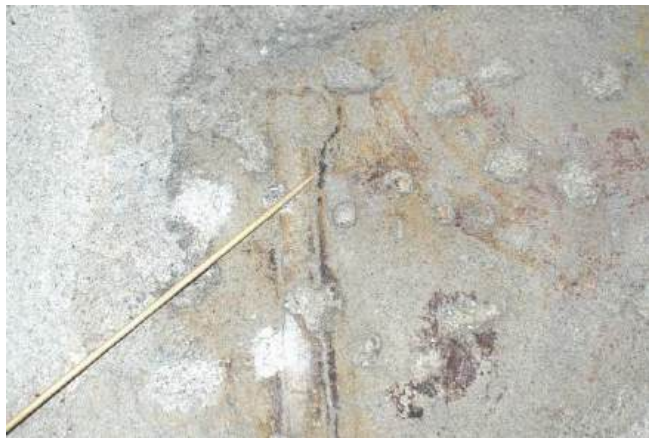
Black		X036_A7

<b>Localizzazione:</b> Soldier's sword hilt.							
<b>Chemical Elements (count/s)</b>							
<b>K (K<math>\alpha_1</math>)</b>	<b>Ca (K<math>\alpha_1</math>)</b>	<b>Fe (K<math>\alpha_1</math>)</b>	<b>Cu (K<math>\alpha_1</math>)</b>	<b>Hg (L<math>\alpha_1</math>)</b>	<b>Pb (L<math>\alpha_1</math>)</b>	<b>Sr (K<math>\alpha_1</math>)</b>	<b>Sn (K<math>\alpha_1</math>)</b>
-	23.87	8.15	1.22	-	1.22	7.29	-
<b>Interpretazione:</b> The presence of calcium, strontium and iron may be related to the support and/or the use of a black pigment.

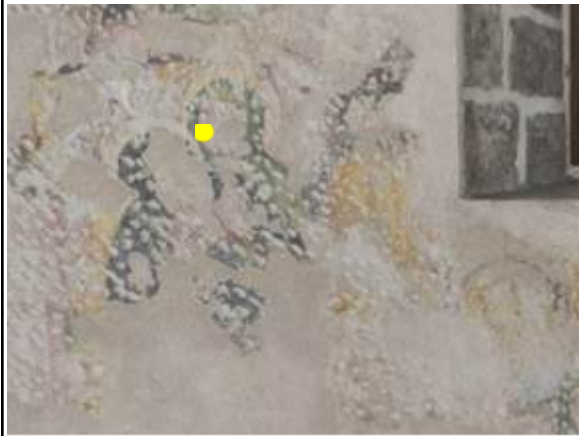
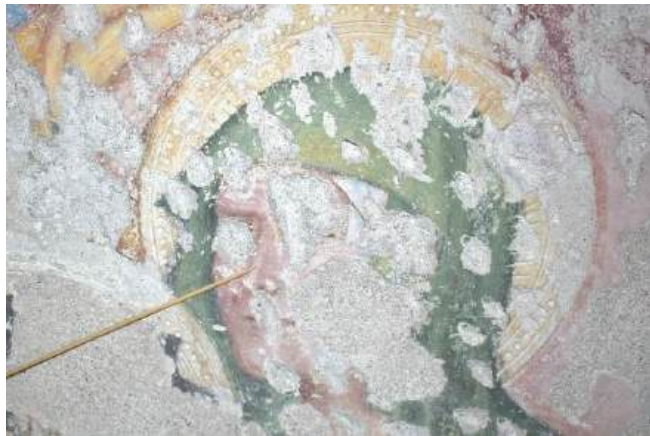
Incarnato		X037_A8

<b>Location:</b> Nose of Mary of Cleophas(?).							
<b>Chemical Elements (count/s)</b>							
<b>K (K<math>\alpha_1</math>)</b>	<b>Ca (K<math>\alpha_1</math>)</b>	<b>Fe (K<math>\alpha_1</math>)</b>	<b>Cu (K<math>\alpha_1</math>)</b>	<b>Hg (L<math>\alpha_1</math>)</b>	<b>Pb (L<math>\alpha_1</math>)</b>	<b>Sr (K<math>\alpha_1</math>)</b>	<b>Sn (K<math>\alpha_1</math>)</b>
-	30.02	5.62	1.39	-	-	6.28	-
<b>Interpretation:</b> The presence of calcium, strontium and iron may be related to the support and/or the use of a red ochre mixed with lime or Bianco San Giovanni.

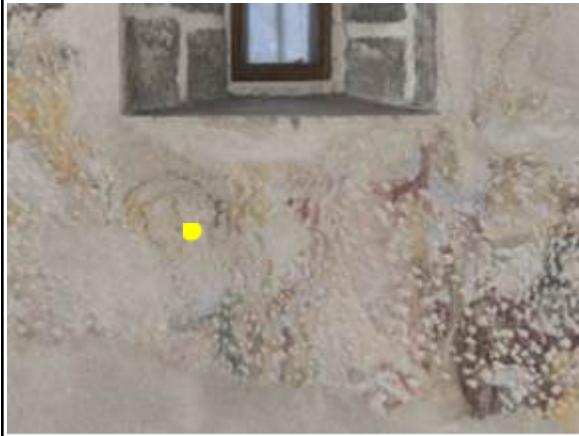
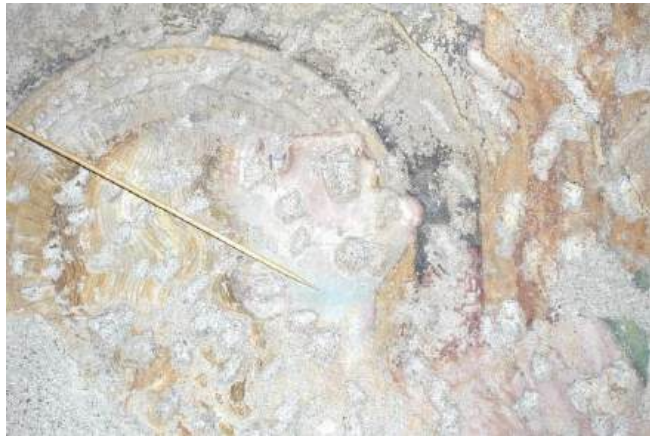
Incarnato		X038_A8

<b>Localizzazione:</b> Mary Magdalene's neck.							
<b>Chemical Elements (count/s)</b>							
<b>K (K<math>\alpha_1</math>)</b>	<b>Ca (K<math>\alpha_1</math>)</b>	<b>Fe (K<math>\alpha_1</math>)</b>	<b>Cu (K<math>\alpha_1</math>)</b>	<b>Hg (L<math>\alpha_1</math>)</b>	<b>Pb (L<math>\alpha_1</math>)</b>	<b>Sr (K<math>\alpha_1</math>)</b>	<b>Sn (K<math>\alpha_1</math>)</b>
-	30.09	6.69	1.39	-	1.67	6.03	-
<b>Interpretation:</b> The presence of calcium, strontium and iron can be related to the support and/or the use of a red ochre mixed with lime or Bianco San Giovanni and a green earth.

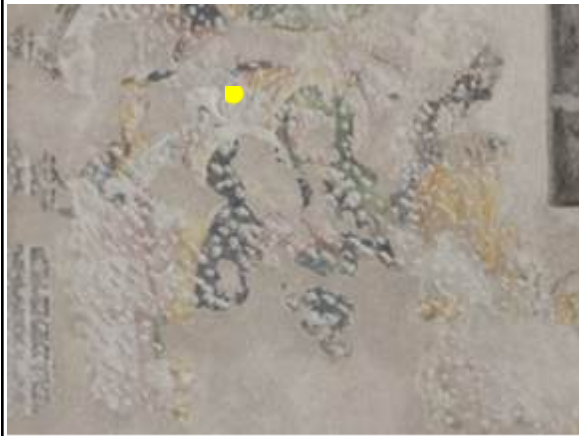
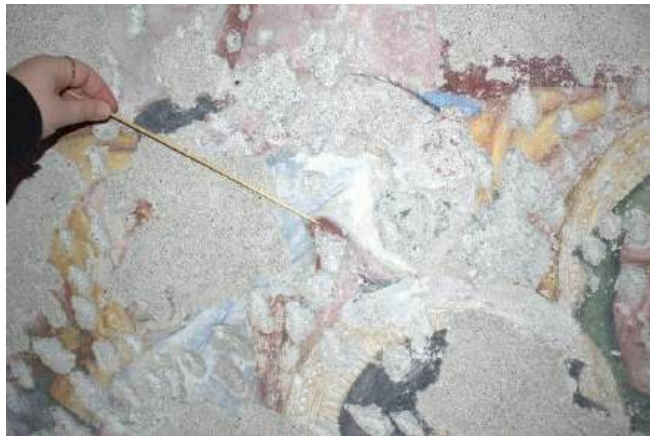
<b>Red</b>		X039_A8

<b>Location:</b> Edge of the veil of Mary of Magdala (?).							
<b>Chemical Elements (count/s)</b>							
<b>K (K<math>\alpha_1</math>)</b>	<b>Ca (K<math>\alpha_1</math>)</b>	<b>Fe (K<math>\alpha_1</math>)</b>	<b>Cu (K<math>\alpha_1</math>)</b>	<b>Hg (L<math>\alpha_1</math>)</b>	<b>Pb (L<math>\alpha_1</math>)</b>	<b>Sr (K<math>\alpha_1</math>)</b>	<b>Sn (K<math>\alpha_1</math>)</b>
-	24.21	13.42	-	78.41	9.33	7.40	-
<b>Interpretation:</b> The presence of calcium, strontium and iron can be related to the support. The presence of mercury indicates the use of Cinnabar.

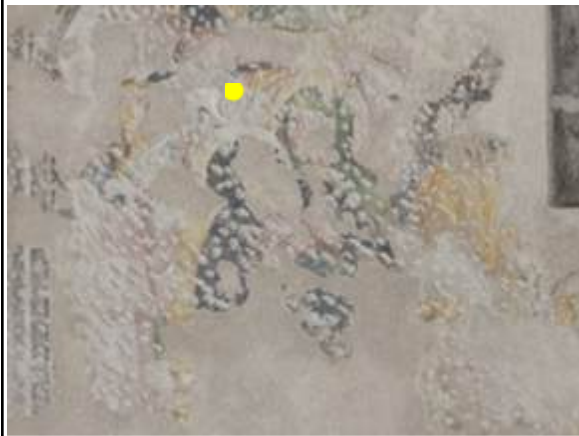
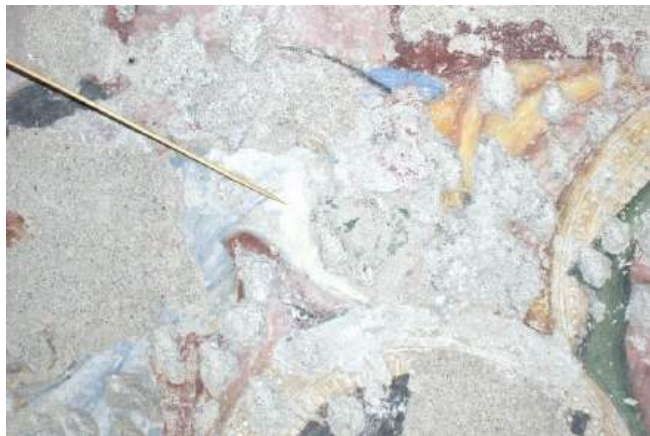
White		X040_A8

<b>Location:</b> Veil of Mary of Magdala (?).							
<b>Chemical Elements (count/s)</b>							
<b>K (K<math>\alpha_1</math>)</b>	<b>Ca (K<math>\alpha_1</math>)</b>	<b>Fe (K<math>\alpha_1</math>)</b>	<b>Cu (K<math>\alpha_1</math>)</b>	<b>Hg (L<math>\alpha_1</math>)</b>	<b>Pb (L<math>\alpha_1</math>)</b>	<b>Sr (K<math>\alpha_1</math>)</b>	<b>Sn (K<math>\alpha_1</math>)</b>
-	44.13	2.90	-	-	3.39	4.53	-
<b>Interpretation:</b> The presence of calcium, strontium and iron may be related to the support and/or the Bianco San Giovanni/lime.

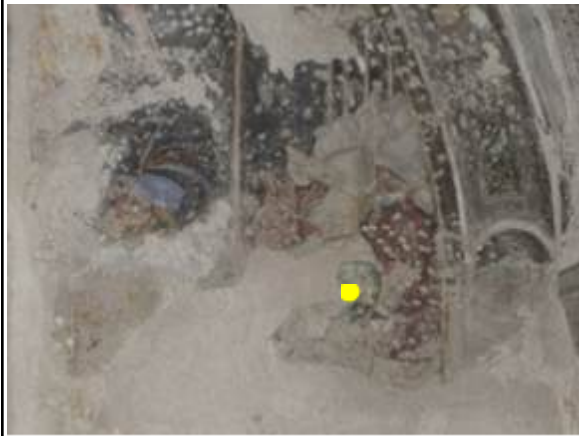
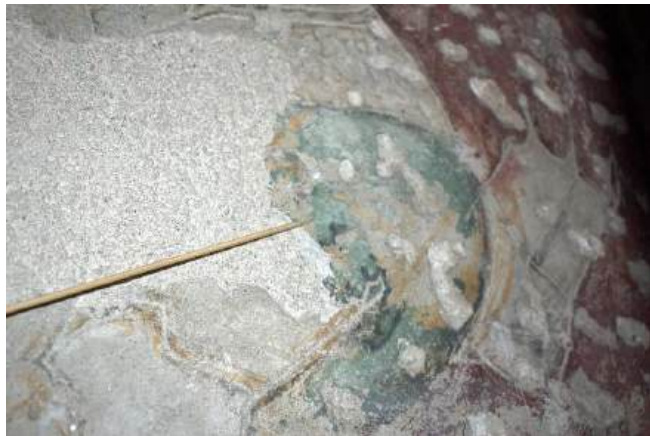
Green		X041_A7

<b>Location:</b> Soldier's sleeve.							
<b>Chemical Elements (count/s)</b>							
<b>K (K<math>\alpha_1</math>)</b>	<b>Ca (K<math>\alpha_1</math>)</b>	<b>Fe (K<math>\alpha_1</math>)</b>	<b>Cu (K<math>\alpha_1</math>)</b>	<b>Hg (L<math>\alpha_1</math>)</b>	<b>Pb (L<math>\alpha_1</math>)</b>	<b>Sr (K<math>\alpha_1</math>)</b>	<b>Sn (K<math>\alpha_1</math>)</b>
-	16.55	26.75	-	-	27.19	6.20	-
<b>Interpretation:</b> The presence of calcium, strontium and iron can be related to the support. The presence of lead indicates the presence of residues of the materials used for the metal leaf gilding.

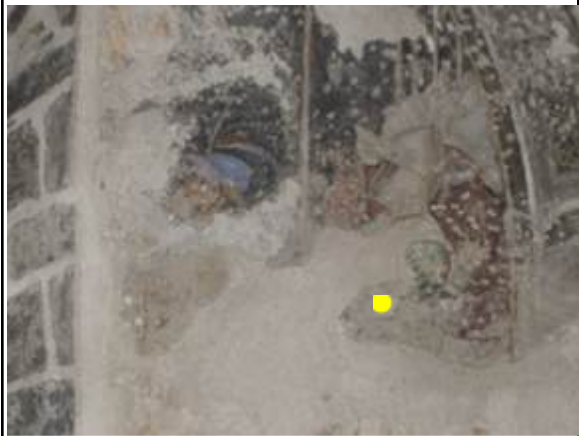
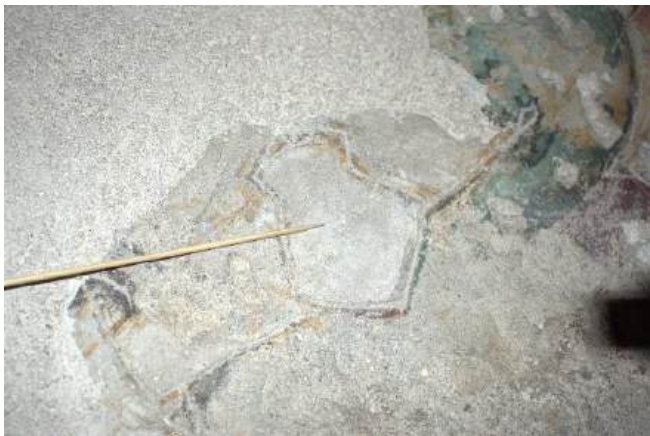
Intonaco		X042_A7

<b>Location:</b> Sleeve of the Soldier's armour.							
<b>Chemical Elements (count/s)</b>							
<b>K (K<math>\alpha_1</math>)</b>	<b>Ca (K<math>\alpha_1</math>)</b>	<b>Fe (K<math>\alpha_1</math>)</b>	<b>Cu (K<math>\alpha_1</math>)</b>	<b>Hg (L<math>\alpha_1</math>)</b>	<b>Pb (L<math>\alpha_1</math>)</b>	<b>Sr (K<math>\alpha_1</math>)</b>	<b>Sn (K<math>\alpha_1</math>)</b>
-	22.53	4.97	1.08	-	-	6.48	-
<b>Interpretazione:</b> The presence of calcium, strontium and iron may be related to support.

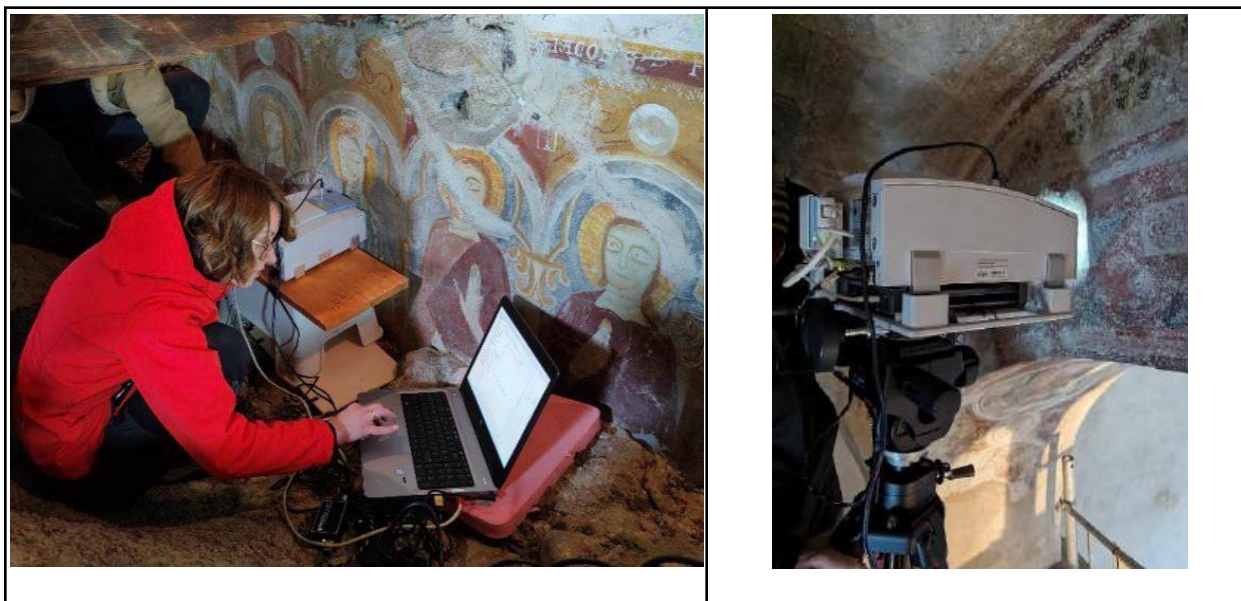
The instrument used is a portable FT-IR spectrophotometer ALPHA II (Bruker Optics) consisting of a CenterGlow™ infrared source, a RockSolid™ interferometer modified to work in any environmental condition and spatial orientation and a DTGS room temperature detector. A system of parabolic mirrors allows it to send and collect ( $22^\circ/22^\circ$ ) the infrared radiation reflected by a surface located about 1 cm away from the instrument. The spectra are acquired in a range that extends from 8000 to 350  $\text{cm}^{-1}$ , with a spectral resolution of 4  $\text{cm}^{-1}$ , and then displayed in pseudo-absorbance [ $\text{Log}(1/R)$ ]. A fully reflective gold plate is used for the background. The diameter of the survey area, visible thanks to an integrated camera, is approximately 3 mm (Figure 1). The data were recorded and processed using the OPUS 8.1 software.

Figure 1 – Images of the portable FT-IR spectrophotometer ALPHA II (Bruker Optics): setup and distance of the instrument from the investigated surface.

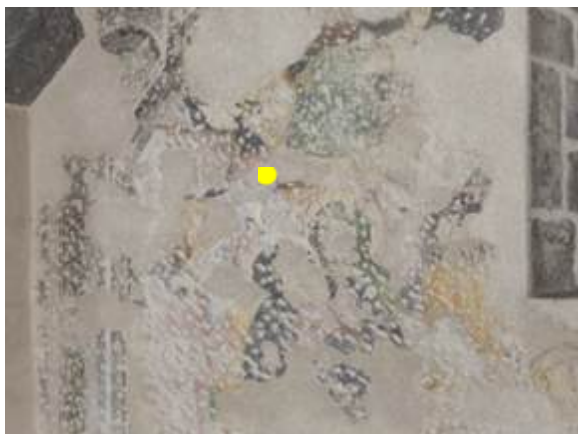
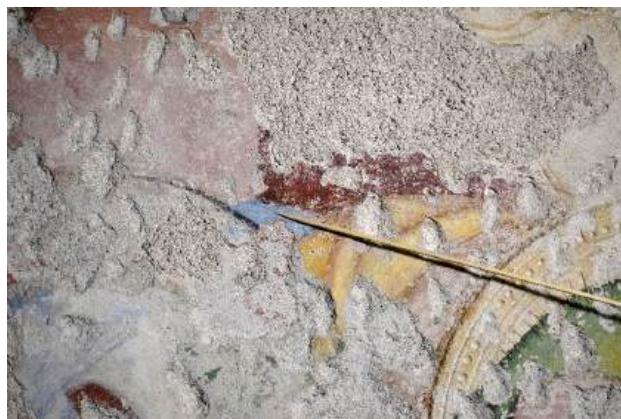
IR01\_A8

**Location:** Area above the halos of the three Marys.

**Interpretation:** Natural ultramarine blue (band at about 2342  $\text{cm}^{-1}$  of the carbon dioxide and bands at about 1007 and 496  $\text{cm}^{-1}$  of the silicate component, in blue reference spectrum of a fresh application of the pigment) and calcium carbonate (reference spectrum in grey).

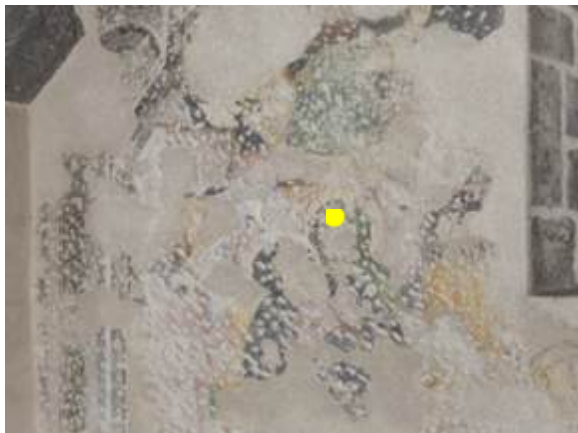
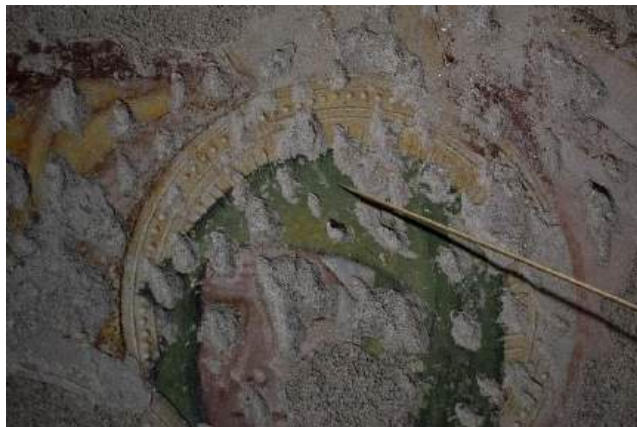
## IR02\_A8

**Location:** Dress covering the head of Mary of Clopas (?).

**Interpretation:** Calcium carbonate (reference spectrum in grey) possible silicate component (bands at about 1078 cm<sup>-1</sup> and hydroxyl groups (-OH) at about 3458 cm<sup>-1</sup>). Doublet at about 4341 and 4255 cm<sup>-1</sup> of complex interpretation.

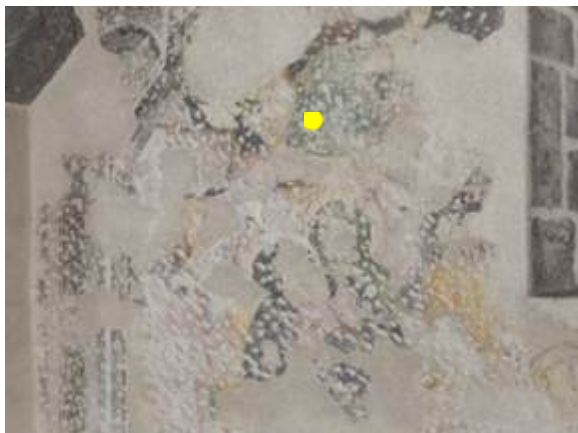
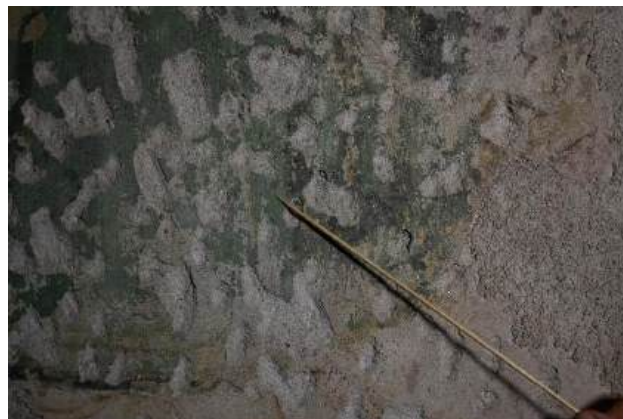
IR03\_A6

**Location:** Robe of Saint Longinus.

**Interpretation:** Calcium carbonate (reference spectrum in grey) and gypsum (reference spectrum in black). Doublet at about 4347 and 4257  $\text{cm}^{-1}$  of complex interpretation.

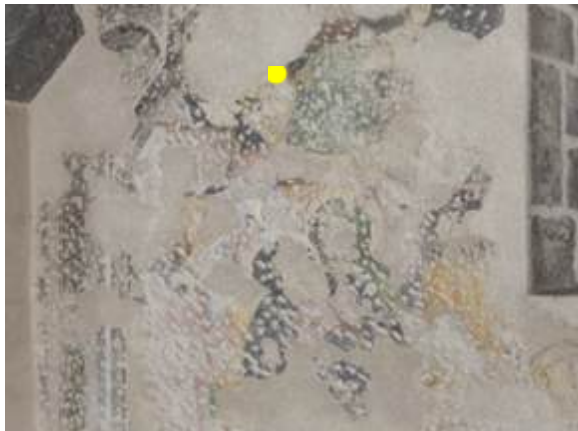
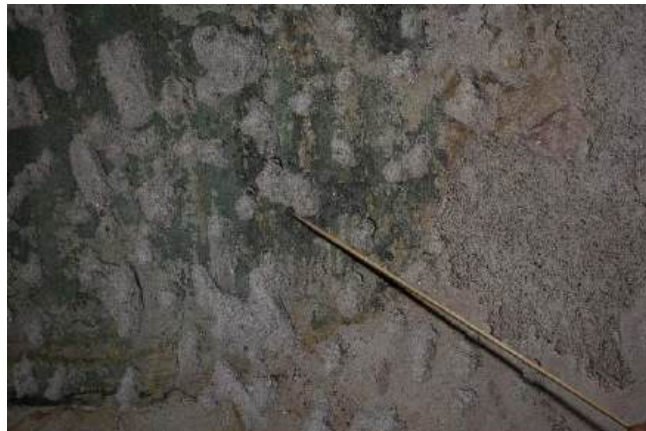
IR04\_A6

**Location:** Robe of Saint Longinus.

**Interpretation:** Calcium carbonate (reference spectrum in grey) and possible oxalates (bands at approximately 1326 and 1682 cm<sup>-1</sup>)

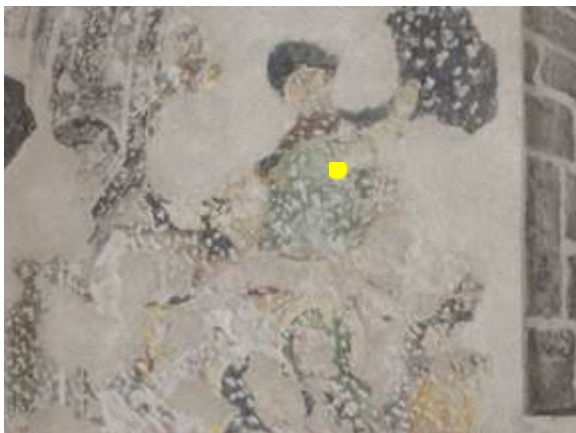
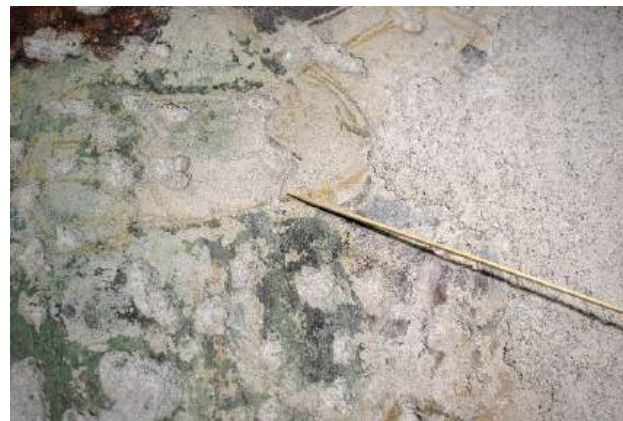
IR05\_A6

**Location:** Sleeve of St. Longinus (armor).

**Interpretation:** Calcium carbonate (reference spectrum in grey). Possible oxalates (bands at about 1328 and 1694/1644 cm<sup>-1</sup>)

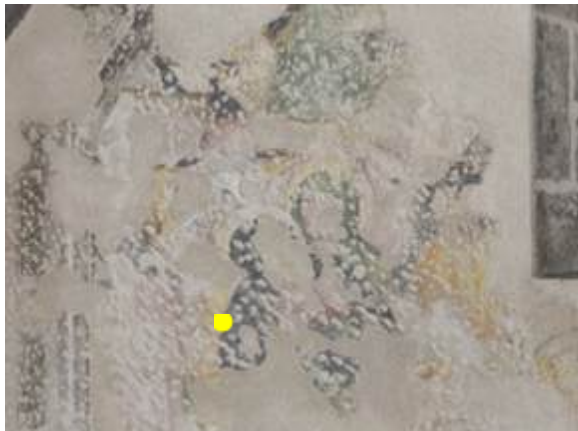
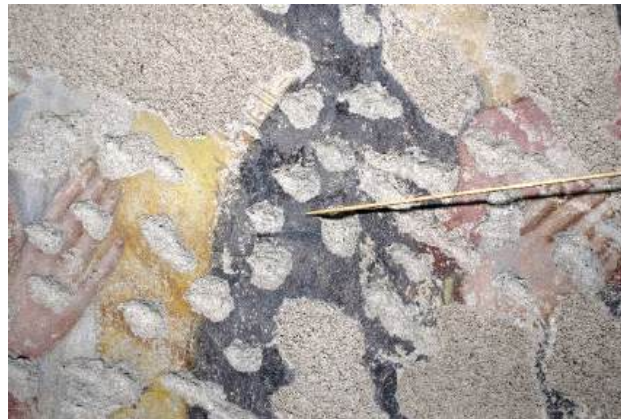
IR06\_A8

**Location:** Clothes of the Virgin Mary (preparatory layer).

**Interpretation:** Calcium carbonate (reference spectrum in grey) and magnesium carbonate (reference spectrum in black)

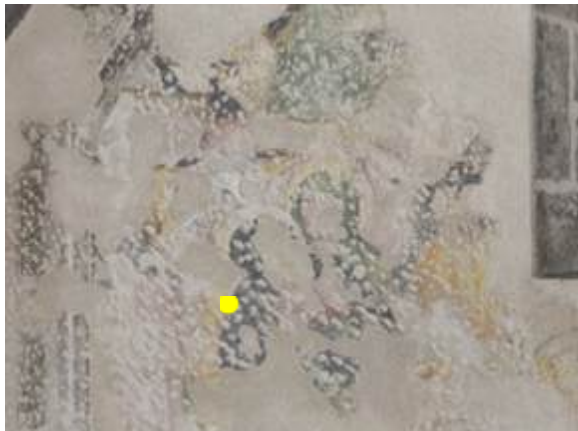
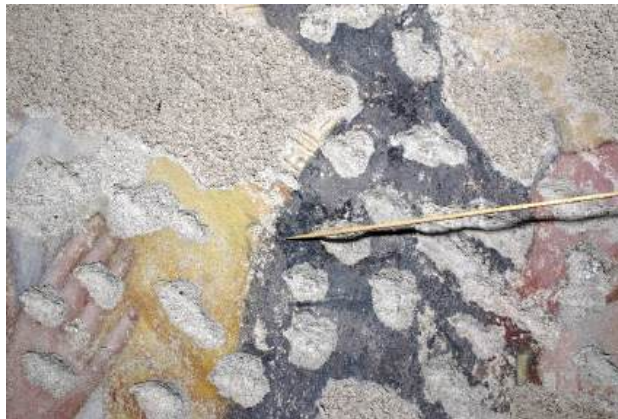
IR07\_A8

**Location:** Vestment of the Virgin Mary (finishing layer, darker).

**Interpretation:** Magnesium carbonate (reference spectrum in black), possible oxalates (band at about 1333  $\text{cm}^{-1}$ ) and possible sulfate (band at about 1119  $\text{cm}^{-1}$ )
