## CHURCH OF SAN VITTORE, MURALTO (LOCARNO)

### THE CRUCIFIXION

#### Report on the Conservation Status of the Fresco Cantiere Studio – BWP 2.1

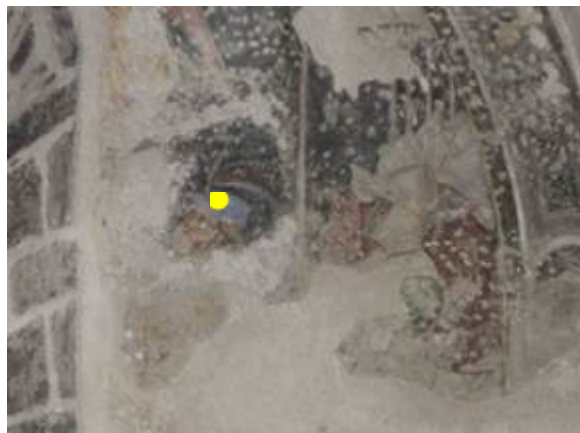
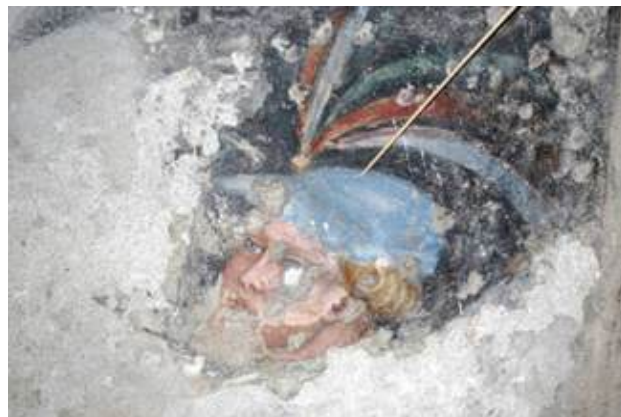
IR08\_A7

**Location:** Headpiece of one of the figures.

**Interpretation:** Calcium carbonate (reference spectrum in grey). Band at about 1226 cm<sup>-1</sup> of complex identification

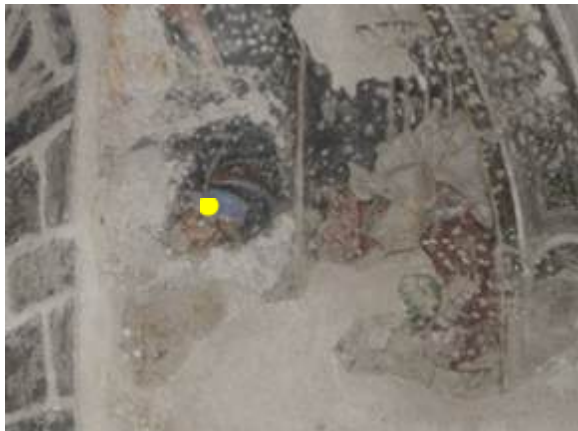
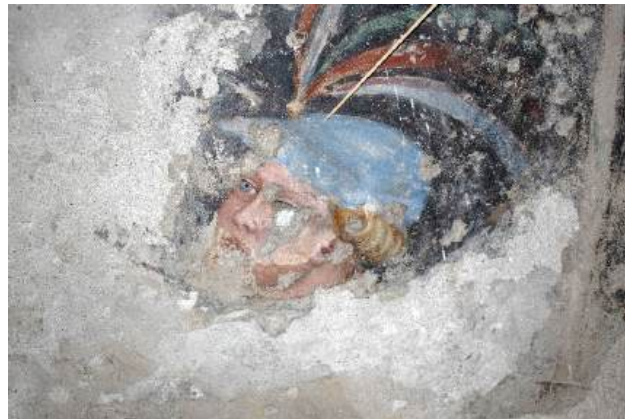
IR09\_A7

**Location:** Headpiece of one of the figures.

**Interpretation:** Calcium carbonate (reference spectrum in grey), magnesium carbonate (reference spectrum in black) and silicate component (bands at approximately 1057 and 752  $\text{cm}^{-1}$ ).

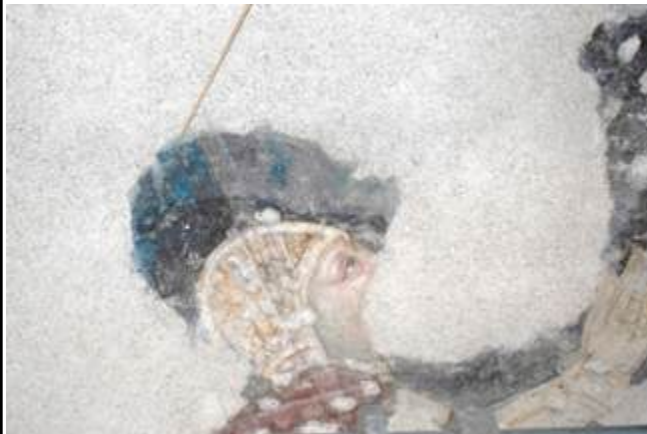
## IR10\_A6

**Location:** Background near the figure of St. Longinus.

**Interpretation:** Azurite (reference spectrum in black) and calcium carbonate (reference spectrum in gray). The bands at about 1624 and 1319  $\text{cm}^{-1}$  could be related to the presence of oxalates. The band at about 1738  $\text{cm}^{-1}$  can be attributed to the carbonyl group ( $\text{C}=\text{O}$ ) of a possible organic material

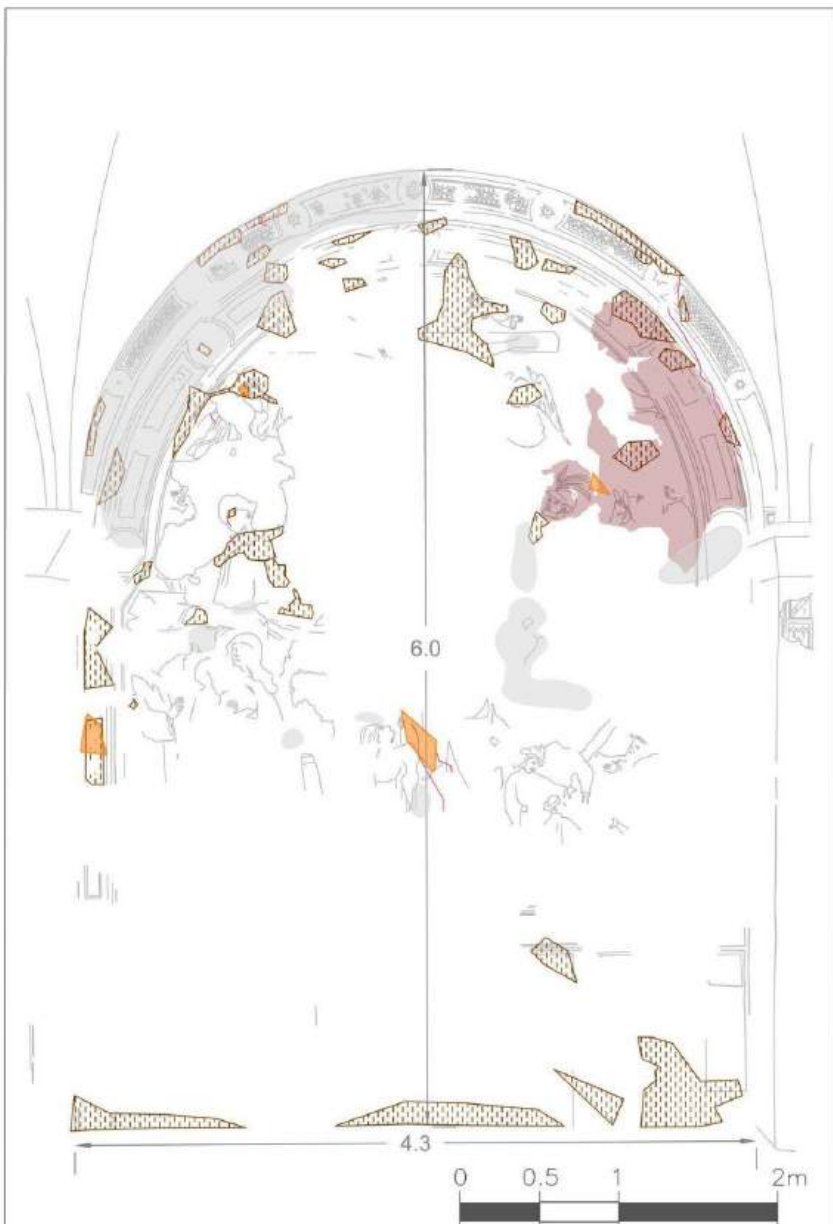
Giornate		Spolvero		Sinopia
	Battitura di corda		Incisione diretta		Disegno a pennello
	Punzonatura		Pentimento		Lamine metalliche
	Pigmento con legante organico
