VILLA MASSERIA DI CACCIAMO

COMUNE DI CALASCIBETTA

Bachelor in Conservation
Stage AW2

Student: Mahek Pednekar
Professor/Restorer: Dr. Raffaella Greca
Architect: Prof. Francesco Mannuccia
Proprietor: Mrs. Luisa Stella

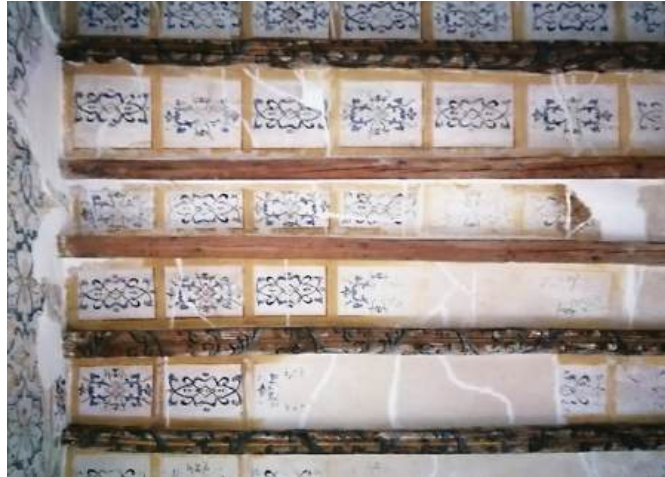
vaulted ceilings and one two flat ceilings divided with wooden beams. The walls of the 2nd and 4th rooms present a decorative perimeter band painted with repetitive motifs (Fig.8). In the 2nd room, the north wall contains a vaulted niche decorated with floral motifs (Fig.9). In the 4th room, a small vaulted antechamber is decorated with landscapes and putti framed by imitation polychrome stuccoes.

Fig.8. Repetitive motifs in Room 2

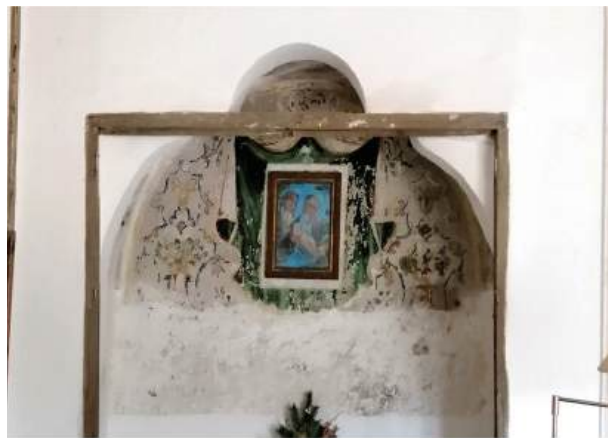
Fig.9. Vault with floral motifs in Room 2 (Chiesa)

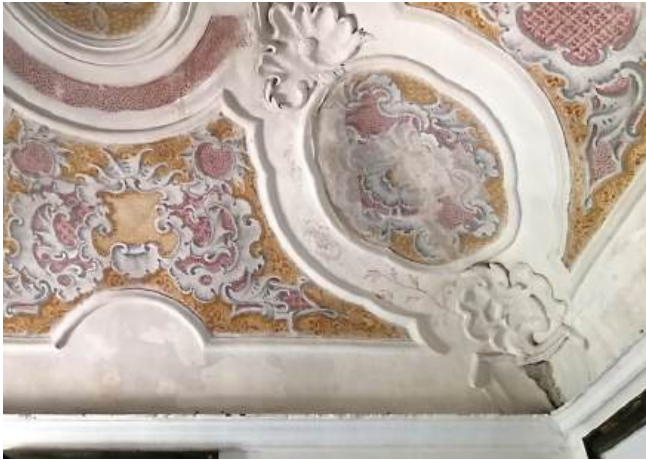
The vaulted ceilings display a late Baroque style, where the painted decoration is framed by stucco elements that divide the space and interact with two-dimensional painted cornices (Fig. 10).

Fig.10. Baroque style painting with stucco frame in Room 3

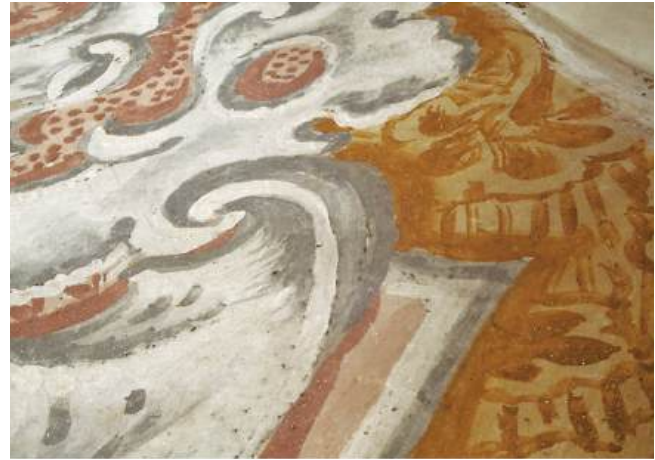
The pictorial technique used for the murals is tempera with pigments bound in lime, as evidenced by the dense application of color (Fig.11).

Fig.11. Thick application of tempera pigments

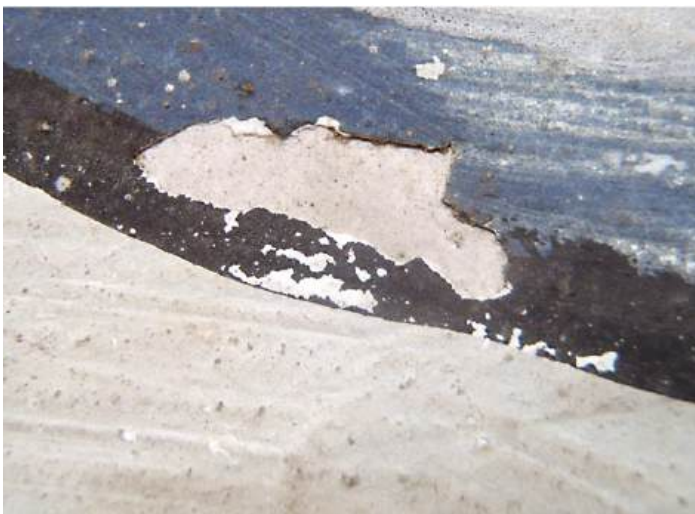
The preparatory layers consist of a first *arriccio* coat, followed by one or sometimes two plaster layers to homogenize the surface and receive the decorative painting, applied in dense tempera layers (Fig. 12). In some areas, thinner and more transparent applications occur due to reduced binder content (Fig.13).

Fig.12. Dense tempera paint layer application

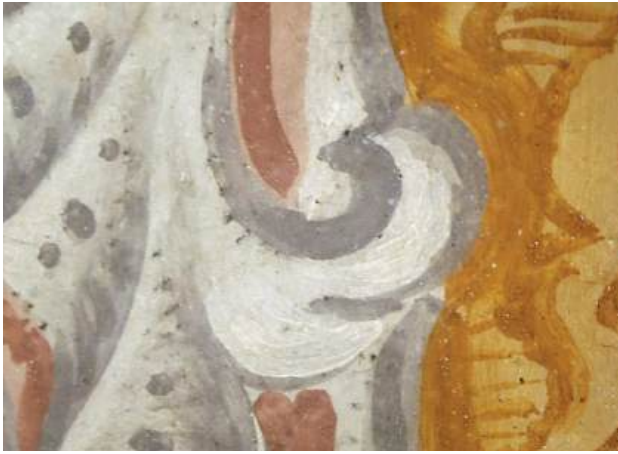
The preparatory drawing was executed directly on the final plaster layer. Traces indicate that the transfer was carried out using the *spolvero* technique (pouncing) (Fig. 13), as well as the use of cartoons for line guidance and stencils for reproducing repetitive motifs.

Fig.13. Traces of spolvero technique

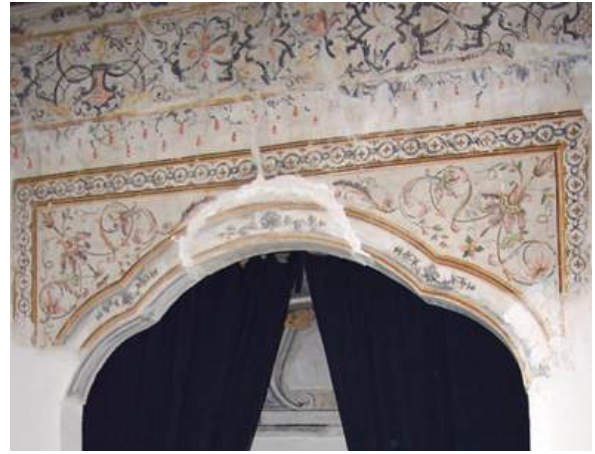
Fig.14. Grottesque-like decoration in Room 4

On the flat ceilings, cooler tones appear: alongside ochres and black, green is also used. Here, the paint layers contain less medium, producing thinner applications and giving the decorations a more linear, almost grottesque-like style (Fig. 14)

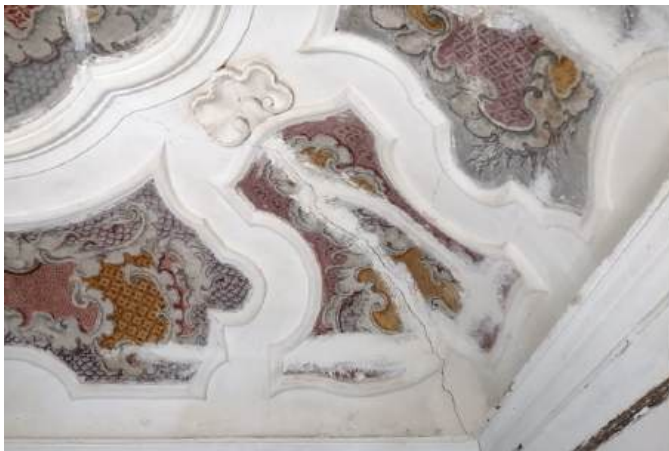
The current state of conservation of Villa Masseria di Cacchiamo and its decorative apparatus reflects a complex interaction between the historical phases of construction, the materials originally employed, the effects of time, and the impact of previous restoration campaigns. Structurally, the building is stable, though not free of critical issues. The masonry walls show evidence of past movements and settlements, with localized cracks and fissures that have been partially addressed in earlier consolidations but which remain visible in some areas (Fig.14). Rising damp continues to affect the lower levels of the walls, as well as the decorative borders in room 2, manifesting in salt efflorescence, powdering, and the partial detachment of plaster layers (Fig.15).

Fig. 14. Visible localised fissures and cracks

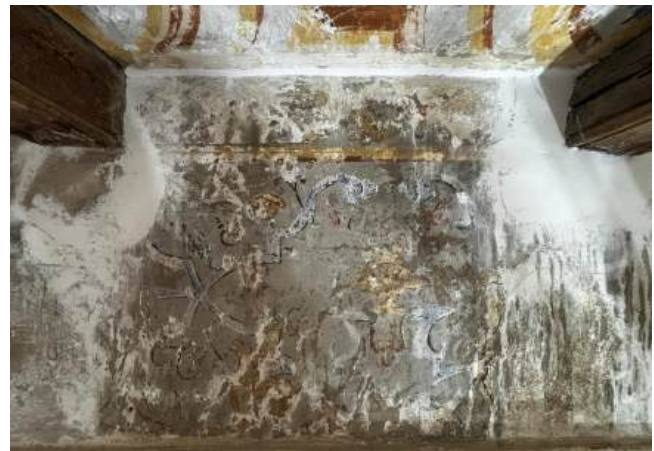
Fig.15. Salt Efflorescence and dampening

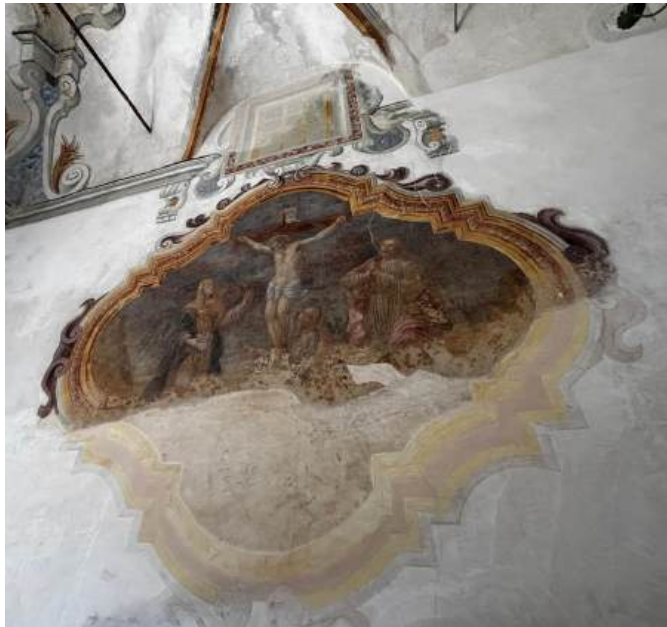
The interior spaces, particularly those of the chapel of San Giuseppe, present greater vulnerability. The frescoes by Giuseppe Tresca, while stabilized in certain zones during past interventions, are still compromised by residual incompatibilities from earlier treatments. Pigment layers in some areas show chromatic alteration, particularly where animal glues or synthetic resins were previously used. Small lacunae and flaking persist, especially in zones exposed to humidity fluctuations. Surface deposits of dust and candle smoke residues are visible, diminishing the chromatic legibility of the painted surfaces. Stuccoes, though largely intact, present micro-cracks, losses of adhesion, and localized detachments (Fig.16).

Fig.16 Fresco in the chapel of San Giuseppe

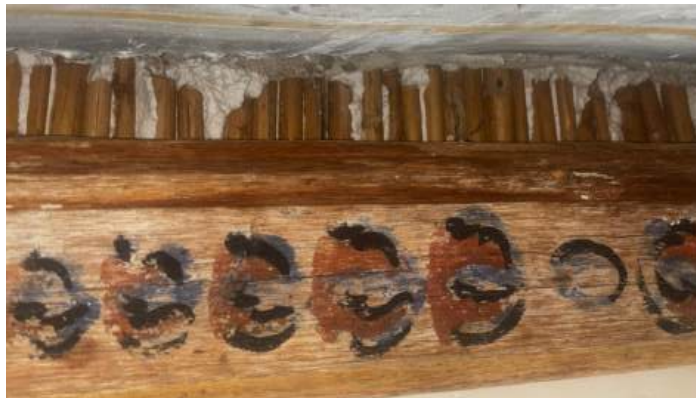
Wooden elements, including beams and decorated furnishings, show evidence of previous attacks by xylophagous insects. While repeated treatments have eliminated active infestations, the structural sections retain traces of past damage and areas of fragility (Fig.17).

Fig.17 Traces of deterioration of wood

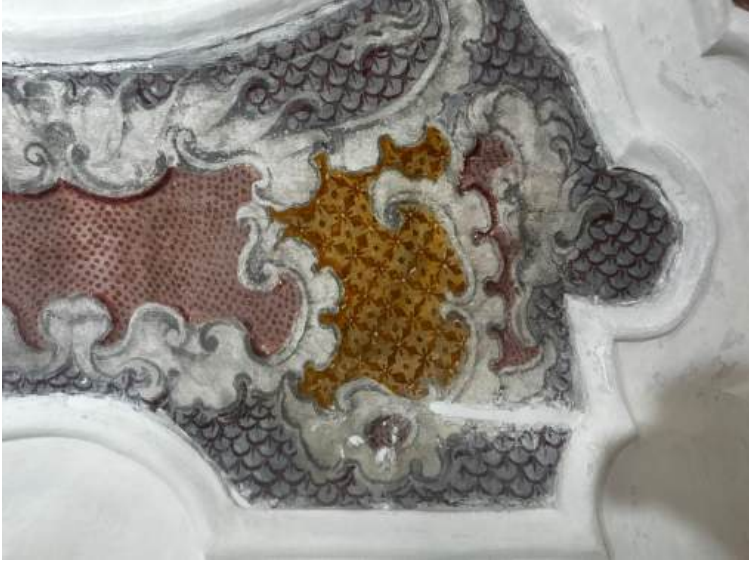
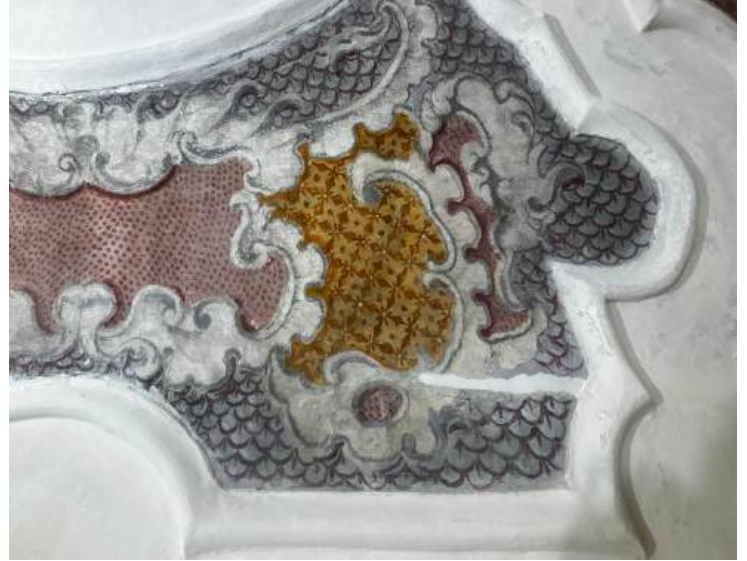
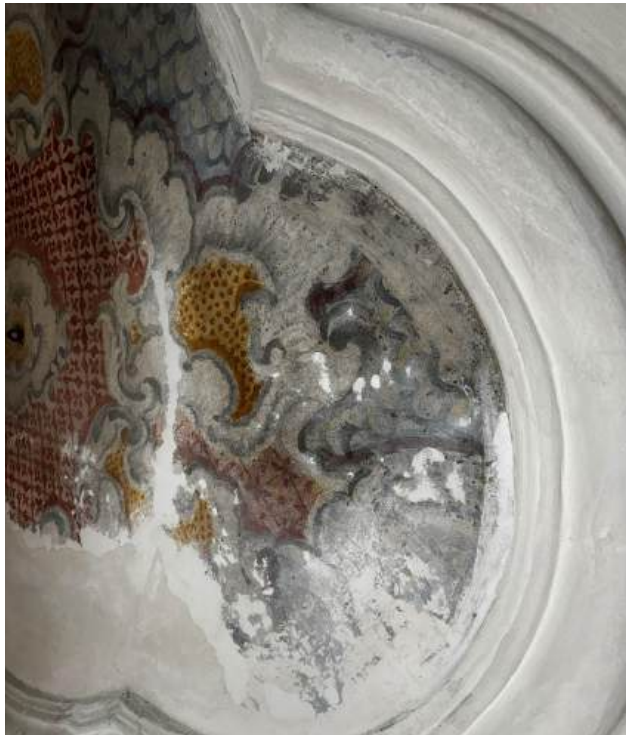
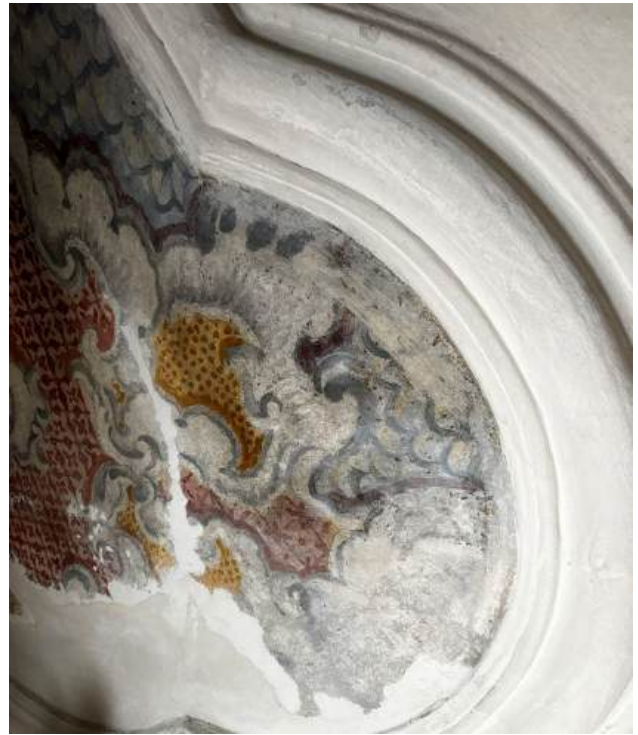
Fig. 18. Before Retouching

Fig. 19. After Retouching

Fig. 20. Before Retouching

Fig. 21. After Retouching

During the first week of conservation activity, work was carried out on the mural paintings on the ceiling of Room 1. Retouching was performed using synthetic brushes and gouache, a water-based medium particularly suited for reversible interventions, applied according to the principle of chromatic integration. This technique was done for the reintegration of abrasions and minor losses while intentionally leaving plaster fillings and lacunae untreated for later intervention (Fig.18,19,20,21). In certain areas, where decorative motifs had lost their clarity and balance, subtle darkening and shading were introduced to recover their legibility and restore a more coherent aesthetic unity. These operations were carefully calibrated to respect the principle of distinguishability, ensuring that the additions complemented the original work without creating false historical readings.

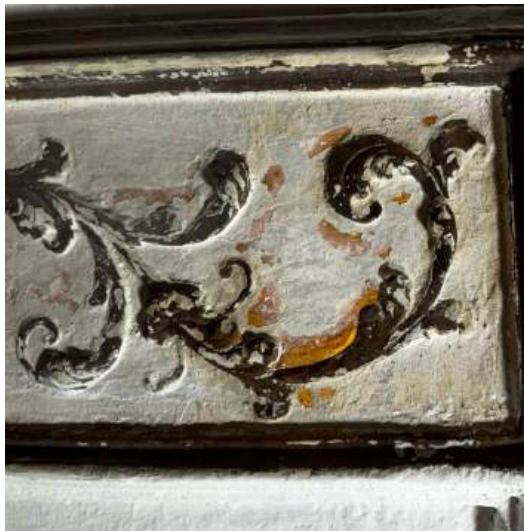
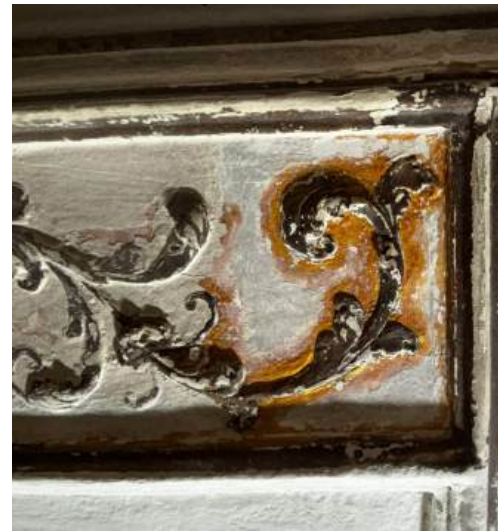
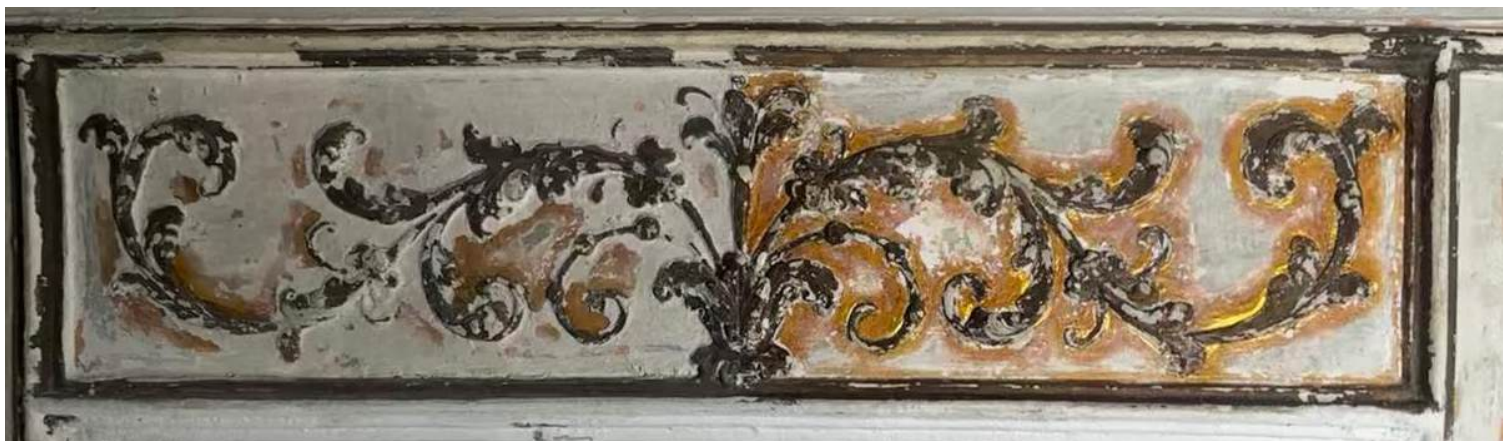
Fig.22 Before cleaning with scalpel

Fig.23 After cleaning with scalpel

Fig.24 On the left is the unclean side in comparison to the cleaned side on the right

In the second week, attention shifted to the stucco-decorated frames, which still preserved traces of gilding. Since gilded surfaces are highly sensitive to water, cleaning was performed with a 1:1 solution of deionized water and alcohol, applied with a brush first and then lightly dabbing with a damp sponge to remove surface dirt and deposits. In order to uncover the authentic gilded details and stucco modeling, residual *scialbatura* (limewash layers) and *schizzi di malta* (mortar splashes from earlier works) were removed mechanically with a scalpel in fine, controlled strokes (Fig.22,23,24). The same procedure was applied to the stucco decorations in Room 2.

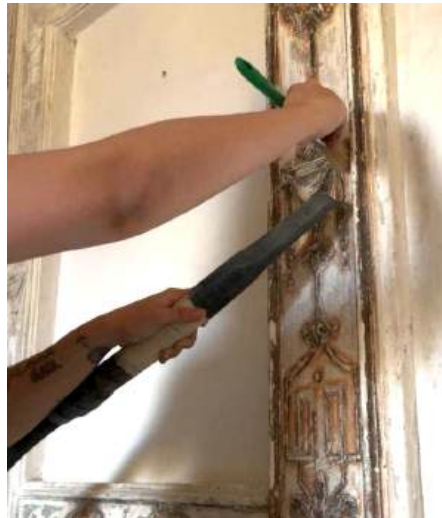
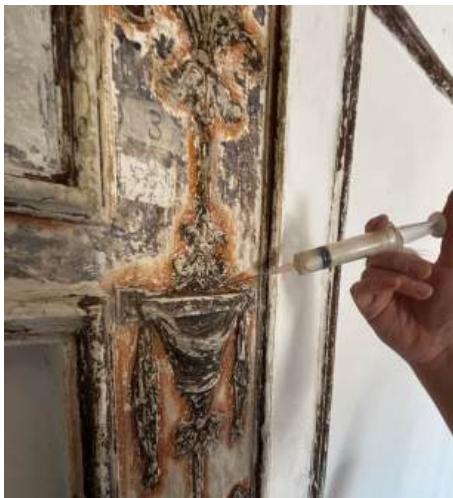
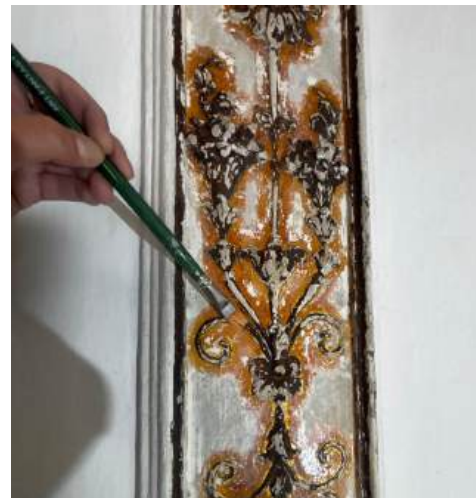
Fig.25 Cleaning dust particles with vacuum cleaner and a brush

Fig.26 Acryl 33 consolidation using a syringe

Fig.27 Acryl 33 consolidation using a brush

Following this, all frames were re-cleaned with soft-bristled brushes and a vacuum system to eliminate fine dust particles in preparation for consolidation (Fig.25). Consolidation was carried out using Acryl 33 (an acrylic copolymer dispersion produced by CTS, Florence), diluted to 5% in water. Acryl 33 is particularly valued in conservation for its ability to penetrate porous and friable stucco, strengthening it internally while maintaining reversibility and not significantly altering the material's appearance (*CTS Technical Datasheet, 2005*). The resin was applied both with a brush on surface areas and with a syringe for injection into deep crevices, ensuring uniform reinforcement (Fig.26,27).

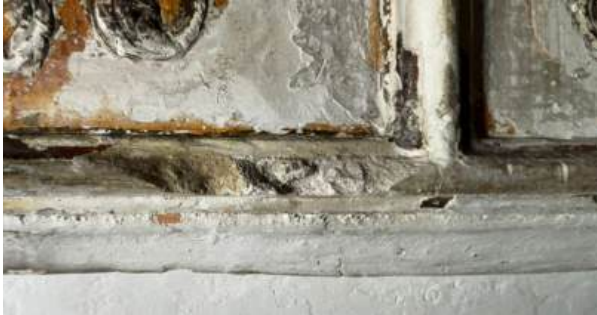
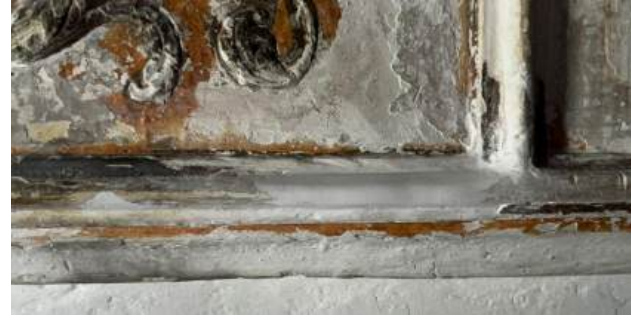
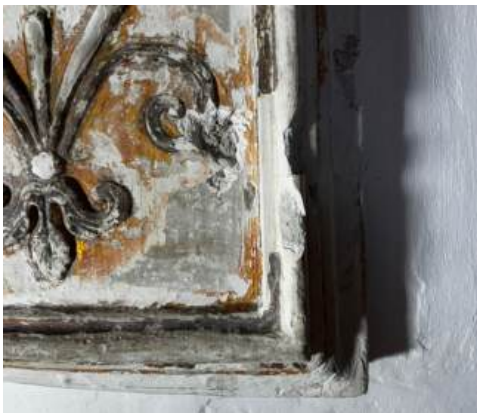
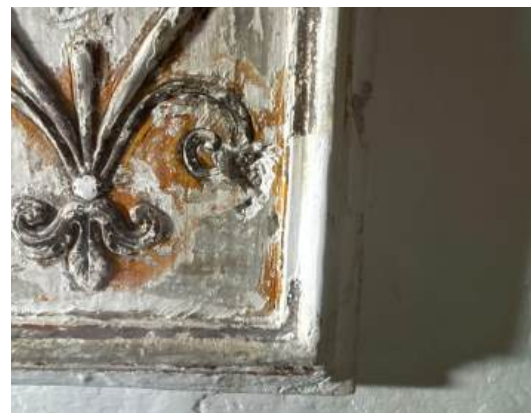
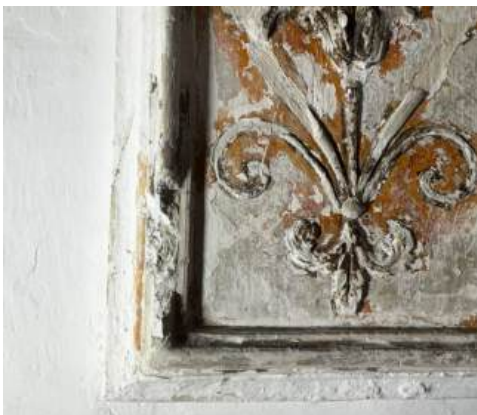
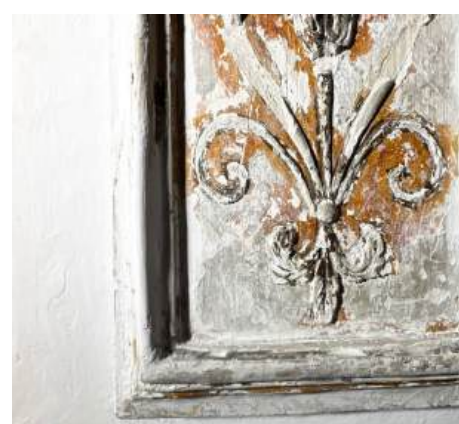
Fig.28 Lacunae

Fig.29 After filling the lacunae

Fig.30 Lacunae

Fig.31 After filling the lacunae

Fig.32 Lacunae

Fig.33 After filling the lacunae

Losses in the stucco were then addressed with a filling paste composed of gesso and water, prepared to a toothpaste-like consistency, which was applied into lacunae, shaped, and once dry, refined with fine sandpaper to harmonize with the original decoration without erasing the distinction between old and new (Fig.28,29,30,31,31,33).

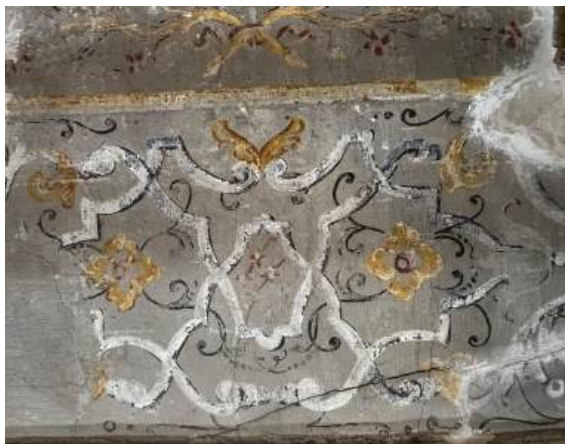
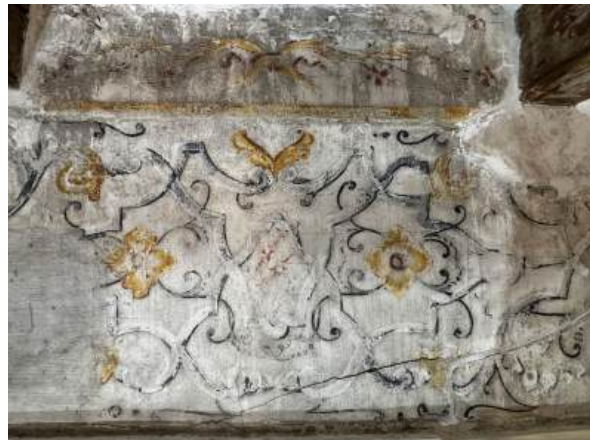
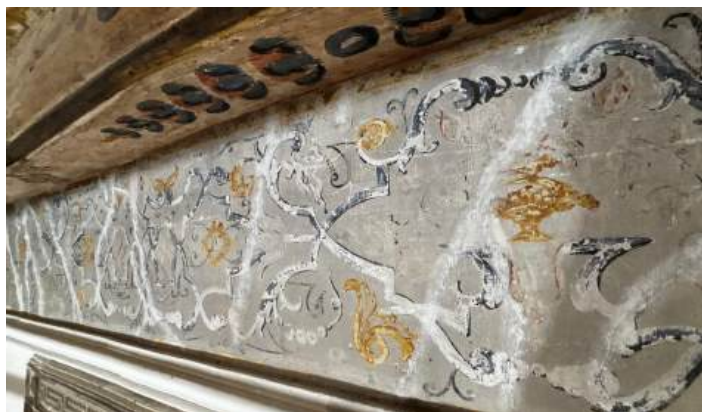
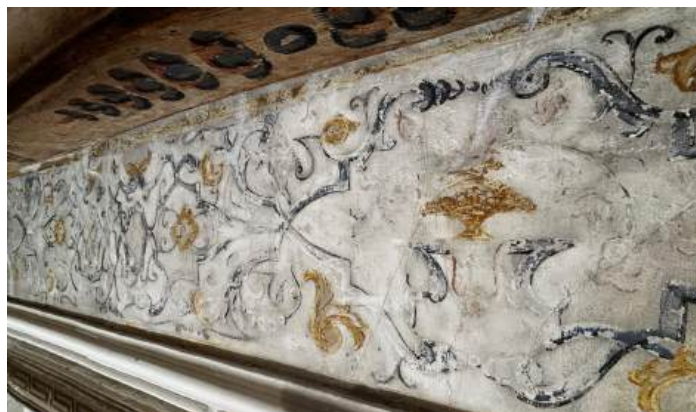
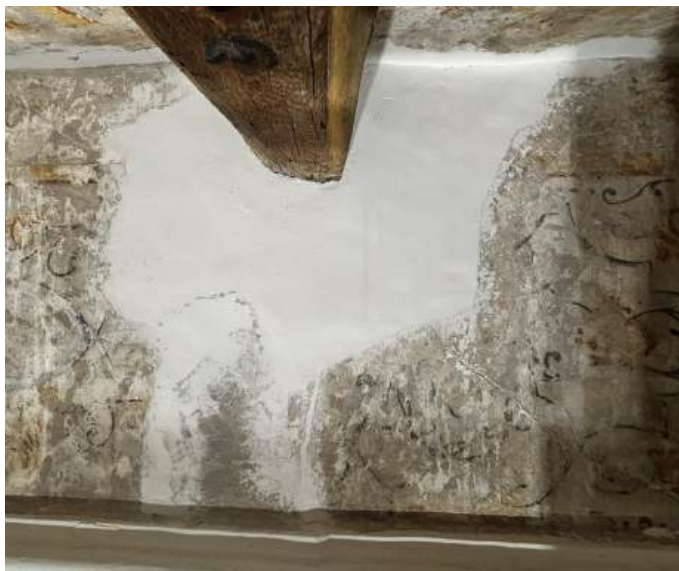
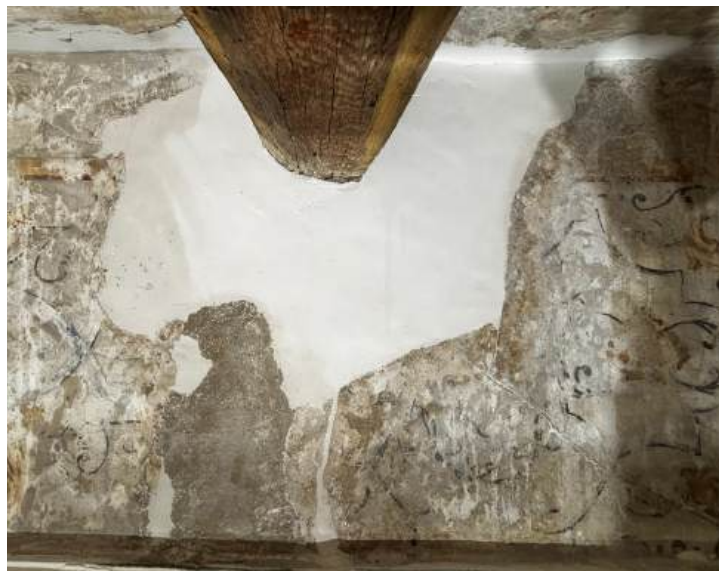
Fig.34 Before cleaning

Fig.35 After cleaning

Fig.36 Before cleaning

Fig.37 After cleaning

Fig.38 Before cleaning

Fig.39 After cleaning

The third week focused on the painted borders beneath the ceiling in Room 2, decorated with polychrome motifs in red, blue, and yellow. These pigments were found to be unstable and highly sensitive to moisture, and for this reason, cleaning was carried out with damp sponges using gentle circular movements on the surrounding areas while avoiding direct contact with the most delicate pigments (Fig.34,35,36,37). In addition, previous fillings that had encroached unnecessarily onto the painted surfaces were softened with water, gently lifted with a sponge, and subsequently refined with a scalpel (Fig.38,39). New fissures and cracks that emerged during cleaning were carefully filled with gesso mixed with water. A complete consolidation of the powdering pigments was performed first using Acryl 33 in 10% solution and then another round of Acryl 33 in 5% in order to consolidate the pigments and keep them in place.

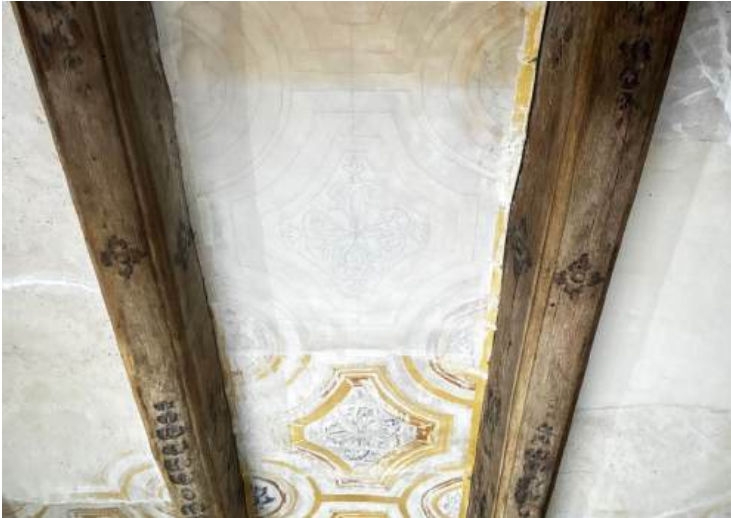
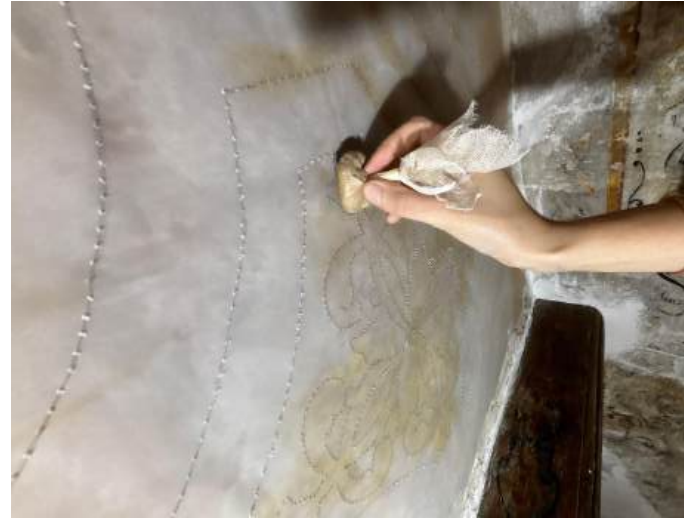
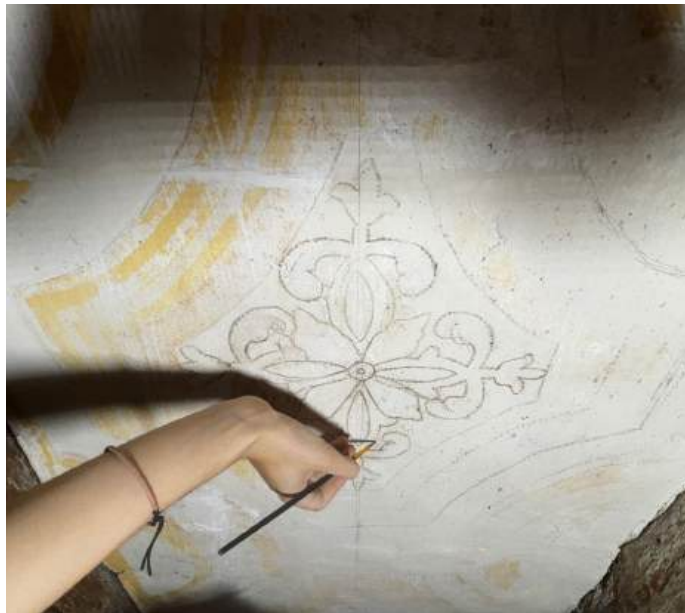
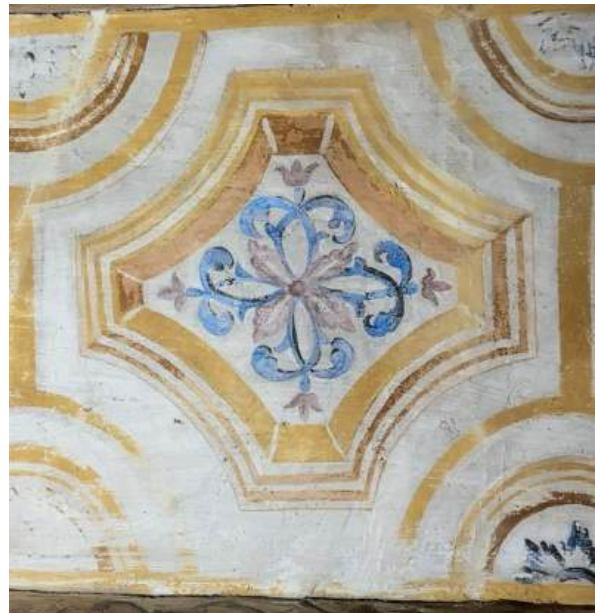
Fig.40 Tracing the designs on a translucent paper

Fig.41 Process of pouncing

Fig.42 Redefining the points

Fig.43 Painting in to complete the motif

In the same period, the ceiling of Room 2 was also the subject of decorative reconstruction in areas where the ornamental painted motifs were entirely lost. The traditional *spolvero* method was used to transfer the missing designs, a technique with long-standing application in fresco painting and decorative reintegration. First, the surviving decoration was traced in pencil on translucent paper, which was then perforated along the outlines with fine pinpricks (Fig.40). This perforated tracing was placed over the damaged areas, and a linen pouch filled with dry pigment was gently tapped over the surface, producing a dotted outline on the plaster (Fig.41). The transferred dots were then joined to reconstruct the motif, refined with pencil, and subsequently reintegrated chromatically to complete the motif (Fig.42,43). This process involved applying transparent, water-thinned layers of paint, gradually building up color until the reconstructed design blended visually with the surrounding decoration. The intervention allowed for a more complete and harmonious reading of the ceiling decoration, while maintaining fidelity to conservation principles of reversibility, legibility, and aesthetic integration.

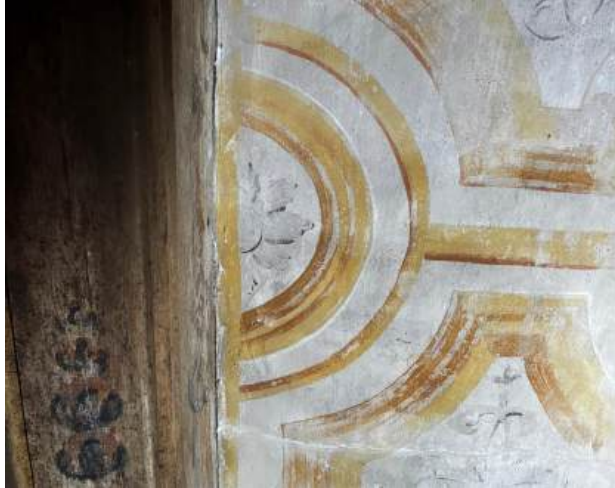
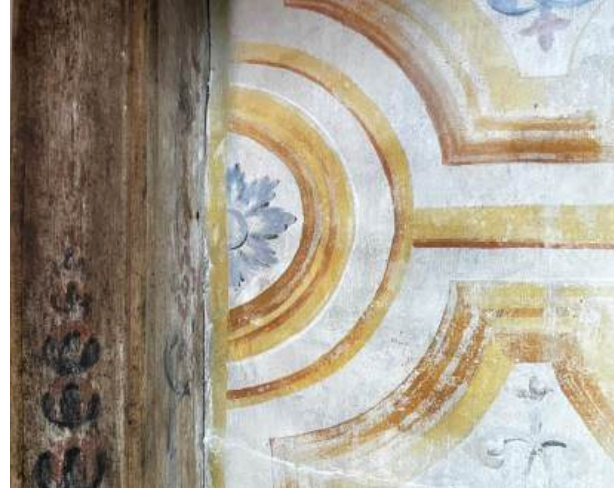
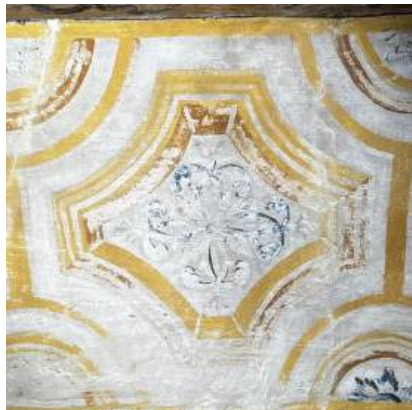
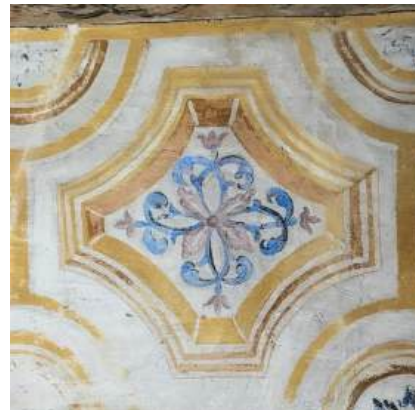
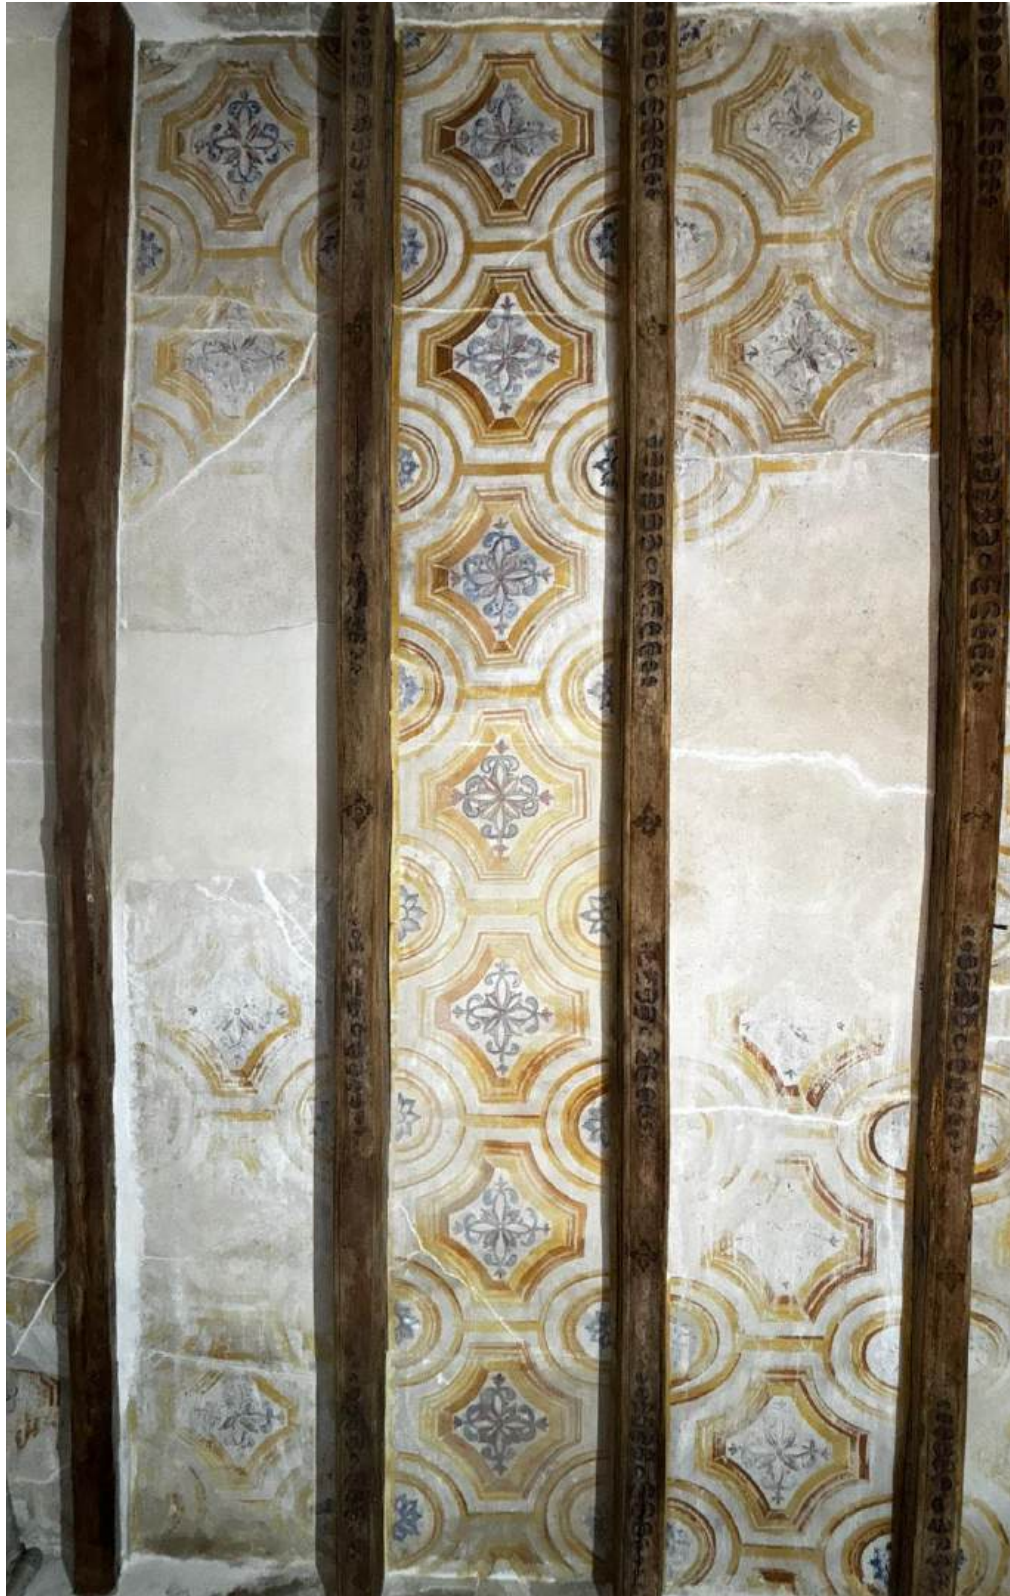
ig. 44 Before retouching

Fig. 45 After retouching

Fig. 44 Before retouching

Fig.46 Re-integration and retouching of one entire phase of the ceiling
