Restoration Report

**Restoration of
The Vestibule in Villa Medici of Merignano
Induno Olona (VA)**

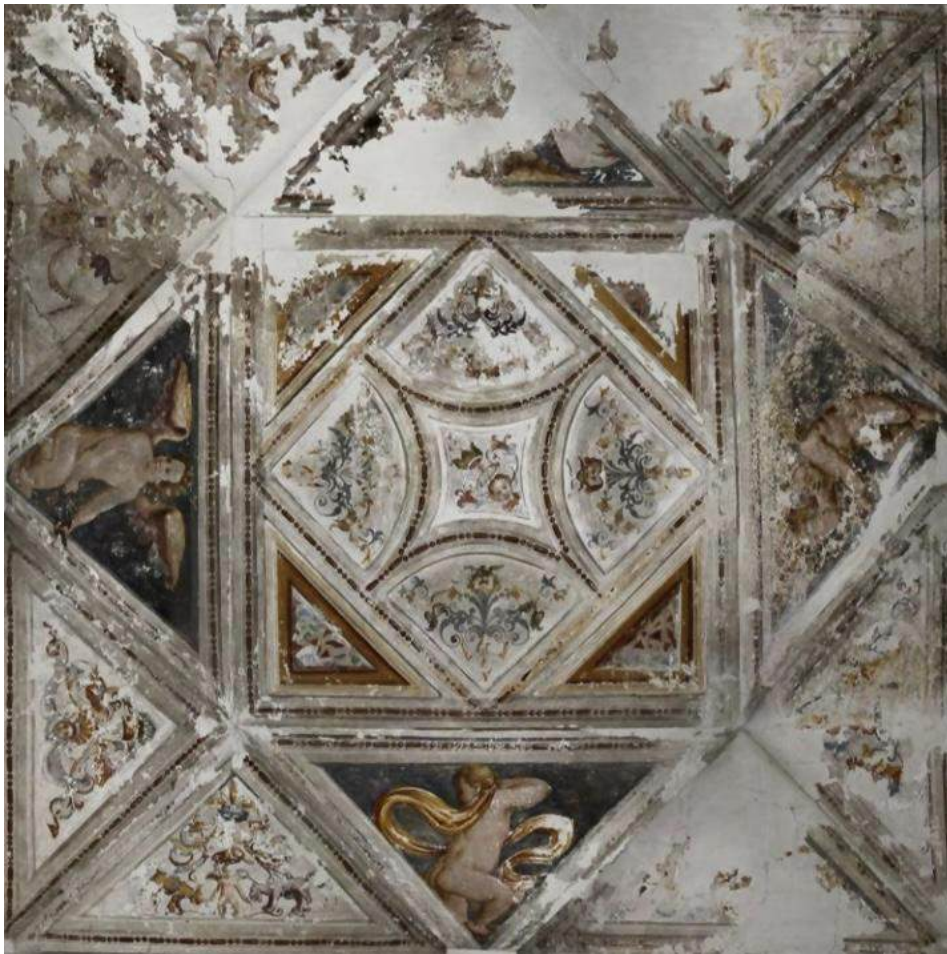
Fig 3 - The Vestibule Vault, before restoration intervention

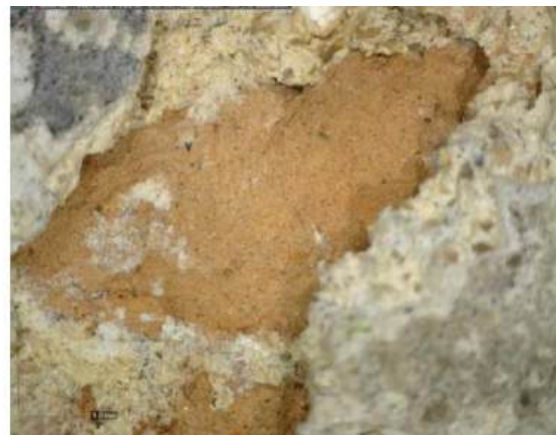
Fig 12 - View of brick of the support

The bricks of the vault are covered with several layers of mortar. The final layer of plaster is particularly smooth, with barely perceptible aggregates. In the degraded areas, numerous calcinaroli are clearly visible. These stones, due to their greater rigidity, have contributed to the formation of shrinkage cracks. The abundant presence of calcinaroli suggests the use of a magnesium-based air lime, which, over time, causes cracking in the mortar due to its expansion.

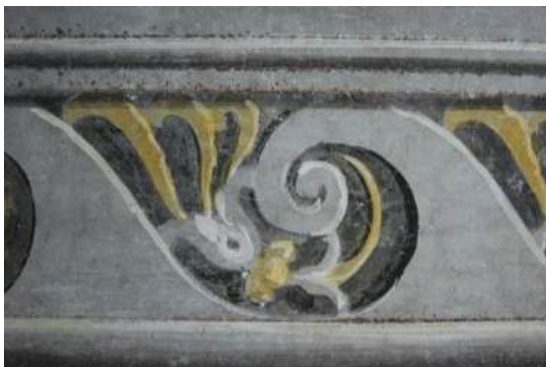
Fig 13 - Red pigment soaked cord splatter

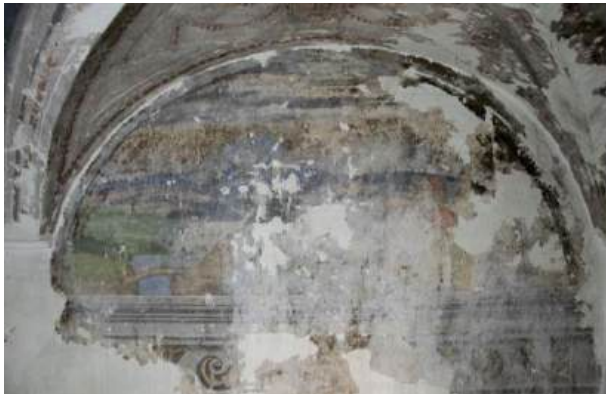
Fig 26 - Lunette Area LNE3

The plaster layers show widespread detachment and fractures. These discontinuities are likely caused by structural stresses related to the construction of the church adjacent to the vestibule. The detachment is particularly evident in areas where it overlaps with fractures, especially in the lunettes, suggesting a correlation between the two phenomena. In some instances, the fractures had been previously filled with stucco, but the detachment persists, indicating the need for consolidation interventions. Moreover, the presence of significant dust and dirt within these fractures suggests that they are not recent.

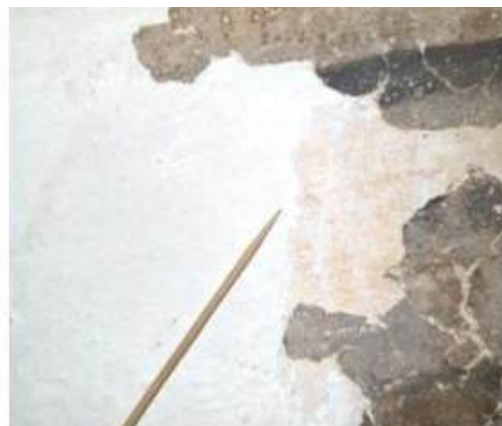
Fig 32 - Reverence point of gray whitewash, VSE2

The removal of the whitewash was carried out using different methods depending on the layer's composition and location (Figure 32). The main techniques for de-whitewashing were: Mechanical dry removal using scalpel and/or chisel and hammer, Abrasive mechanical dry removal using a multifunction tool (Dremel®) and softening with a poultice of saturated ammonium carbonate solution and cellulose pulp (1:1 ratio), left for 30 minutes to 2 hours, followed by mechanical removal with a scalpel.
